# BRIDGE ASSESSMENT REPORT

## Municipal District of Lesser Slave River

Bridge File 71600  
Athabasca River

NOVEMBER 2022

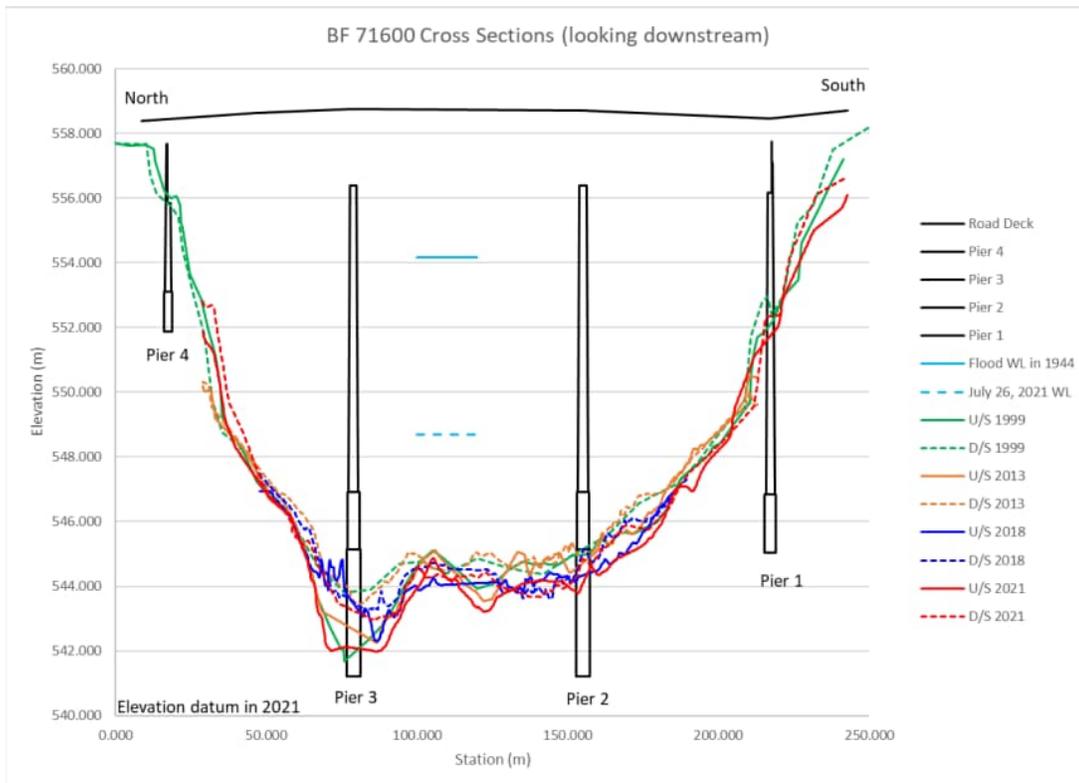
Figure 4-1  
Cross Section from 2021 Scour Survey

Figure 4-1 shows a cross section at the piers noting the scour recorded in previous inspections.

The scour survey recommended the removal of the accumulated debris at Pier 5, and to carry out scour surveys every 3 years to closely monitor the scour development. Drift removal should take place prior to every inspection.

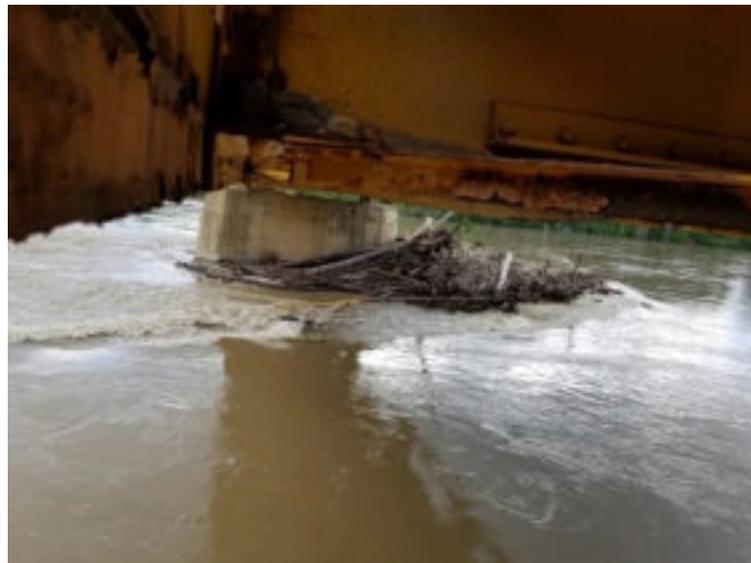
**Figure 5-1**  
**General View of Pier 5 - Looking South**

- Substructure:
  - The north embankment is in 'poor' condition as it is located within an area of unstable soil. Although there has been recurring maintenance and repairs to the north approach, average slope movement is recorded to be 150 mm per year.
  - Heavy scaling was recorded on Piers 4 and 5.
  - Significant debris has accumulated at Pier 5, as shown in **Figure 5-1**, allowing scour to further develop.
  - The bridge was rehabilitated in 2009 which included retrofitting the concrete piers to accommodate the replacement bearings.

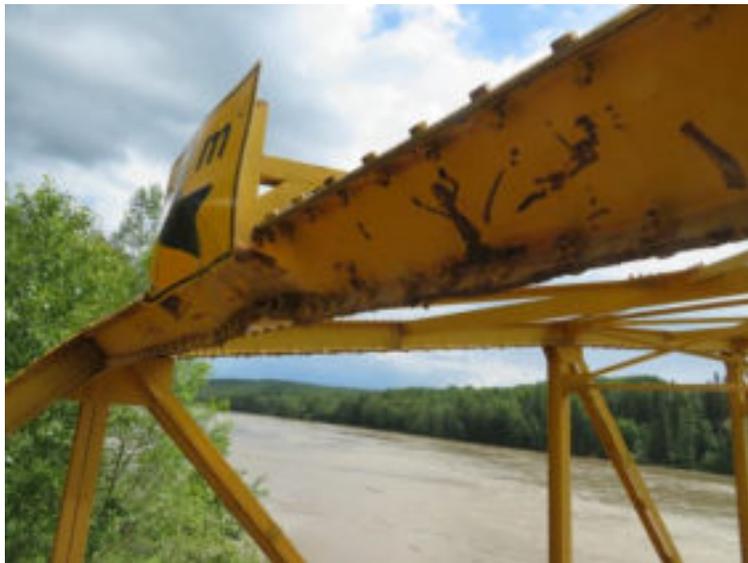
**Figure 5-2**  
**General View of Portal at North Entrance of Span 6**

- Superstructure:
  - There are several steel components that have some degree of damage and need to be either straightened or replaced. These elements include a number of bent sway braces and the portals, batter posts with nicks and minor bending, diagonal members with minor cracks, deteriorated welds at cross bracing connections, minor dents and bending at vertical members, cracked or missing bolts and a twisted bottom chord at NE due to improper jacking of the truss. **Figure 5-2** shows the typical damage on all the portal struts located at the entrance of the trusses.

- Several bearing anchor bolts are bent or missing, demonstrating how the north embankment has progressively pushed the bridge.
- Wheel guards have worn out with several sections missing through the bridge.
- Top deck planks have deteriorated and developed potholes and rotten spots.
- North entrance guardrail is damaged.
- The bridge was rehabilitated in 2009 which included the replacement of the bearings and replacement of north approach span with a steel jump span.

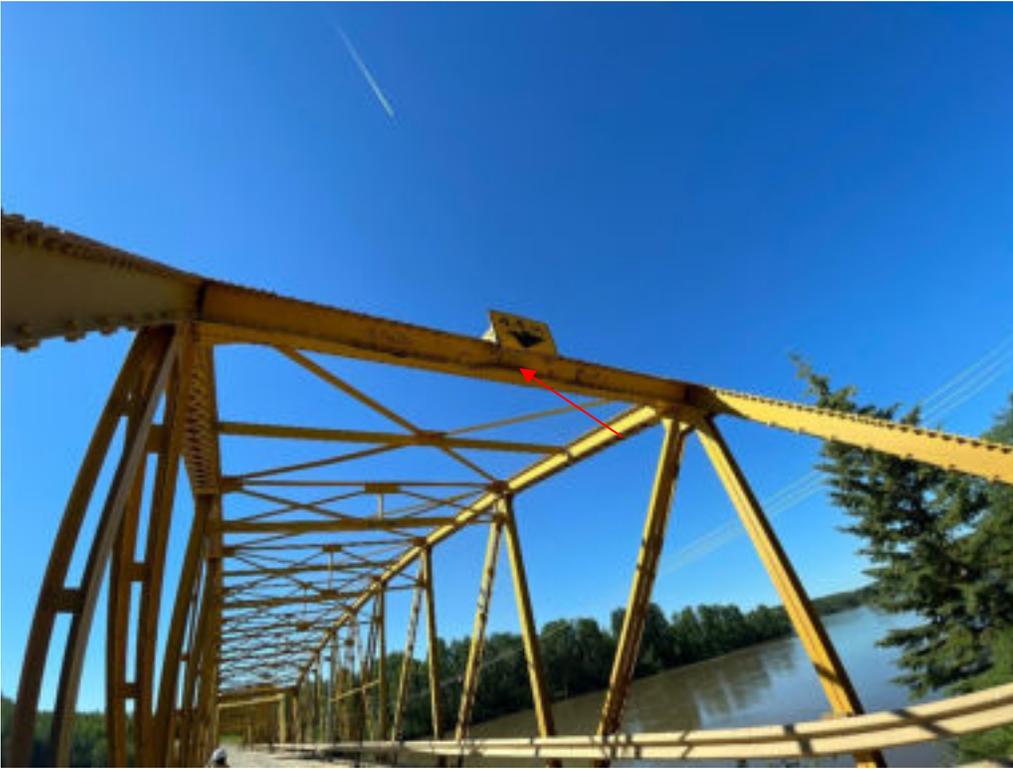
1. S6 - U1U1 damaged

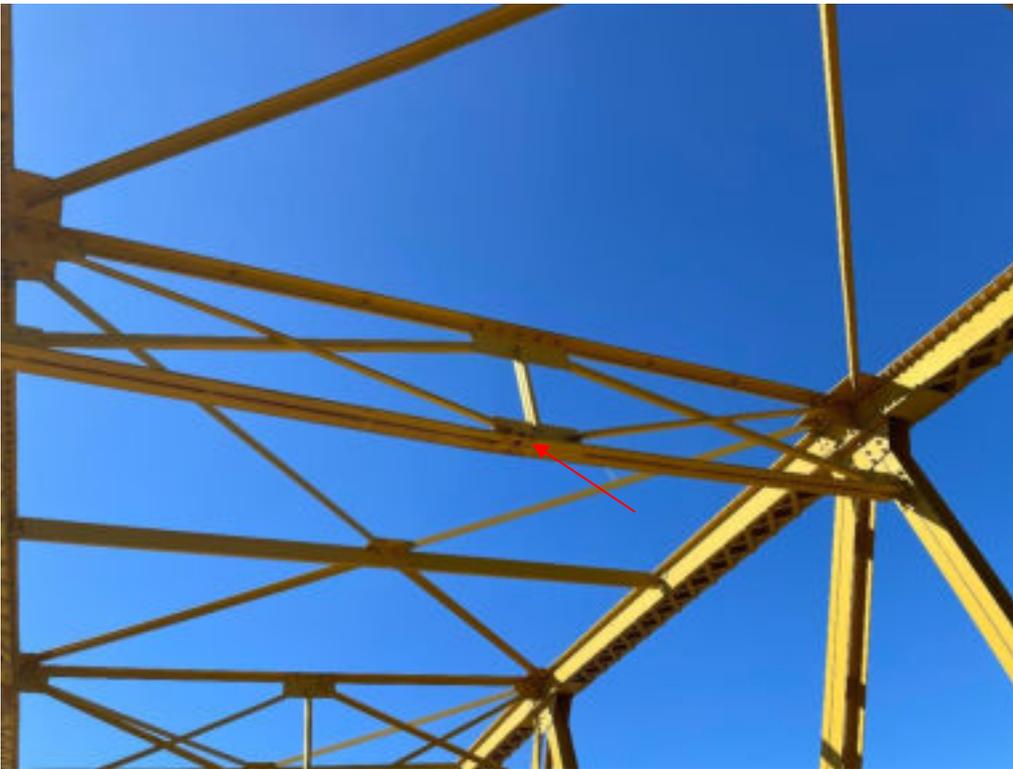
2. S6 - U2U2 damaged

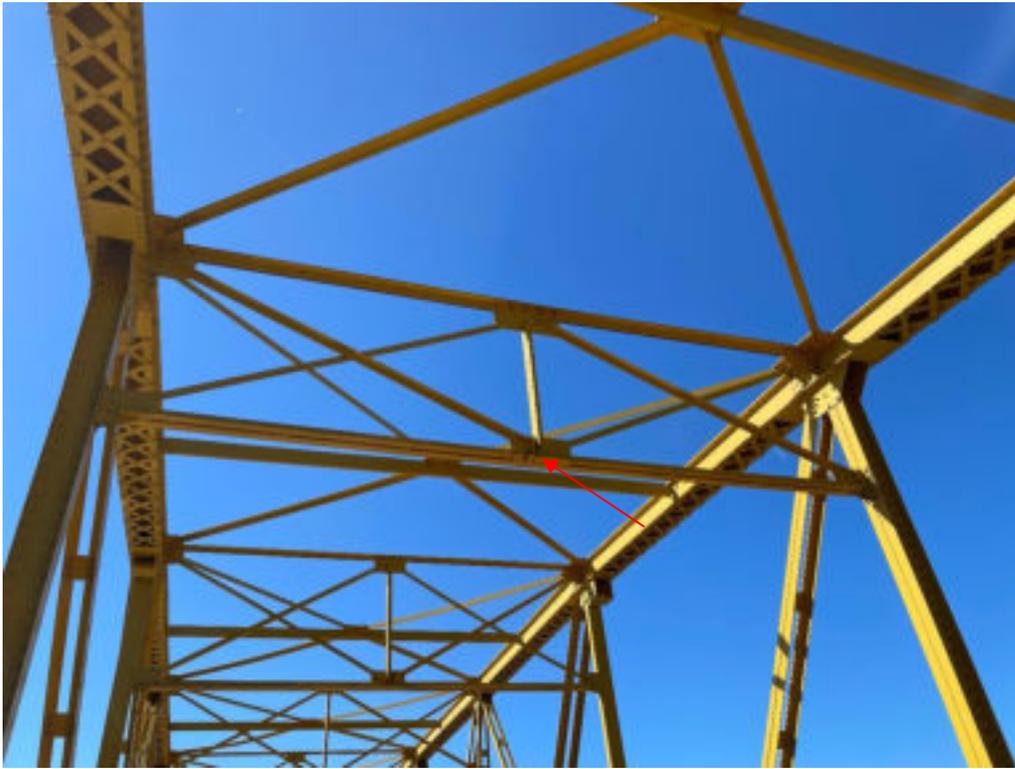
3. S6 - U3U3 damaged

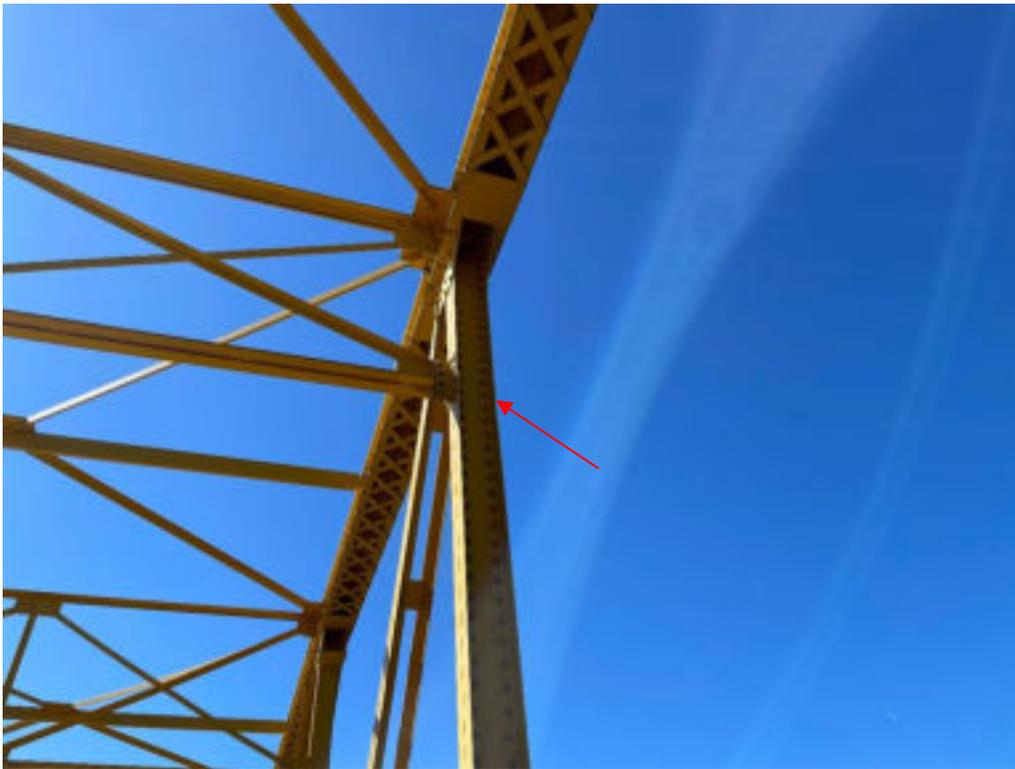
4. S6 - L3U3 damaged

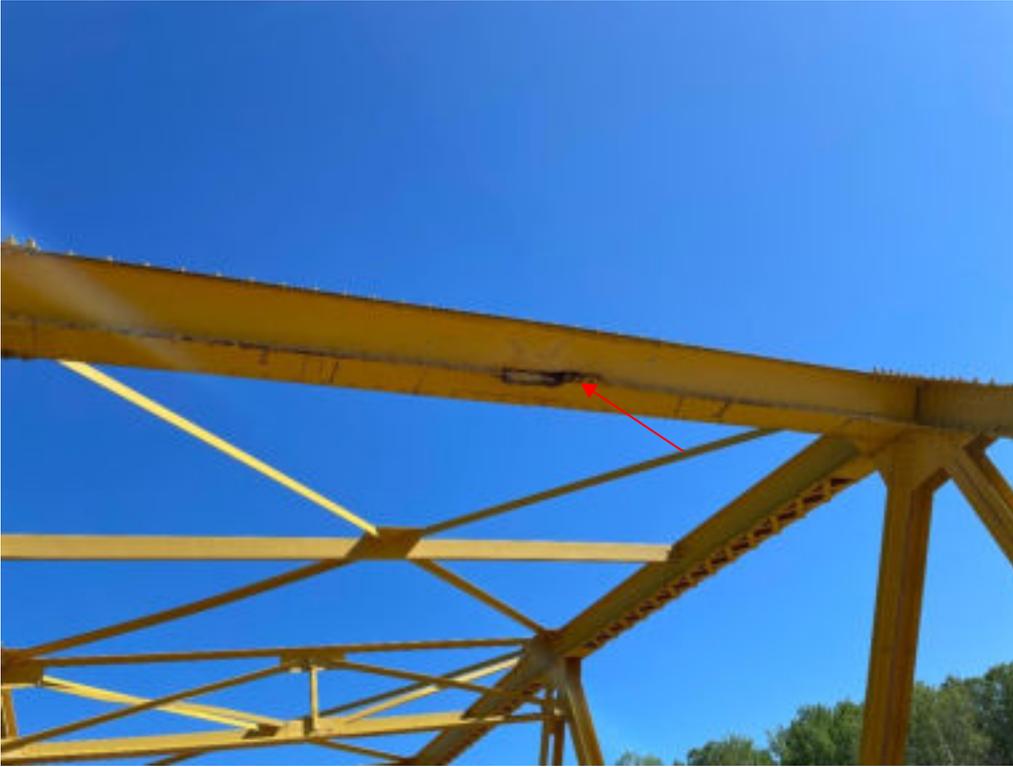
5. S6 -U9U9 damaged

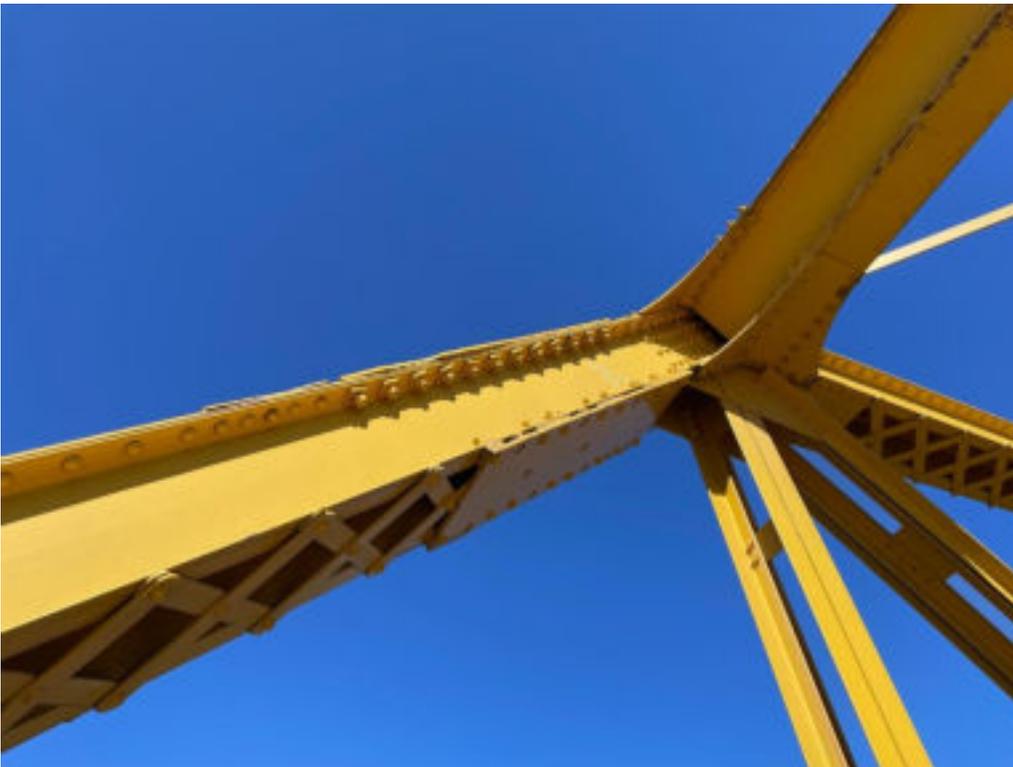
6. S6 - U9L10 W damaged

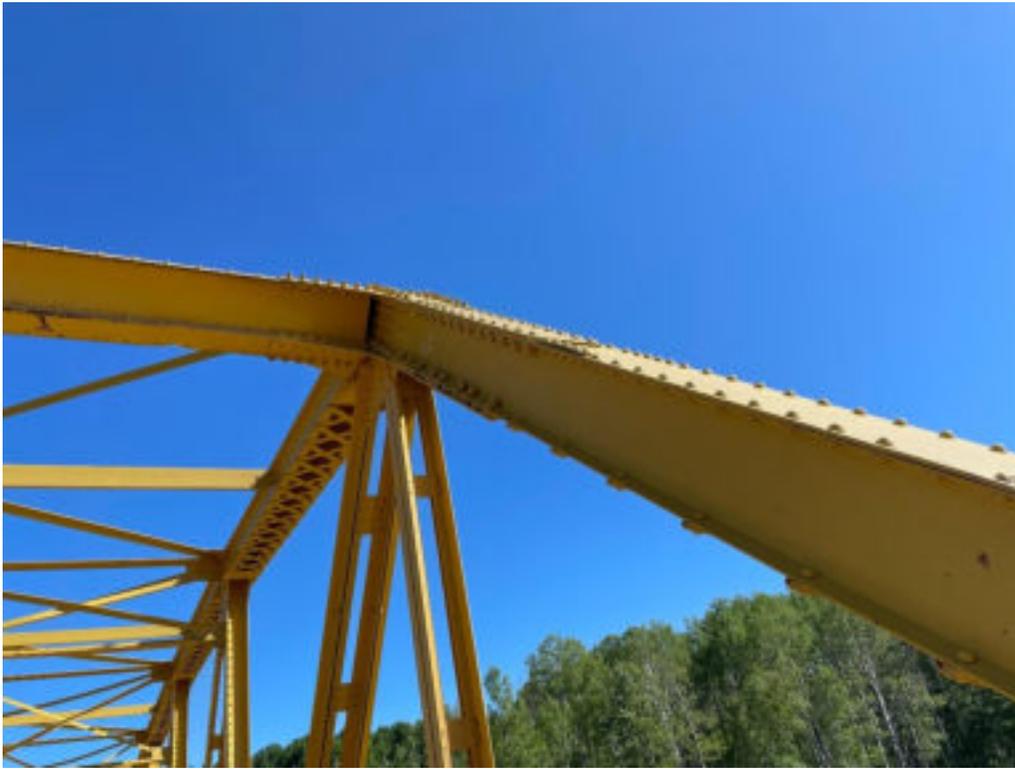
7. S6 - U9L10 E damaged

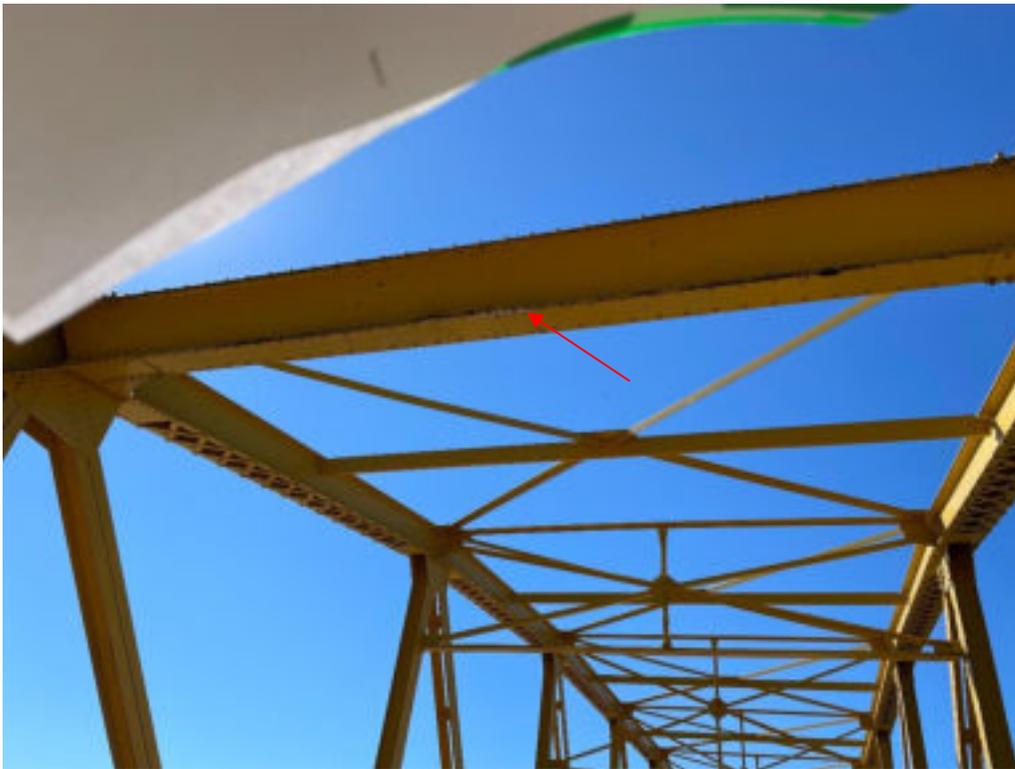
8. S5 - U1U1 E damaged

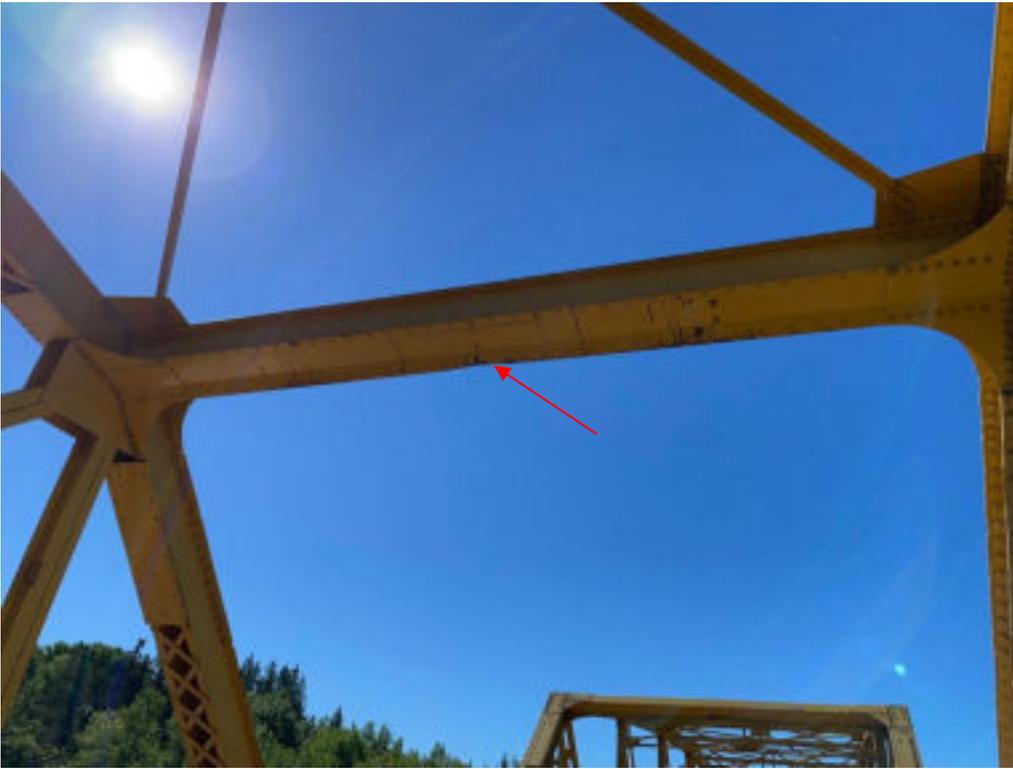
9. S5 - U11U11 E damaged

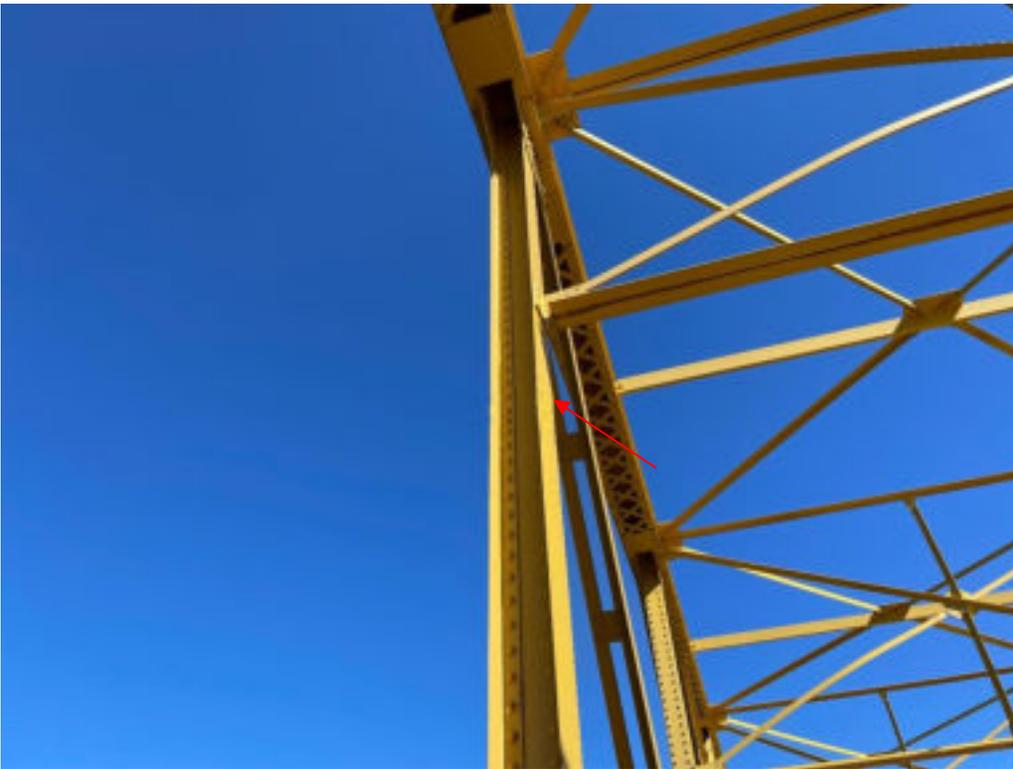
10. S5 - L8U8 damaged

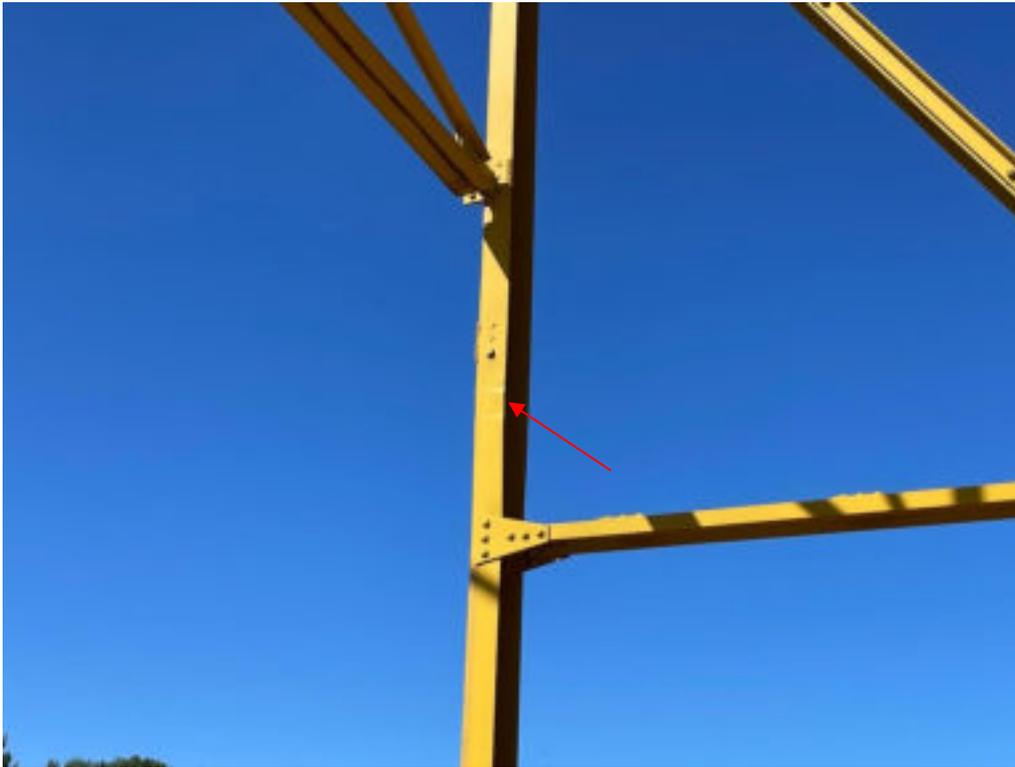
11. S5 - L9U9 damaged

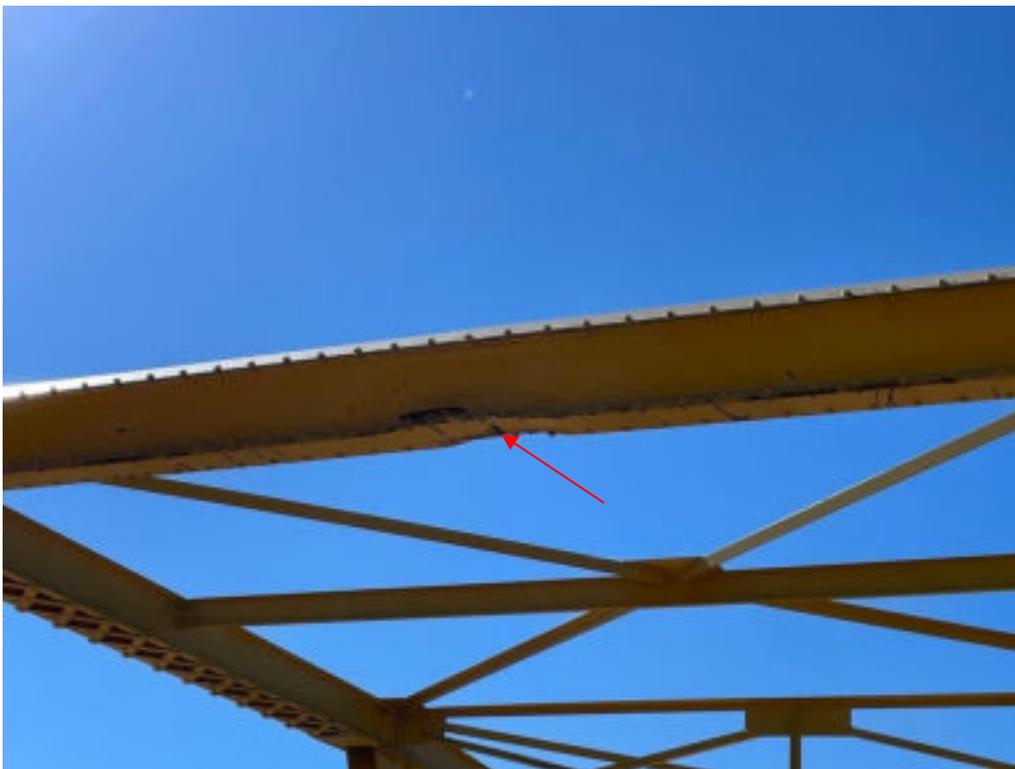
12. S4 - U1U1 damaged

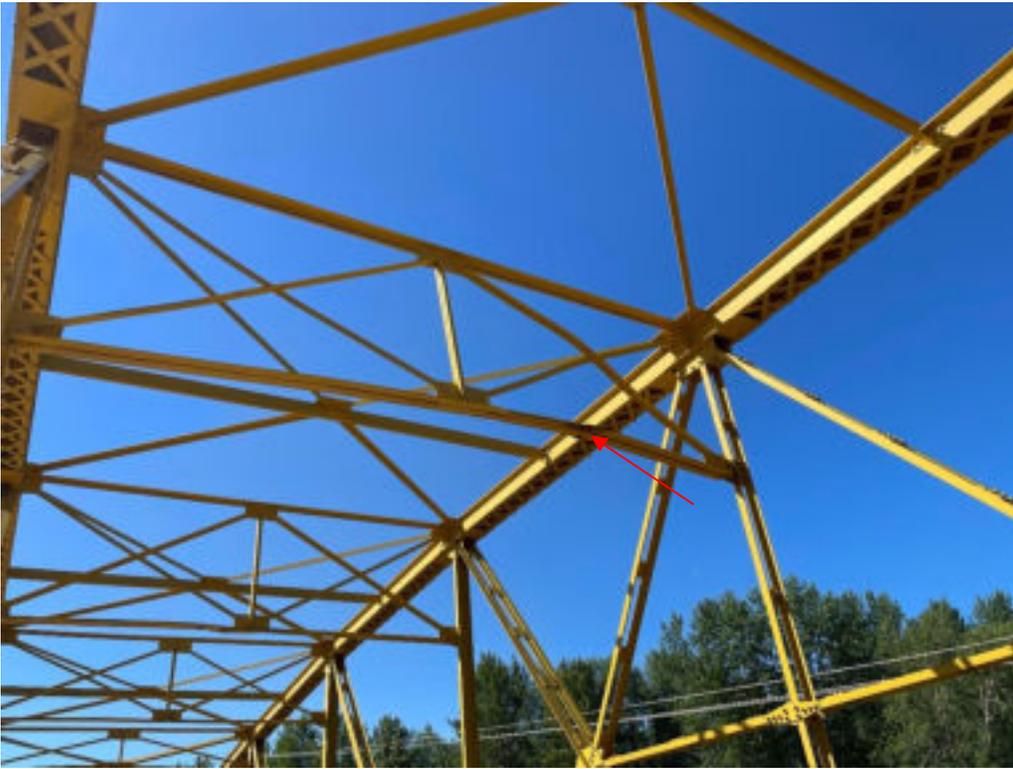
13. S4 - U5U5 damaged

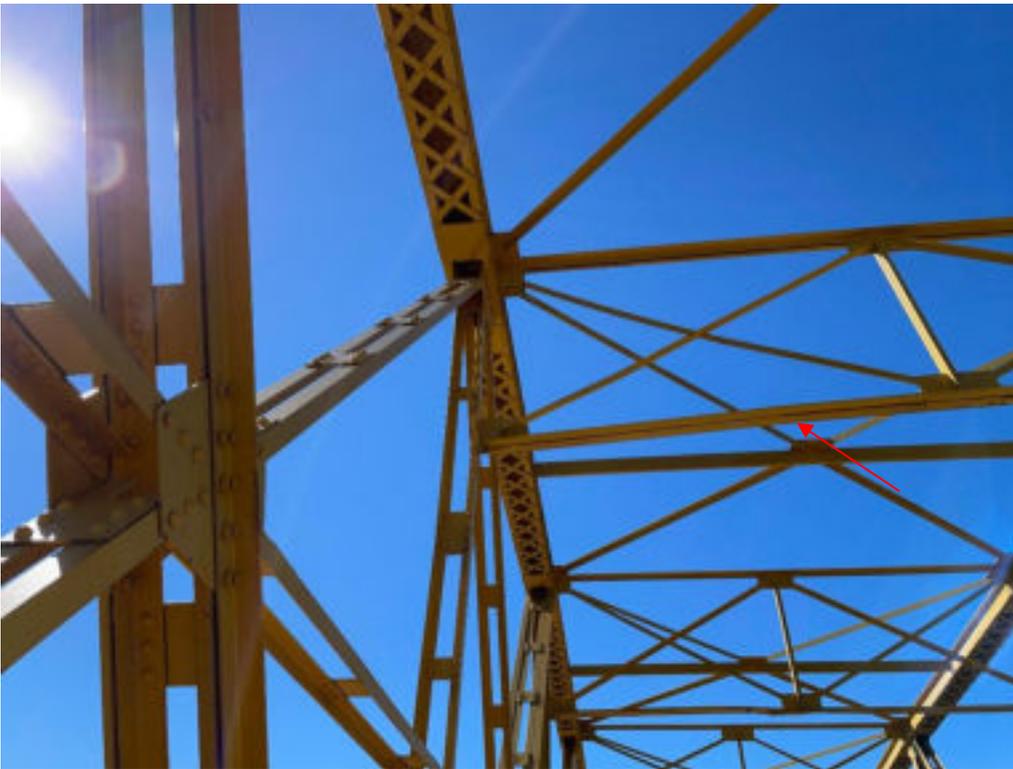
14. S4 - U5L5 E damaged

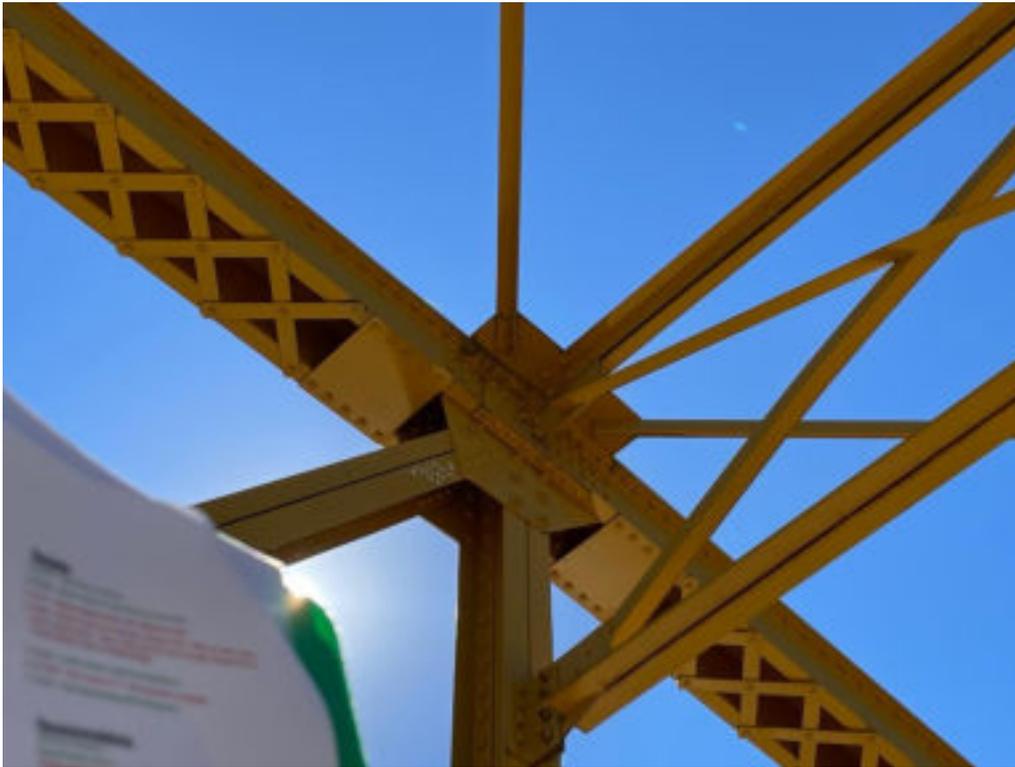
15. S4 - L6U7 E damaged

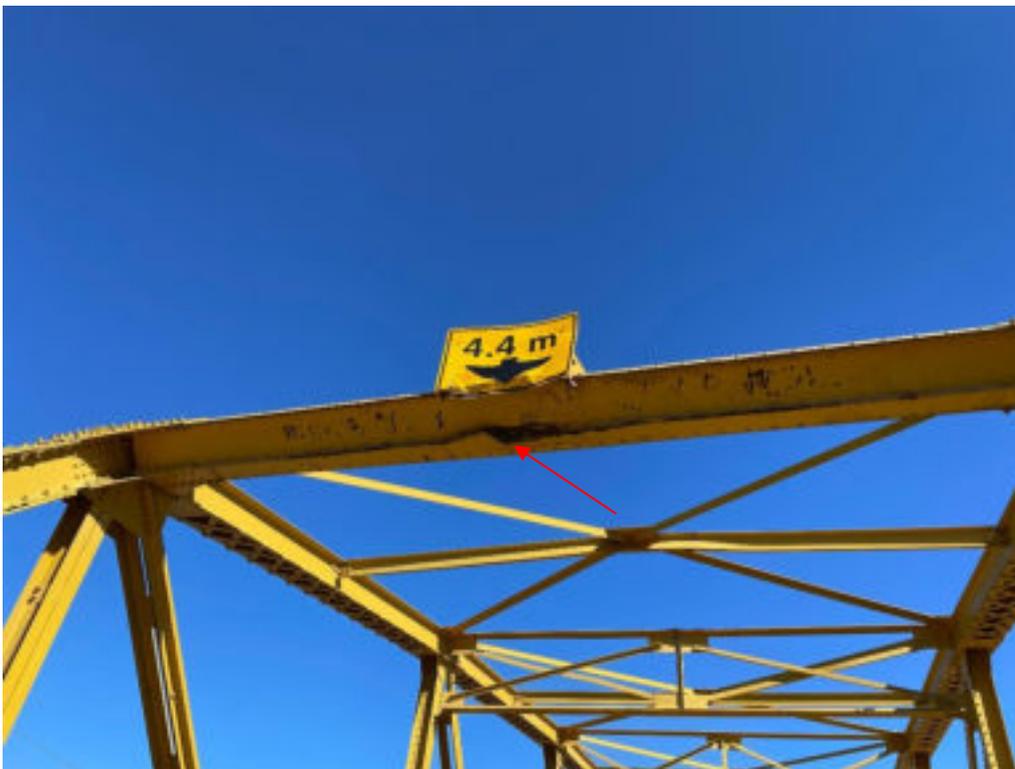
16. S4 - U9U9 damaged

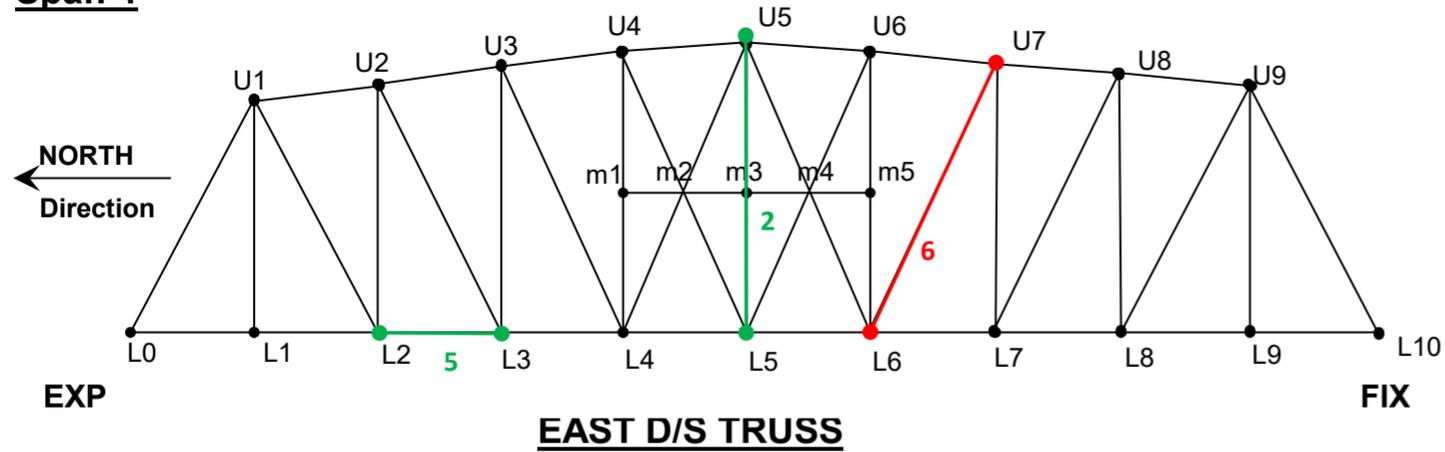
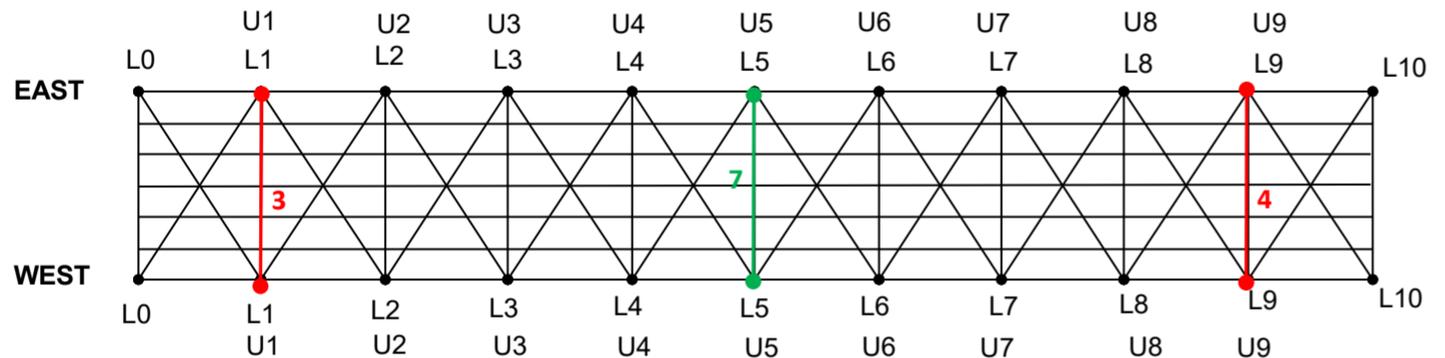
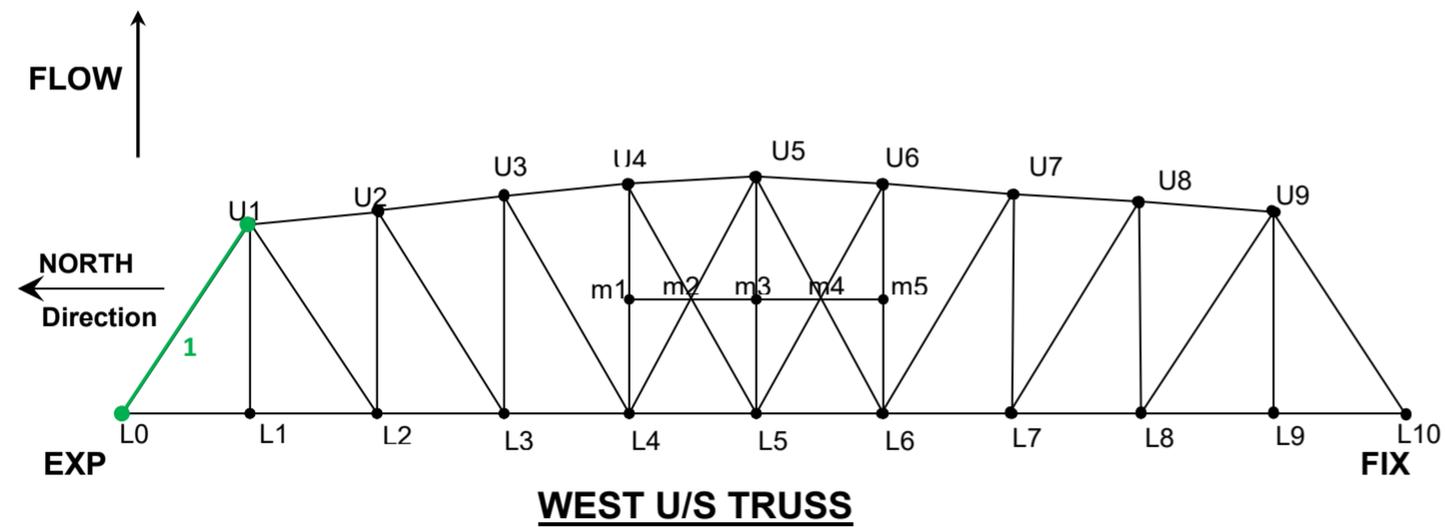
**Span 4**

- 1 L0U1W - Two 20 mm notches.
- 2 U5L5E - 40mm crack at cross bracing connection.
- 3 U1U1 - Bottom flange dented with sheared rivets.
- 4 U9U9 - Stretch marks on backside. Dented 160 x 1500 mm with cracks and 3 rivets broken - total 7 tears up to 25 mm in length. Bowed 45 mm overall. 60mm crack in bottom flange.
- 5 L2L3E - Lower outside angle bent 30x200mm.
- 6 U7-L6E - 3mm crack at U7. Old crack with no change.
- 7 U5U5 - High load damage with bracing bent.

- Grind out notches: 1
- Repair/reweld crack: 2
- Replace members: 3 and 4
- Heat straighten member: 5 and 7
- Assess or replace cracked member: 6

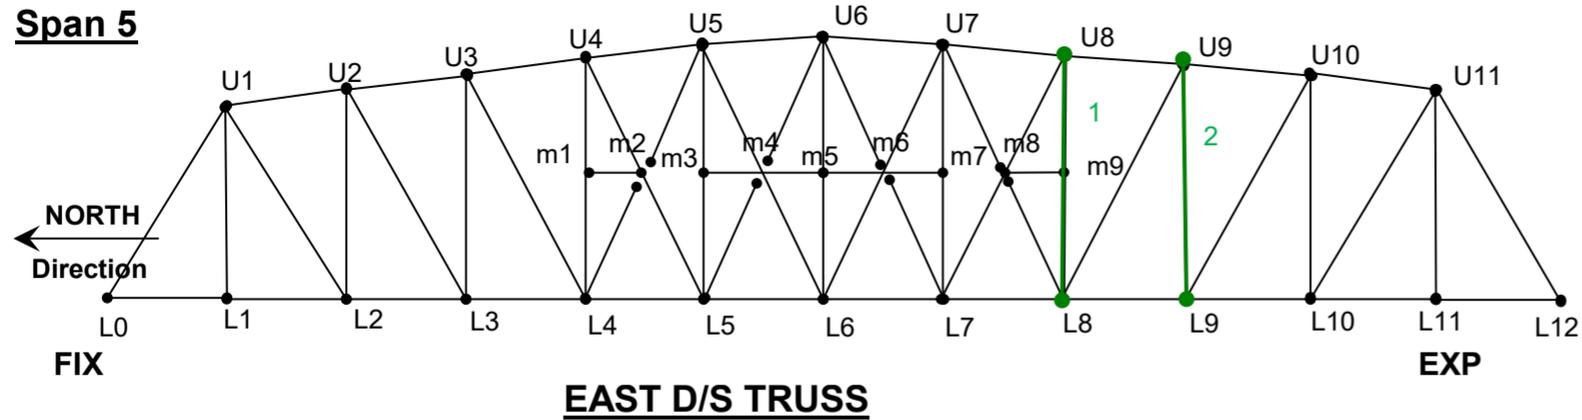
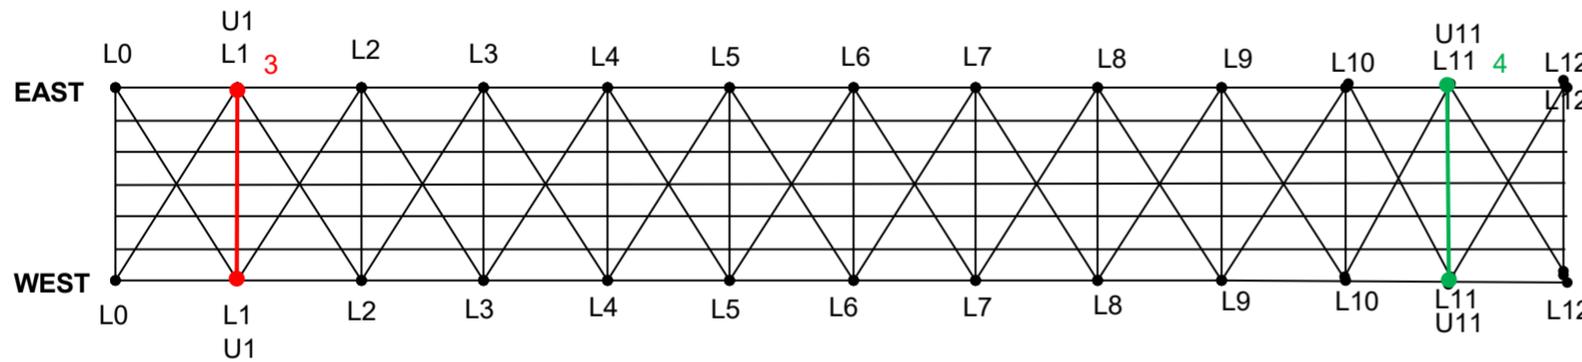
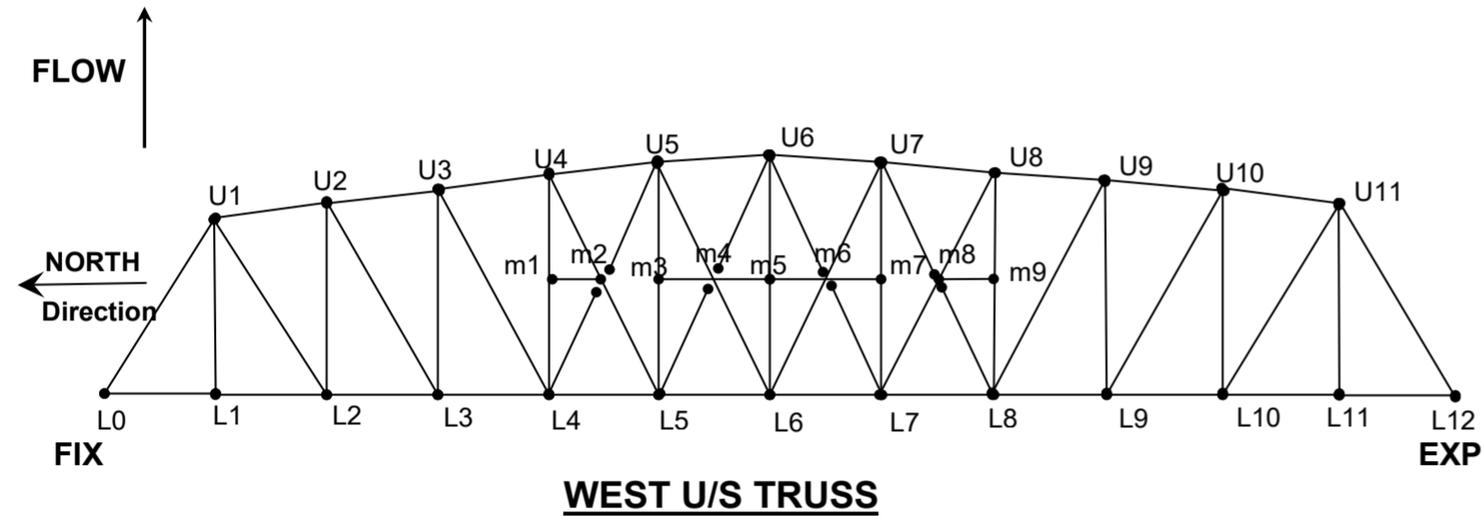
**Span 5**

- 1 U8L8E - Notched and dented 25x500mm.
- 2 U9L9E - Inside flange bent 20mm by wheel guard.
- 3 U1U1 - 24 x 800 mm dent and 25 x 150 mm tear to lower flanges at centerline creating a 10 mm overall bow.
- 4 U11U11 - High load damage and bottom flanges dented.

- Heat straighten members: 1, 2, and 4
- Replace member: 3

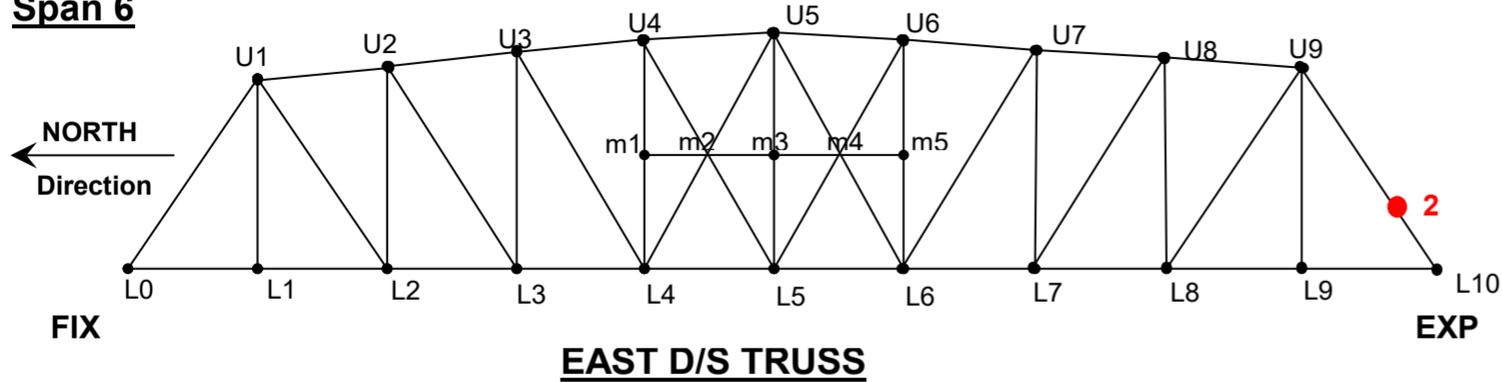
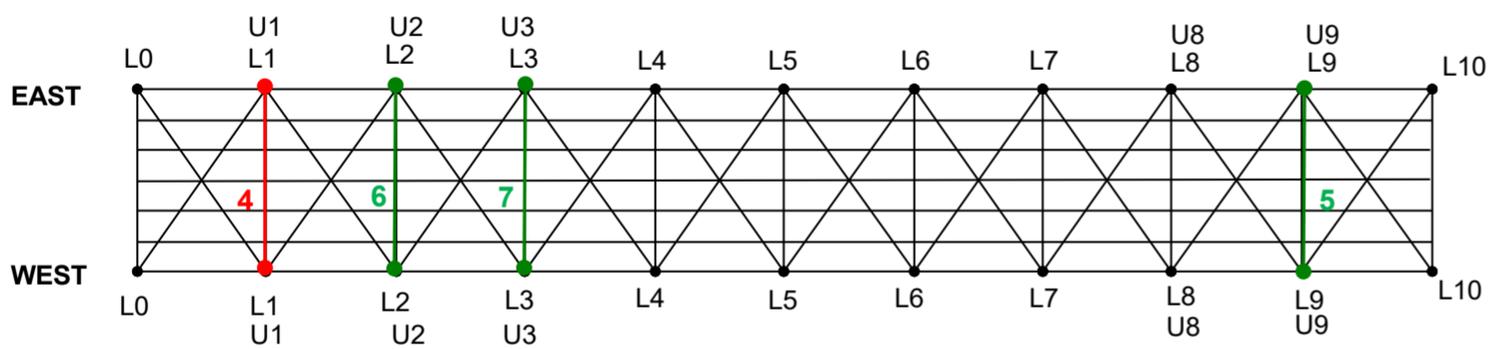
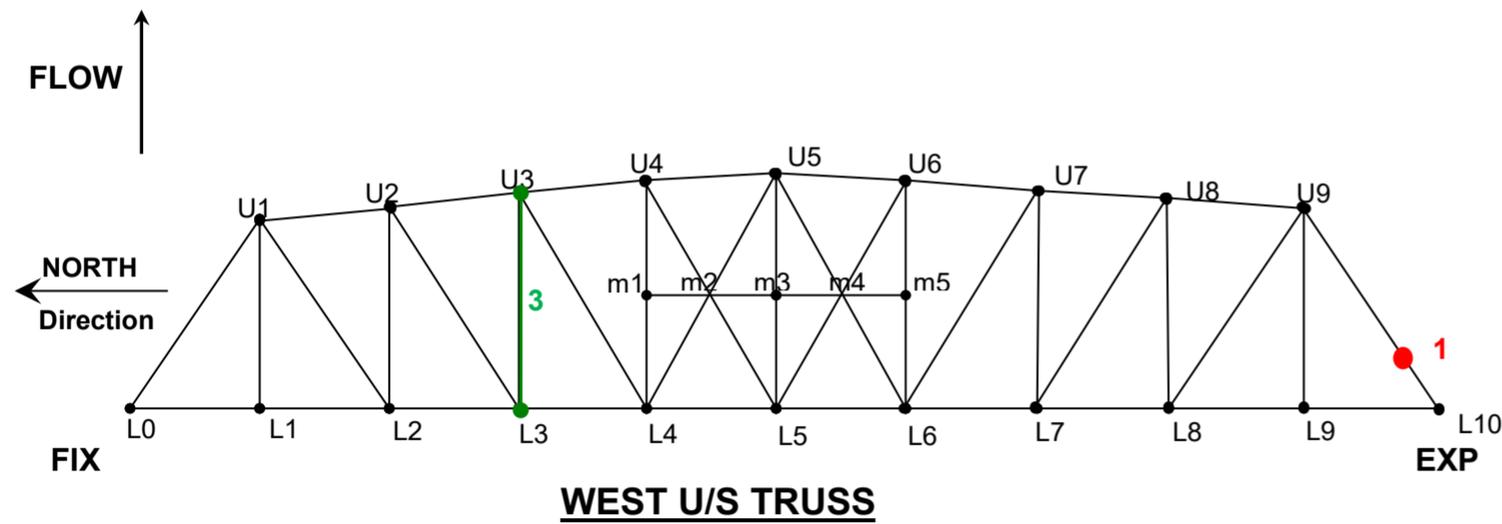
**Span 6**

- 1 U9L10W - Cracked wedge washer.
- 2 U9L10E - Cracked wedge washer.
- 3 U3L3W - Minor bends at sway bracing connection.
- 4 U1U1 - High load damage with multiple dents and bends at bottom flange. 60mm crack in bottom flange.
- 5 U9U9 - High load damage with dent on bottom side.
- 6 U2U2 - High load damage with bracing bent.
- 7 U3U3 - High load damage with bracing bent.

- Replace cracked washers: 1 and 2
- Heat straighten member: 3, 5, 6, and 7
- Replace member: 4

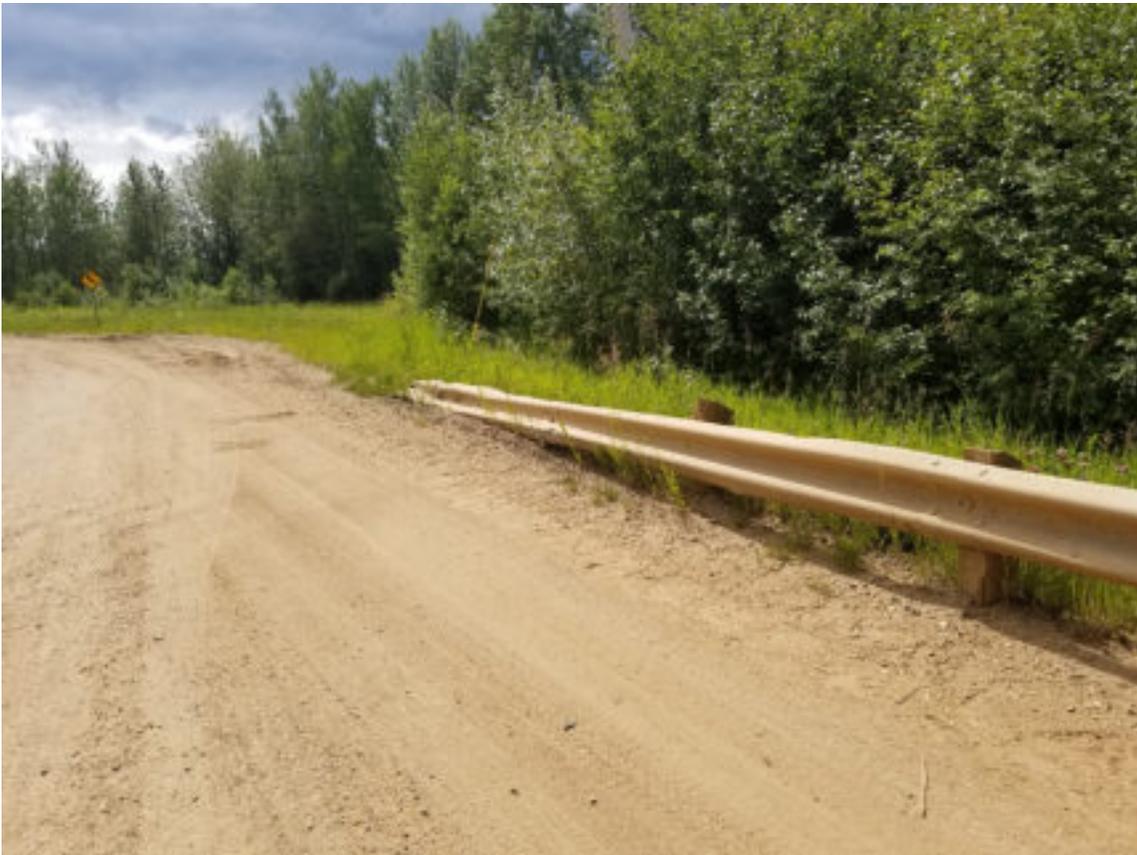
3.  
Abutment 1 approach west guardrail end with minor damage.

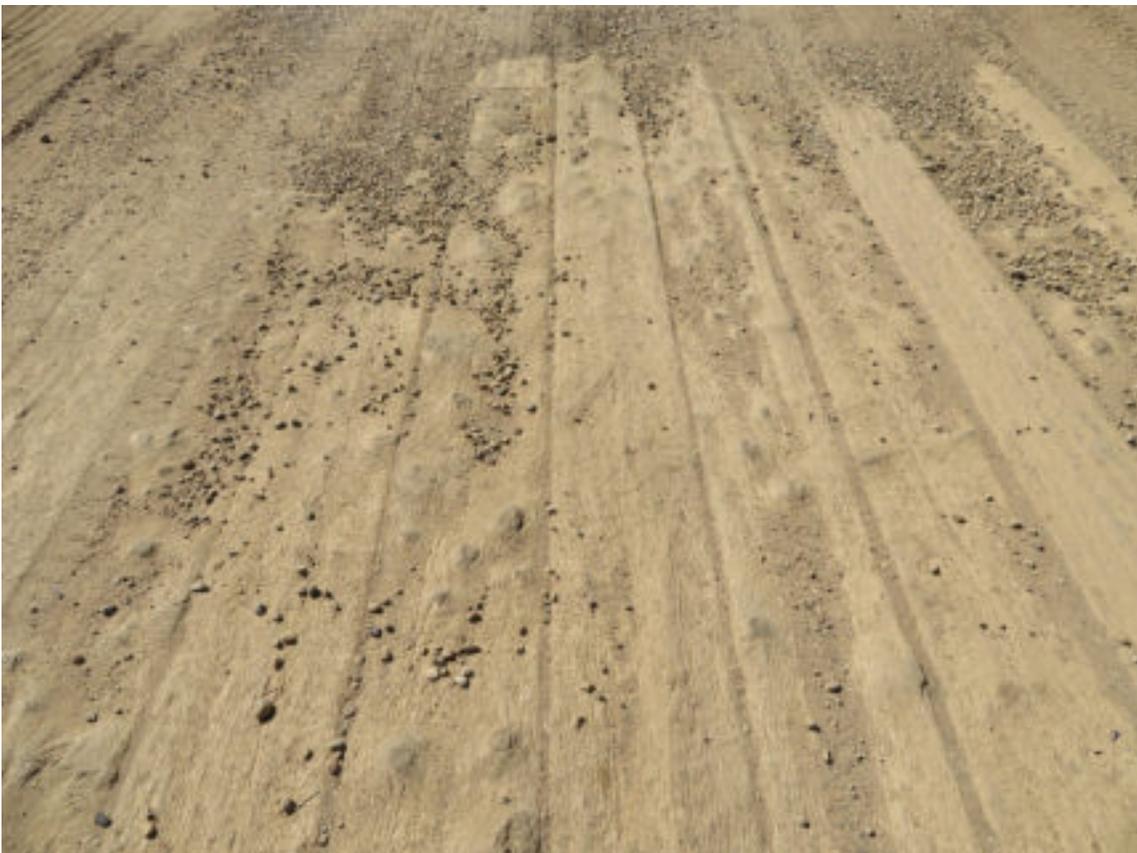
4.  
Approach strip deck worn up to 25 mm.
