# BRIDGE ASSESSMENT REPORT

## Municipal District of Lesser Slave River

Bridge File 71600  
Athabasca River

NOVEMBER 2022

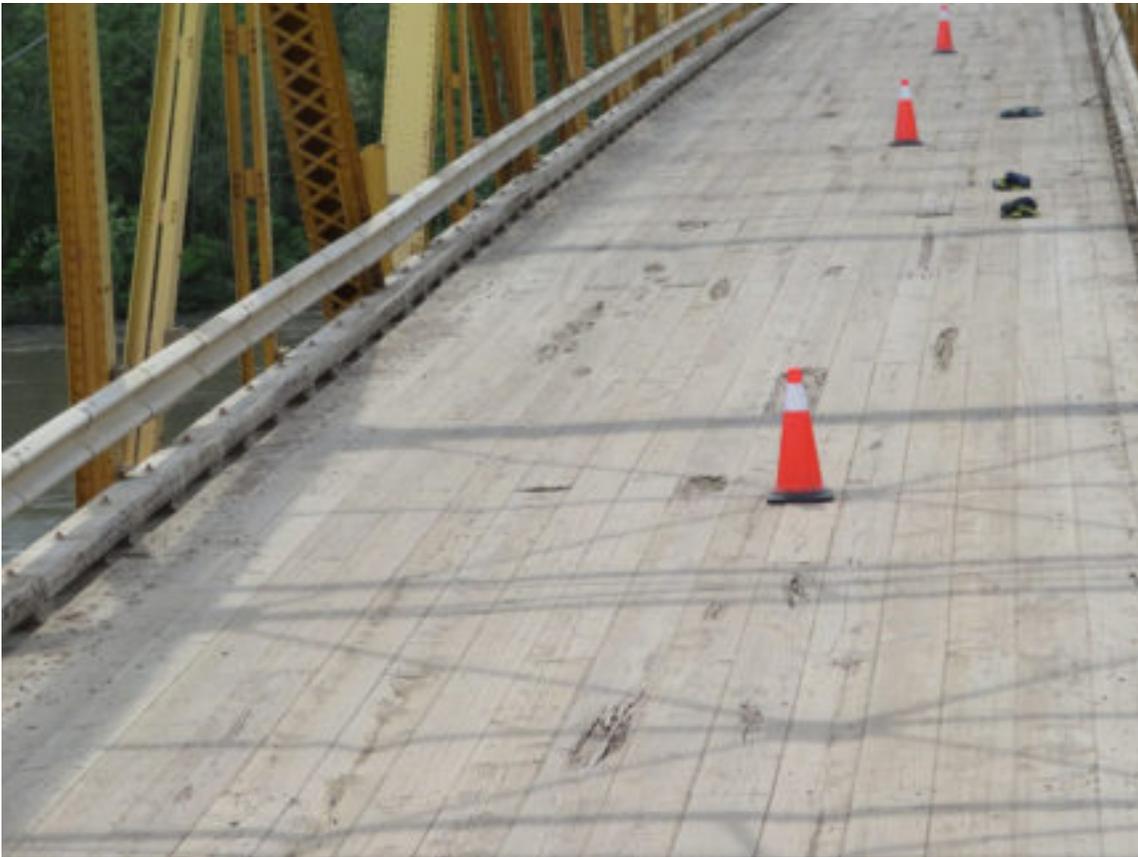
5. Span 4 and 5 strip deck with potholes and spots rotten – looking south.

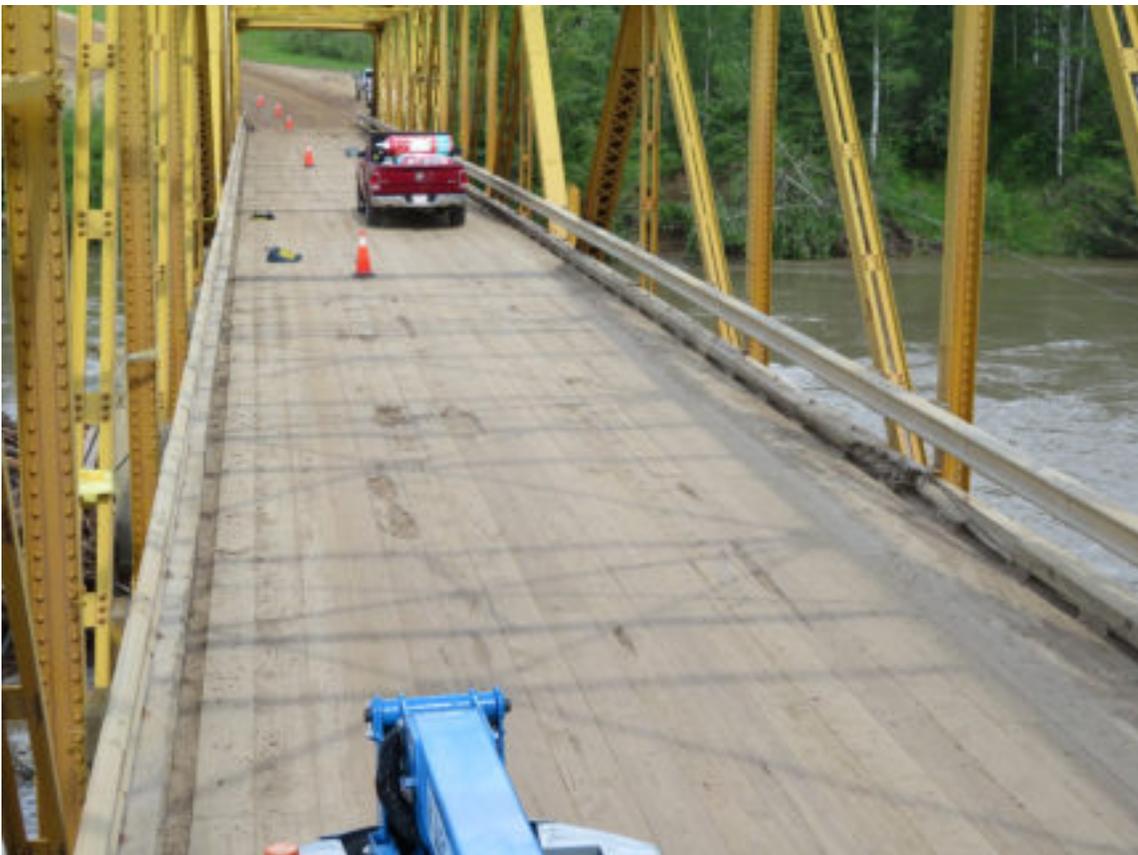
6. Span 5 and 6 strip deck with potholes and spots rotten – looking north.  
Note damage to east wheel guard at span 5.

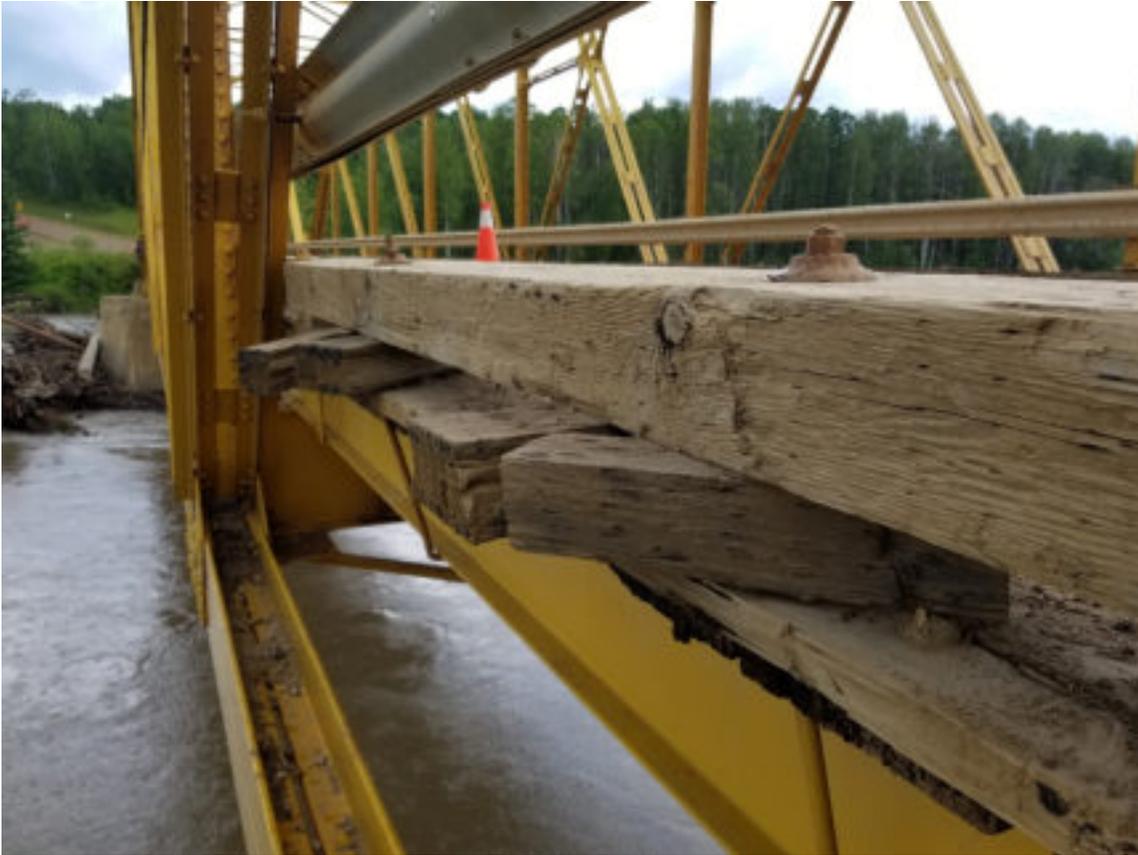
7.  
Span 5 west side  
with wheel guard  
blocks twisted.

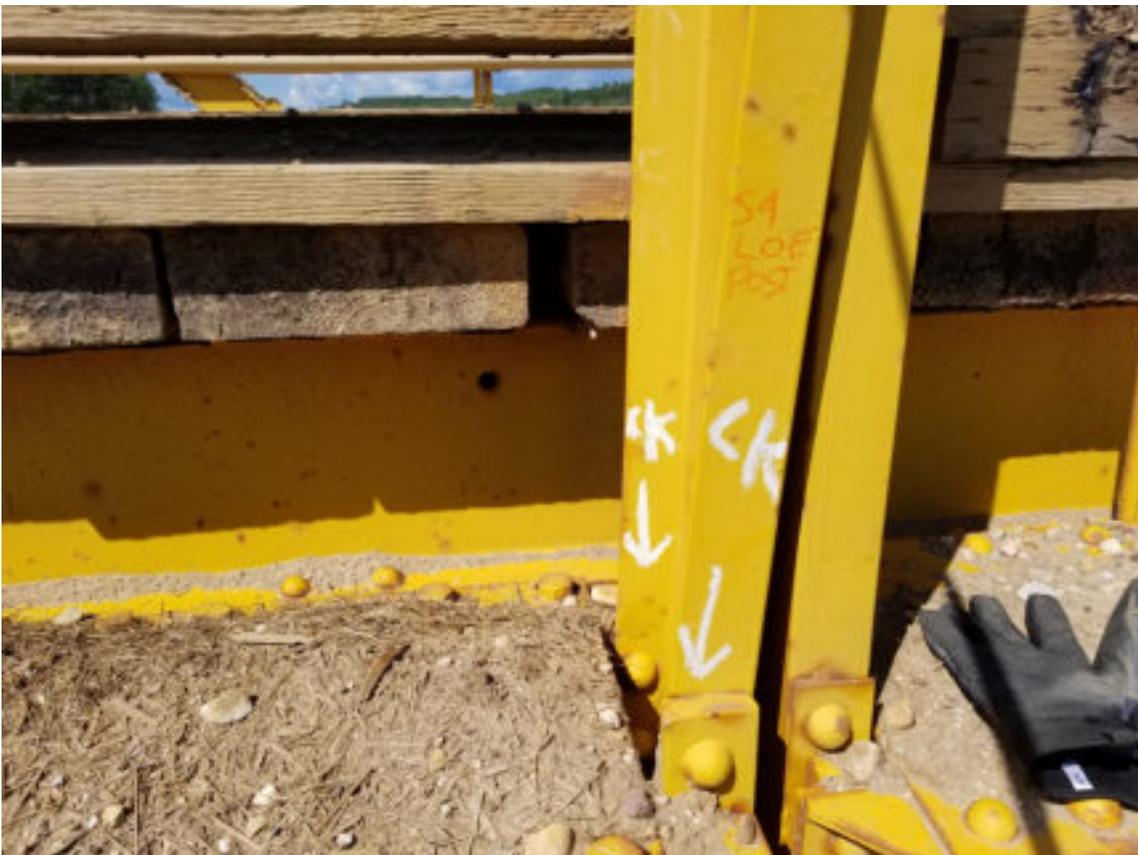
8.  
Span 4 LOE bridge  
rail post cracked at  
bottom rivets.

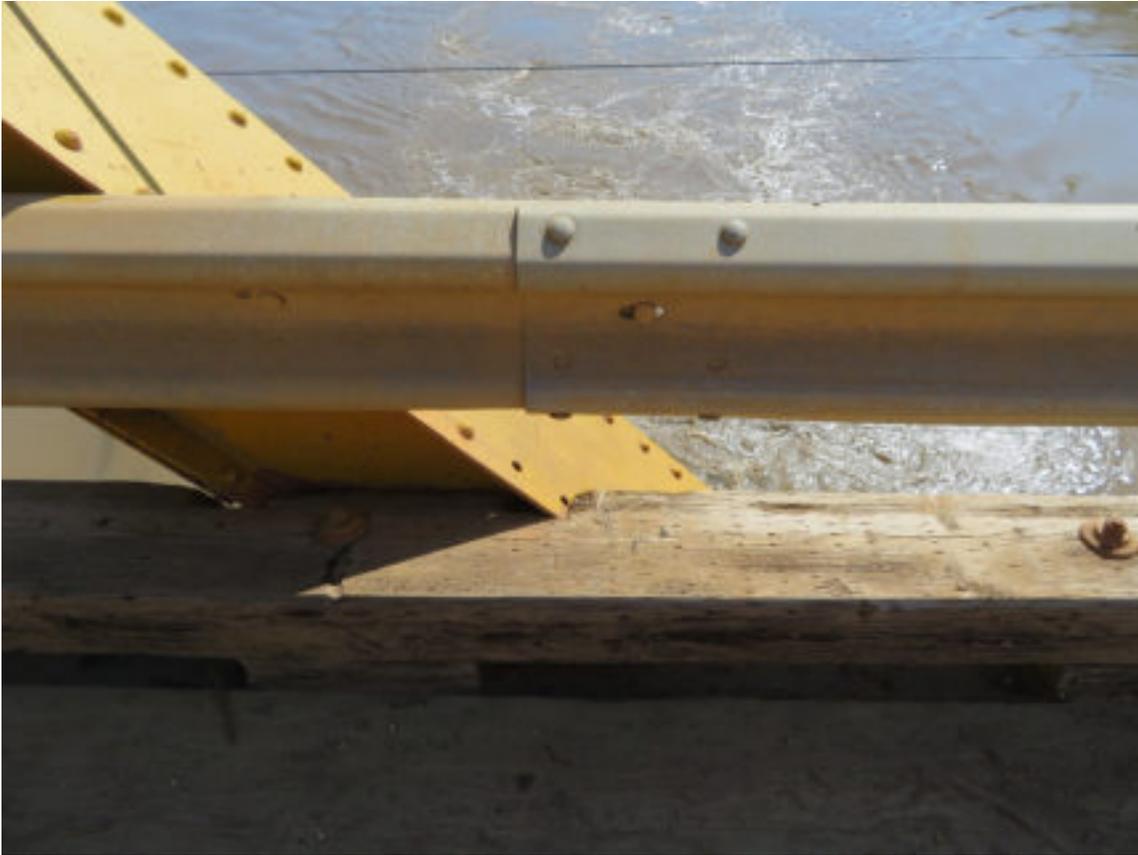
9.  
Typical batter post holes with missing rivets from abandoned rail attachment.

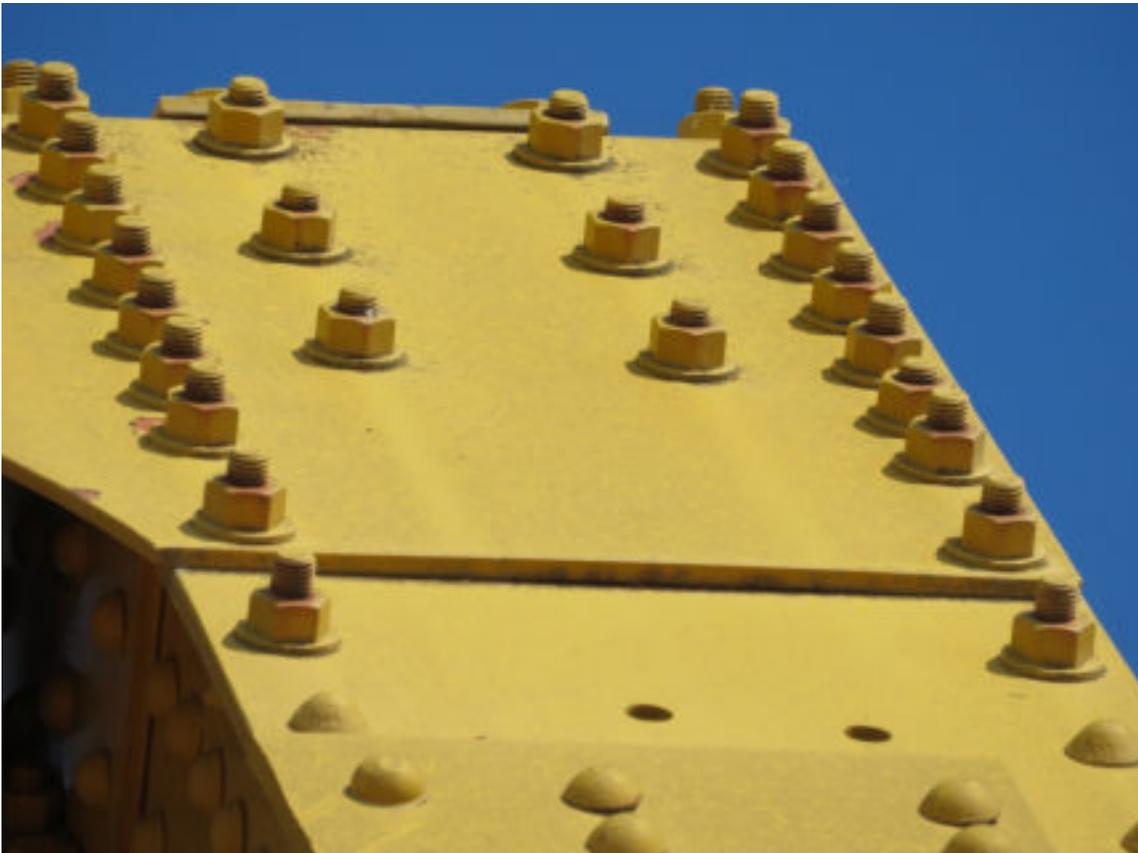
10.  
Typical batter post with open holes near connection from abandoned old portal attachment.

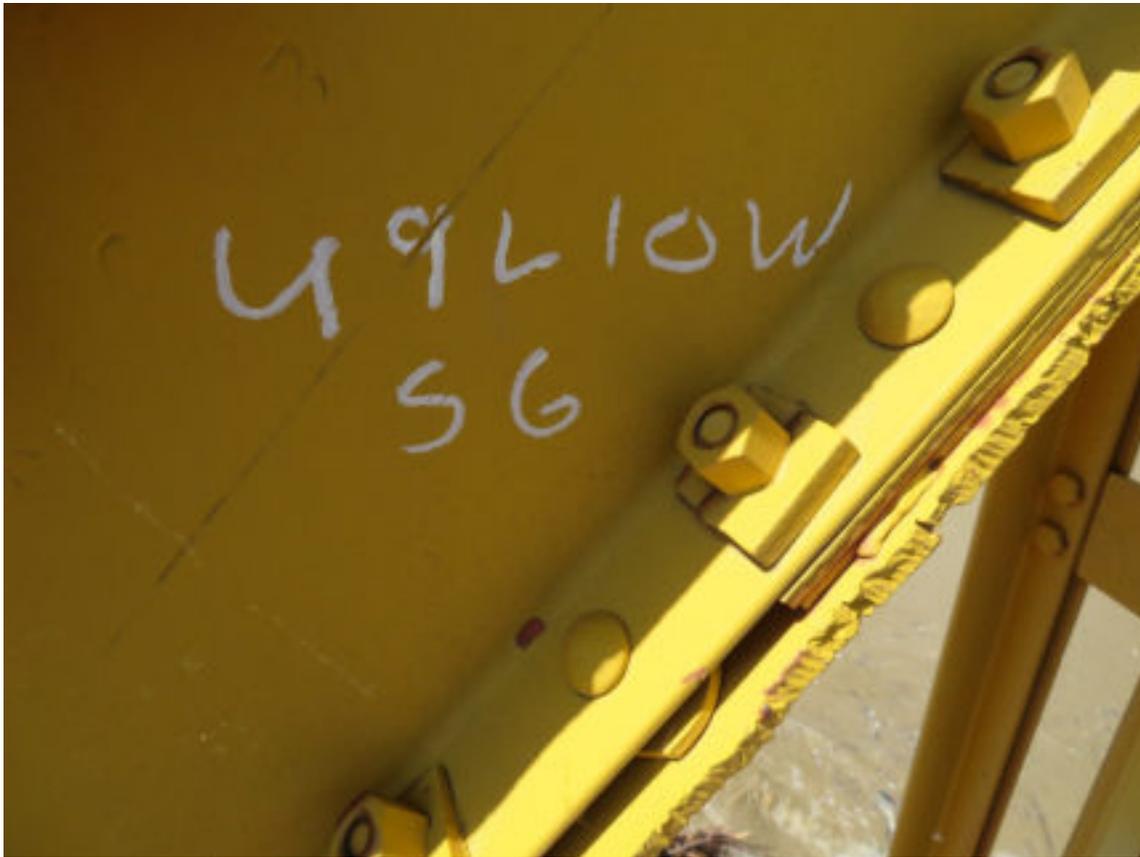
13.  
Span 6 U9L10W  
batter post with  
cracked wedge  
washer.

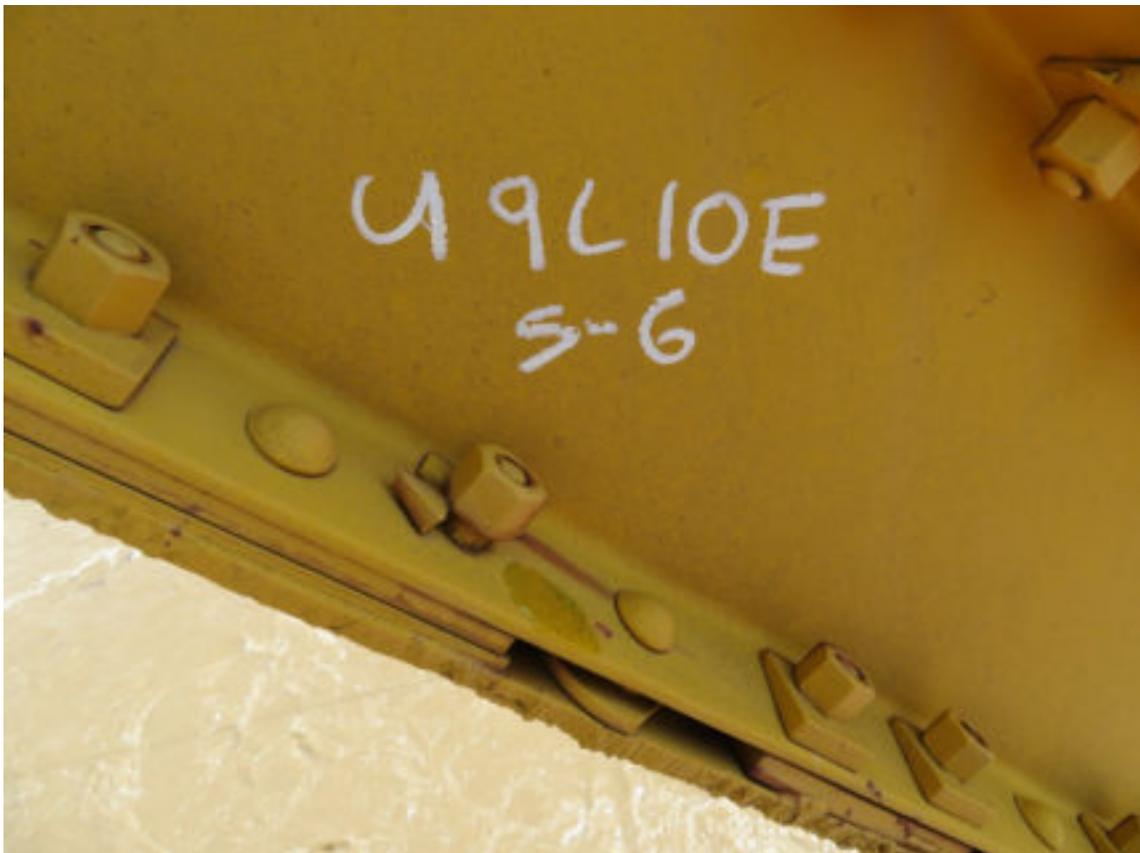
14.  
Span 6 U9L10E  
batter post with  
cracked wedge  
washer.

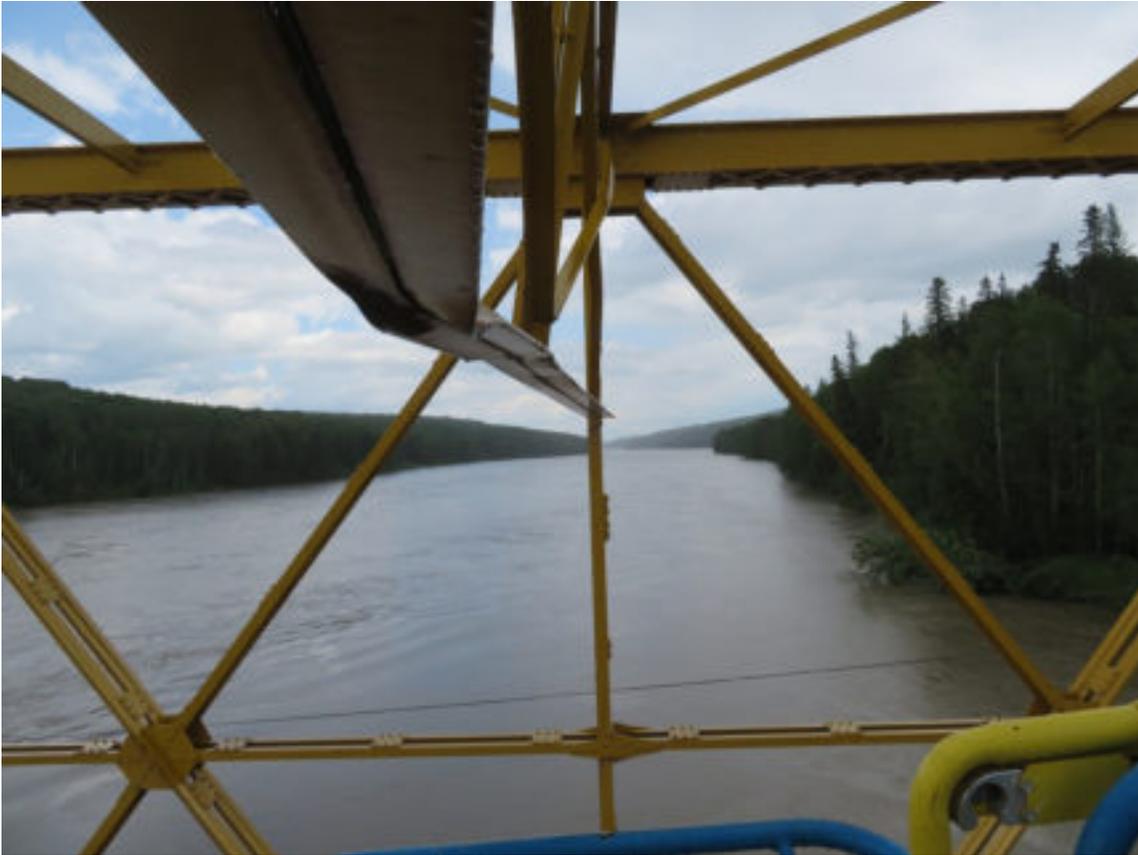
15.  
Span 4 U5U5 sway  
bracing with bend.

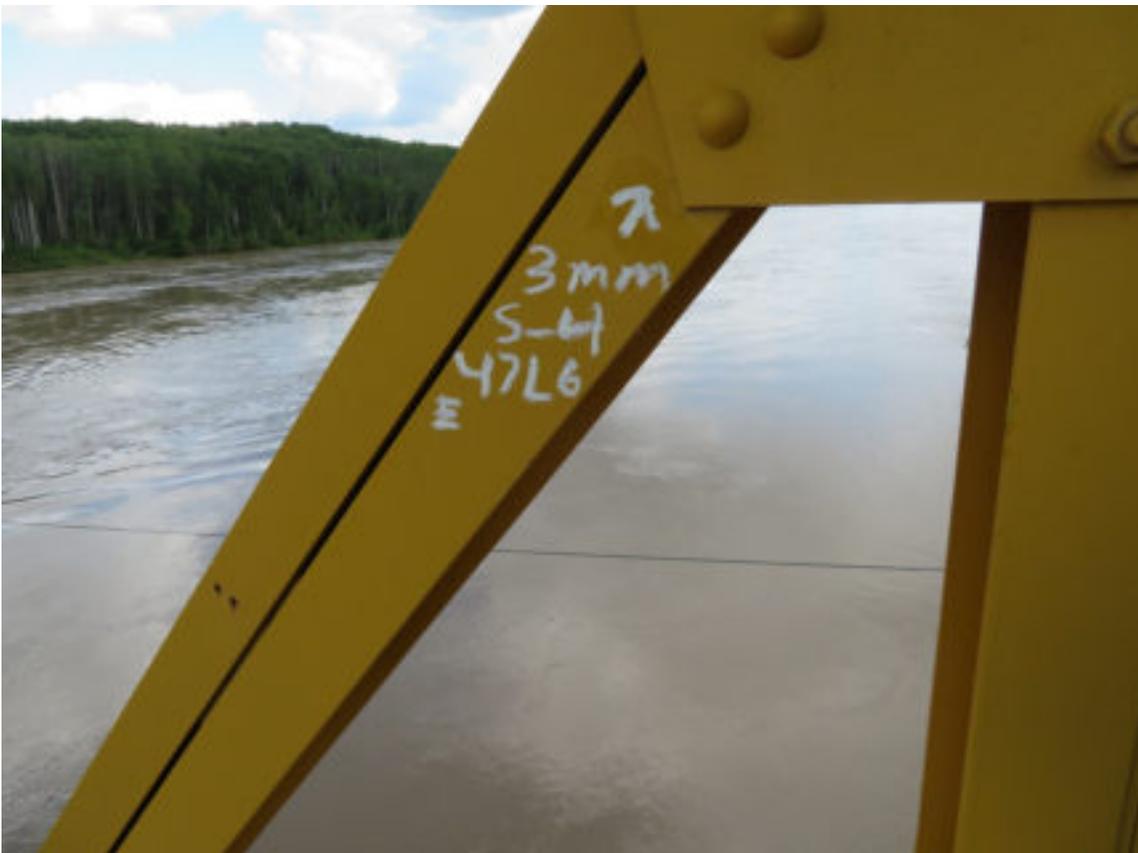
18.  
Span 4 U7L6E diagonal member with 3 mm crack at top.

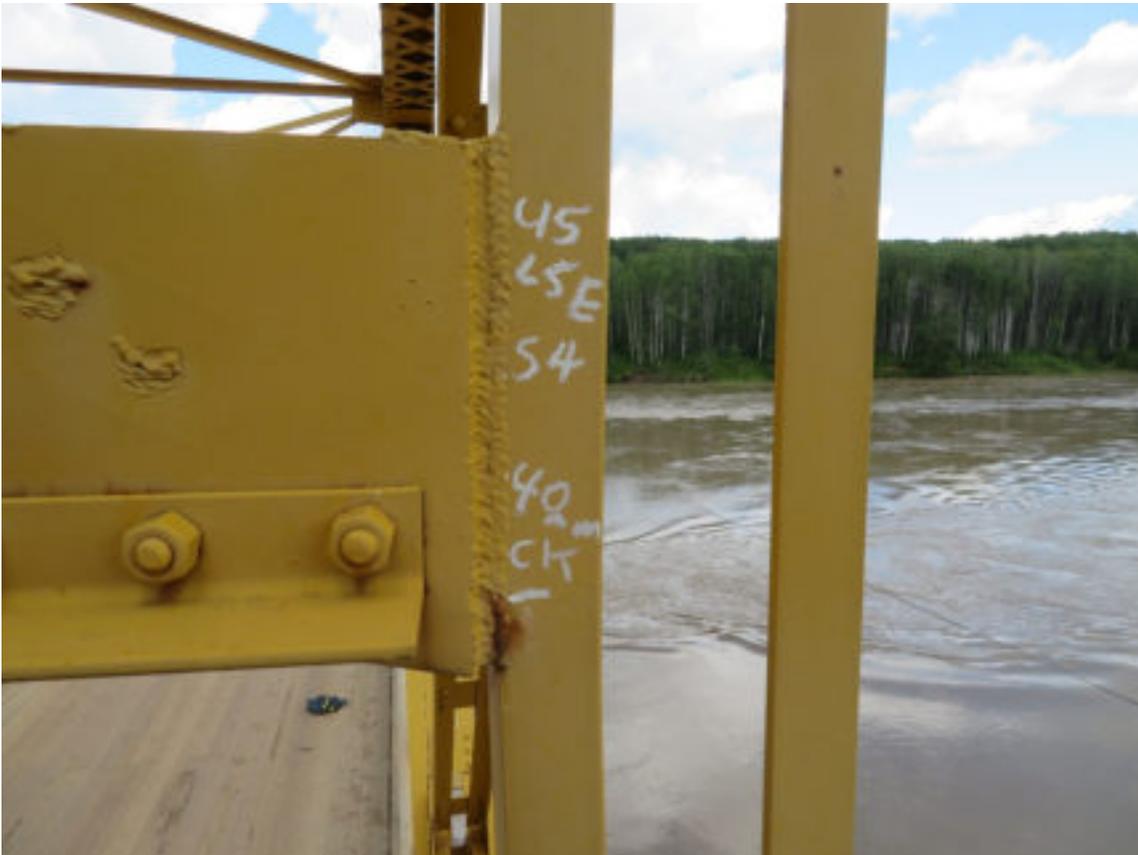
19.  
Span 4 U5L5E vertical member with 40 mm crack at cross bracing connection.

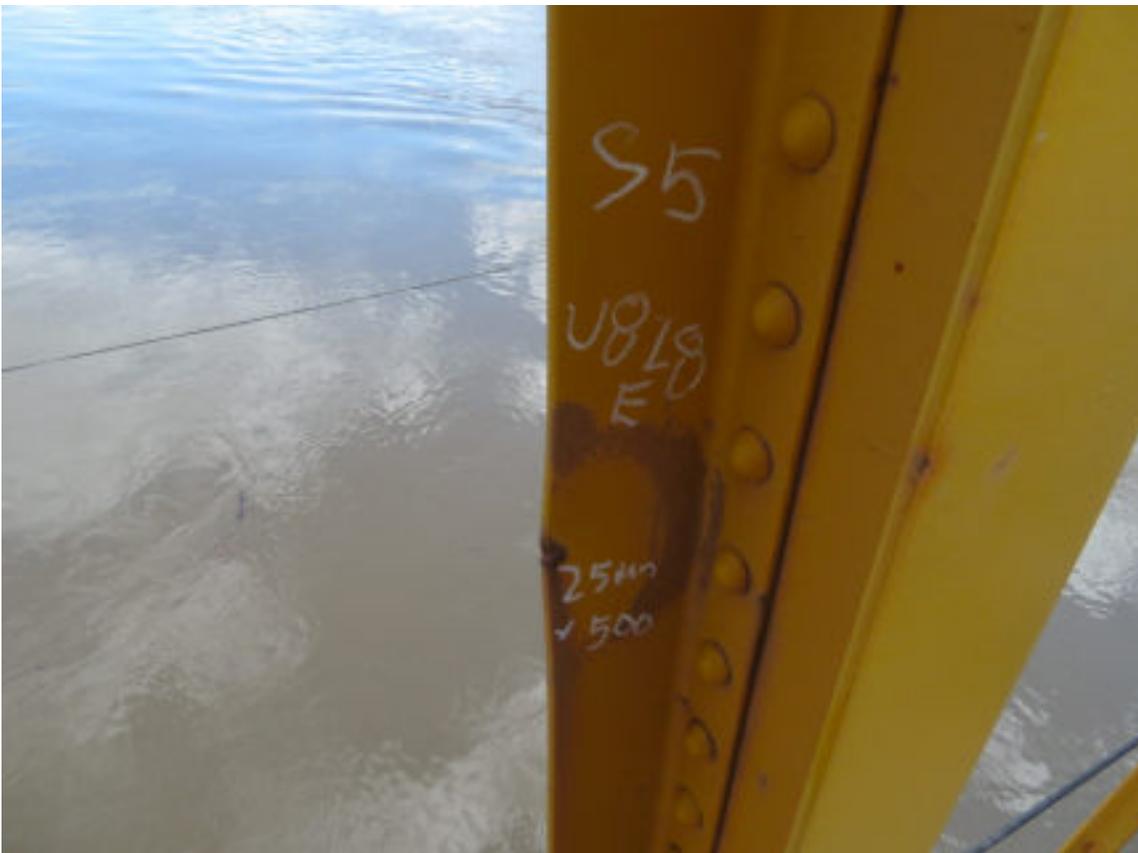
20.  
Span 5 U8L8E vertical member with nick and dent 25x500 mm.

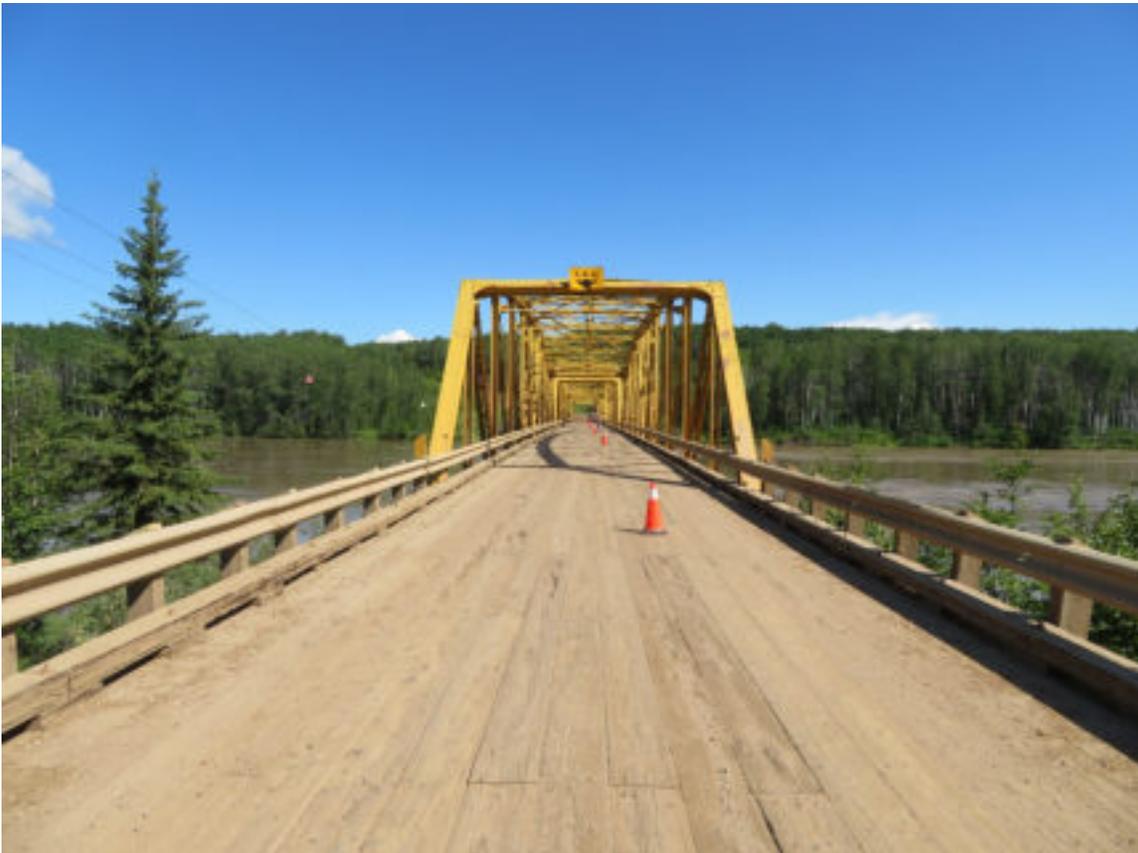
24.  
Span 4 U9U9 south portal, U9L10W batter post, and U9L10E batter post – looking north.  
Note strip deck is worn.

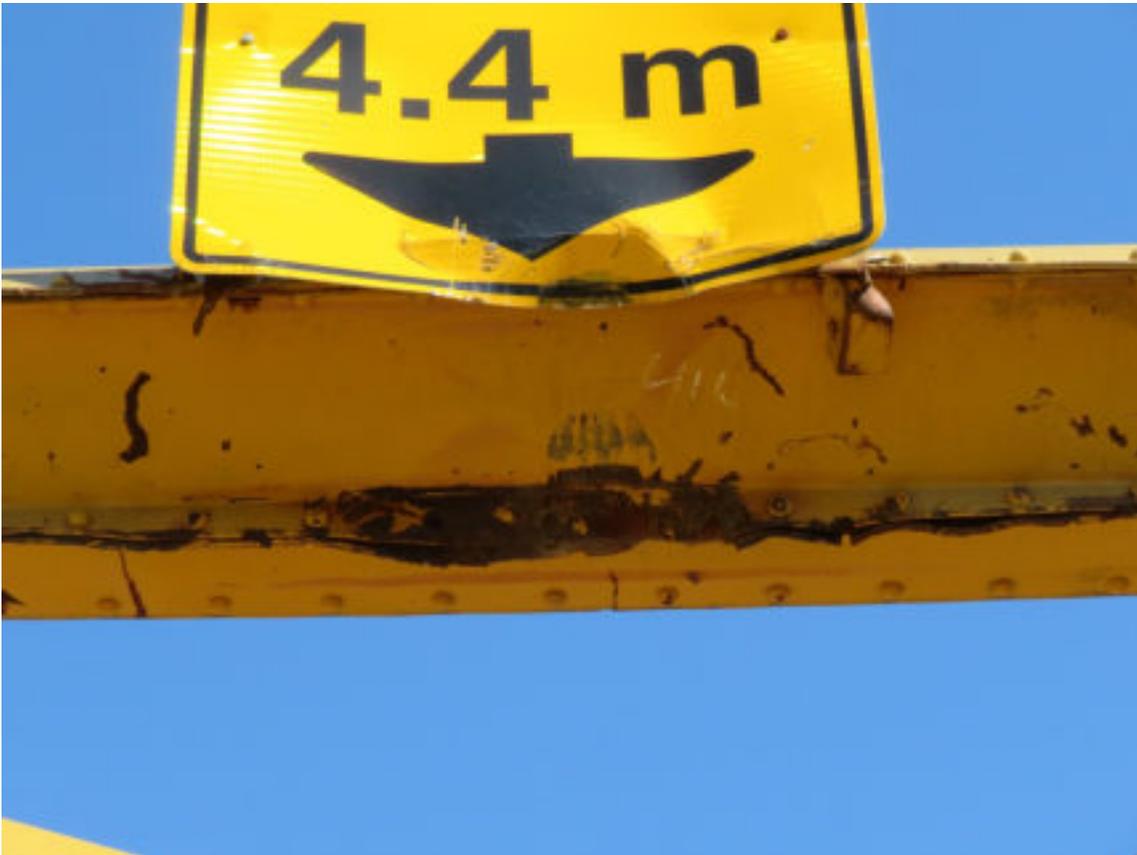
25.

Span 4 U9U9 south portal with highload damage – rivets broken, and holes torn, 60 mm crack in bottom flange.

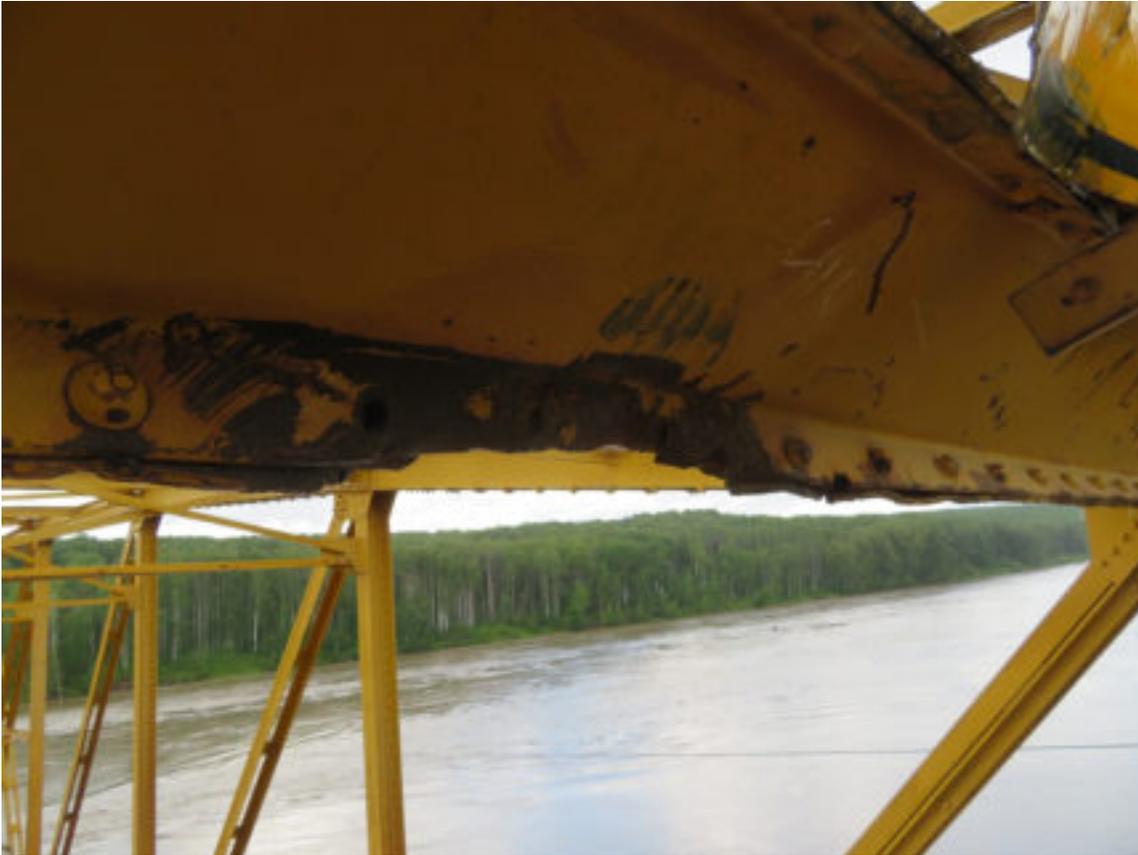
27.  
Span 4 U9U9 south portal with highload damage – rivets broken, and holes torn, 60 mm crack in bottom flange – close view.

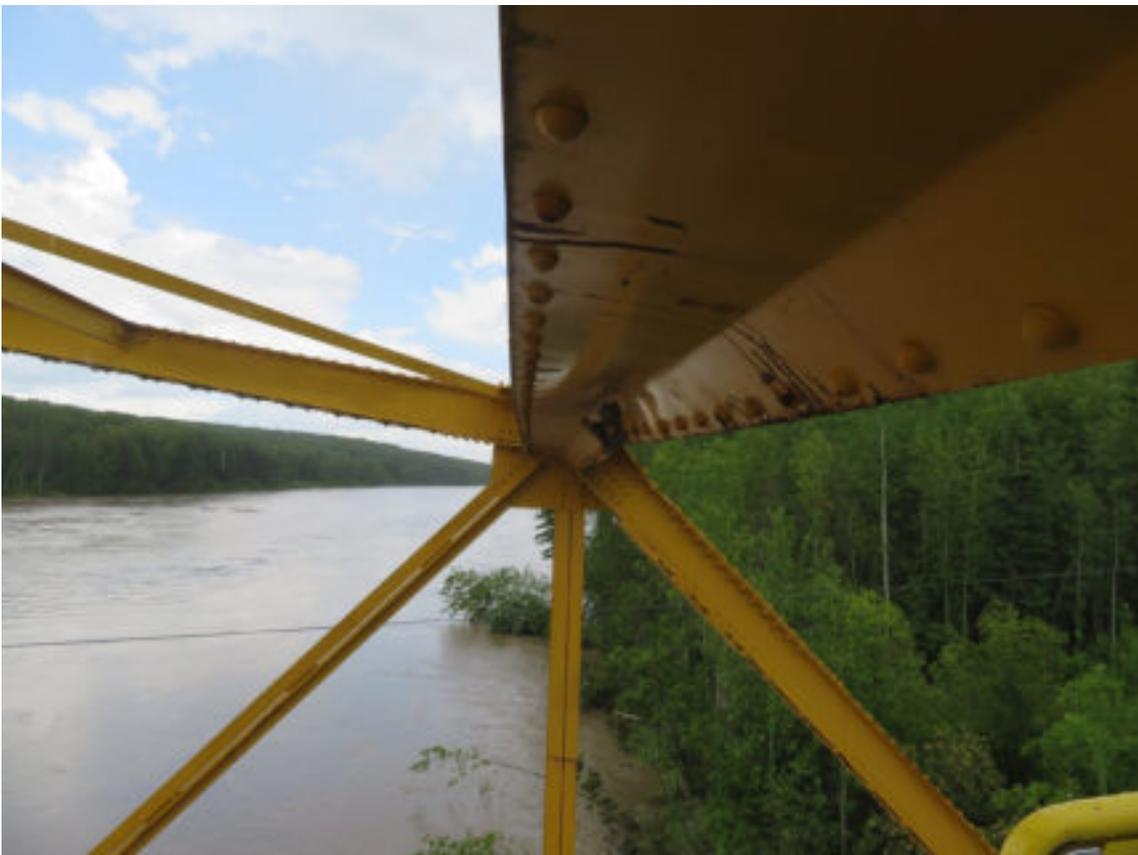
28.  
Span 4 U9U9 south portal with highload damage.

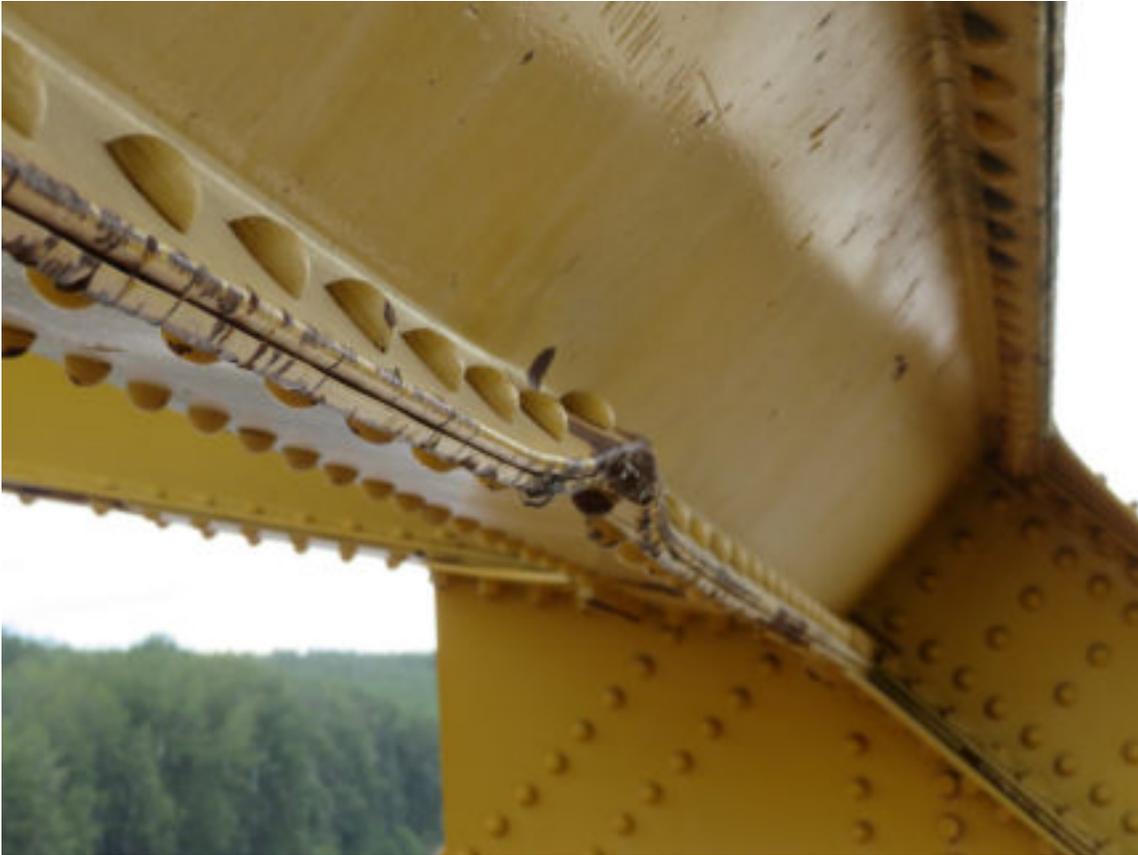
29.  
Span 5 U1U1 north portal bent at bottom side – looking west.

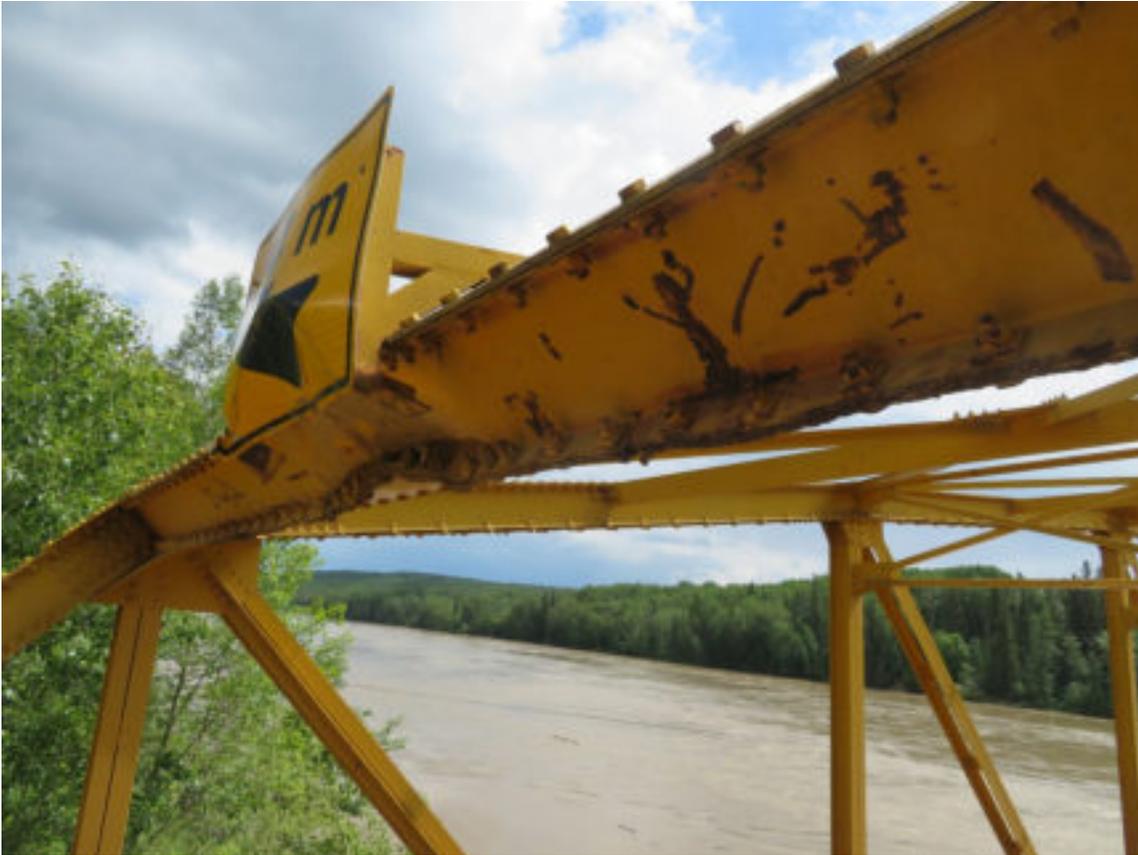
33. Span 6 U1U1 north portal with dents to bottom plate and view of overall damage, 60 mm crack in bottom flange.

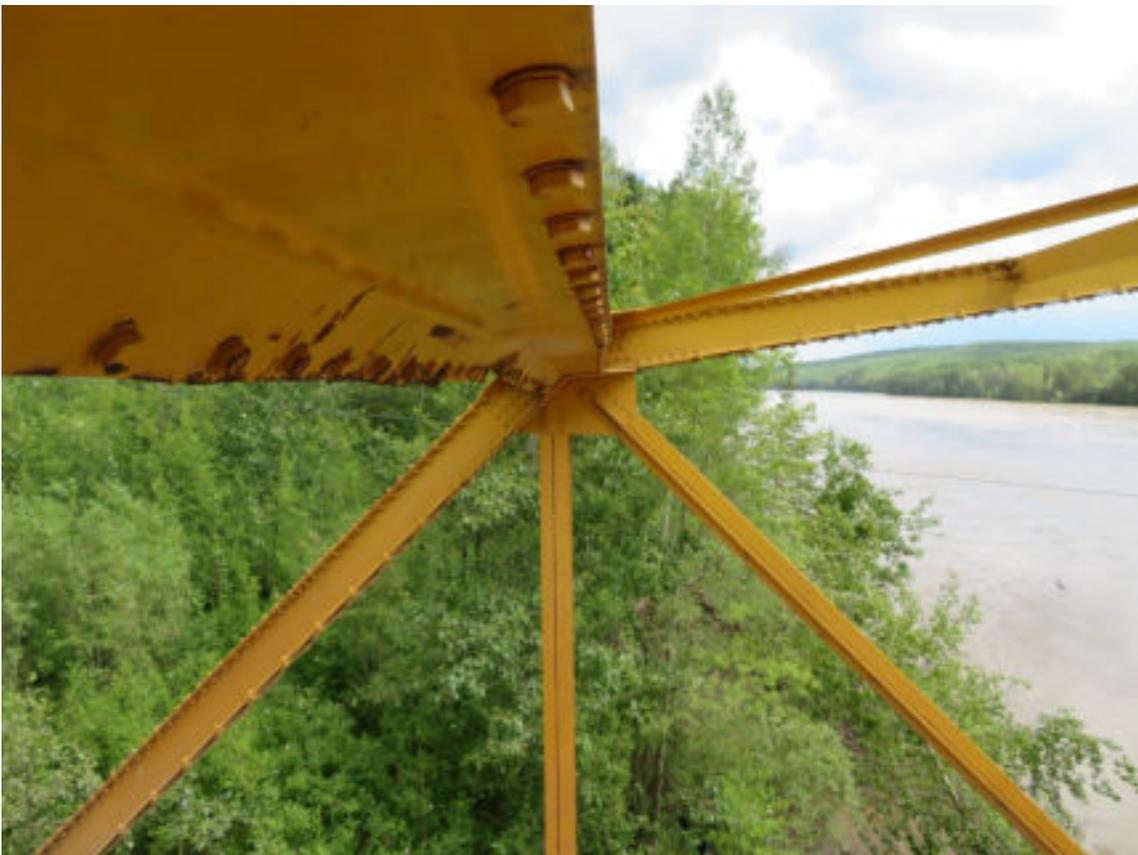
34. Span 6 U1U1 north portal with dents to bottom plate and view of overall damage, 60 mm crack in bottom flange.

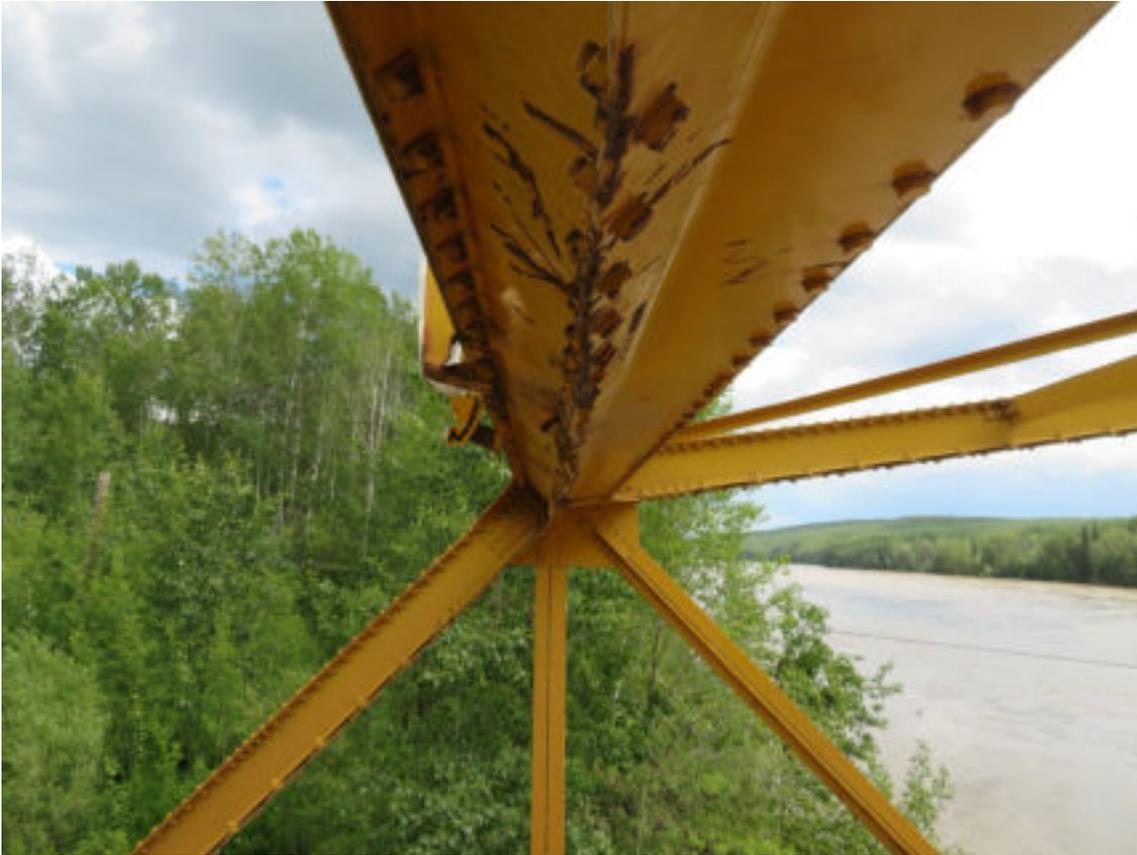
35. Span 6 U1U1 north portal with dents to bottom plate and view of overall damage, 60 mm crack in bottom flange.

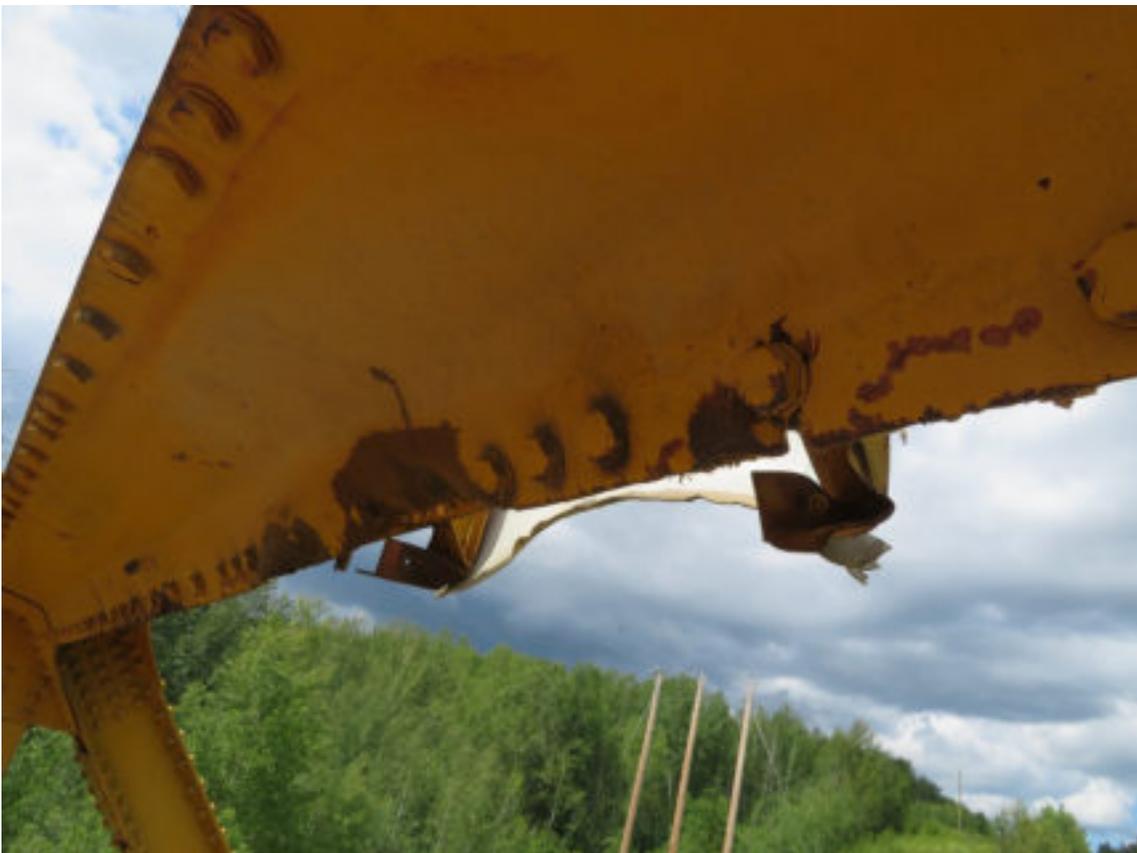
36. Span 6 U1U1 north portal with dents to bottom plate and view of overall damage, 60 mm crack in bottom flange – view from south.

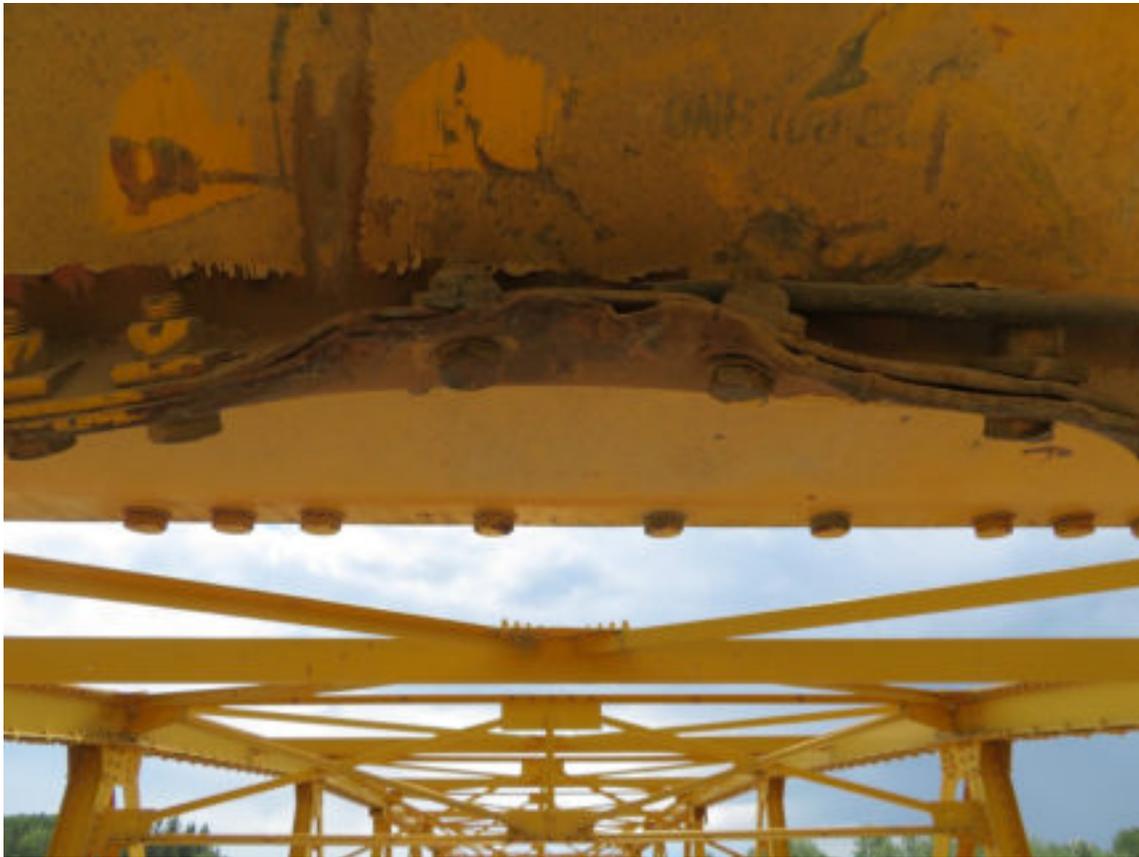
37.  
Span 6 U1U1 north portal with dents to bottom plate, 60 mm crack in bottom flange – close view.

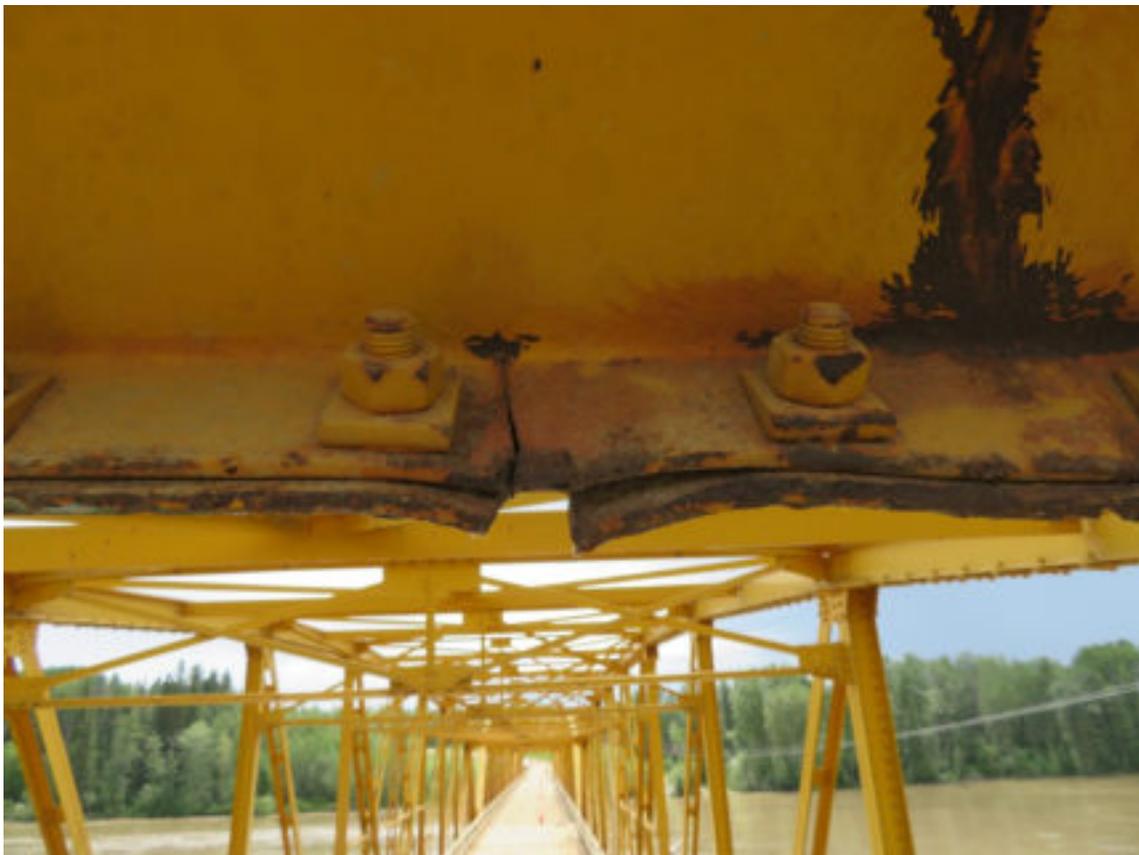
38.  
Span 6 U1U1 north portal with dents and 60 mm crack in bottom flange.
