# BRIDGE ASSESSMENT REPORT

## Municipal District of Lesser Slave River

Bridge File 71600  
Athabasca River

NOVEMBER 2022

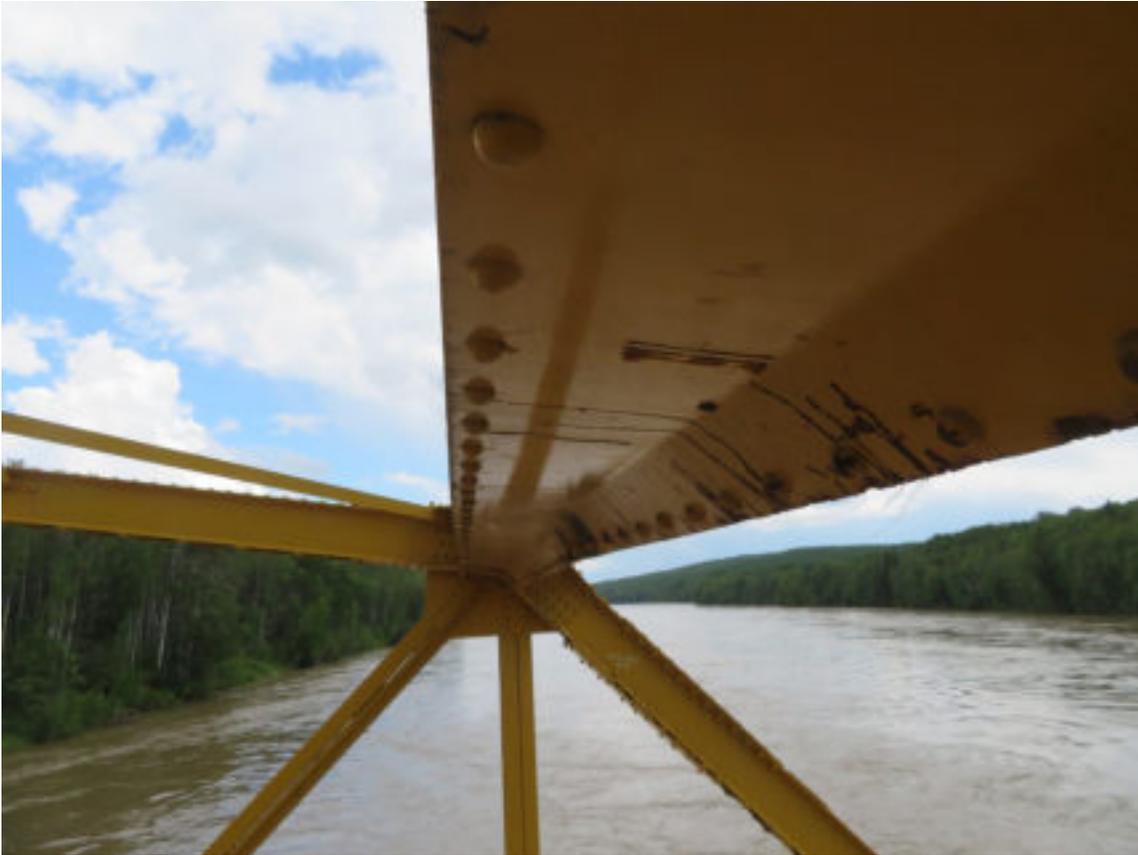
39.  
Span 6 U9U9 south portal with dent on bottom side – looking east.

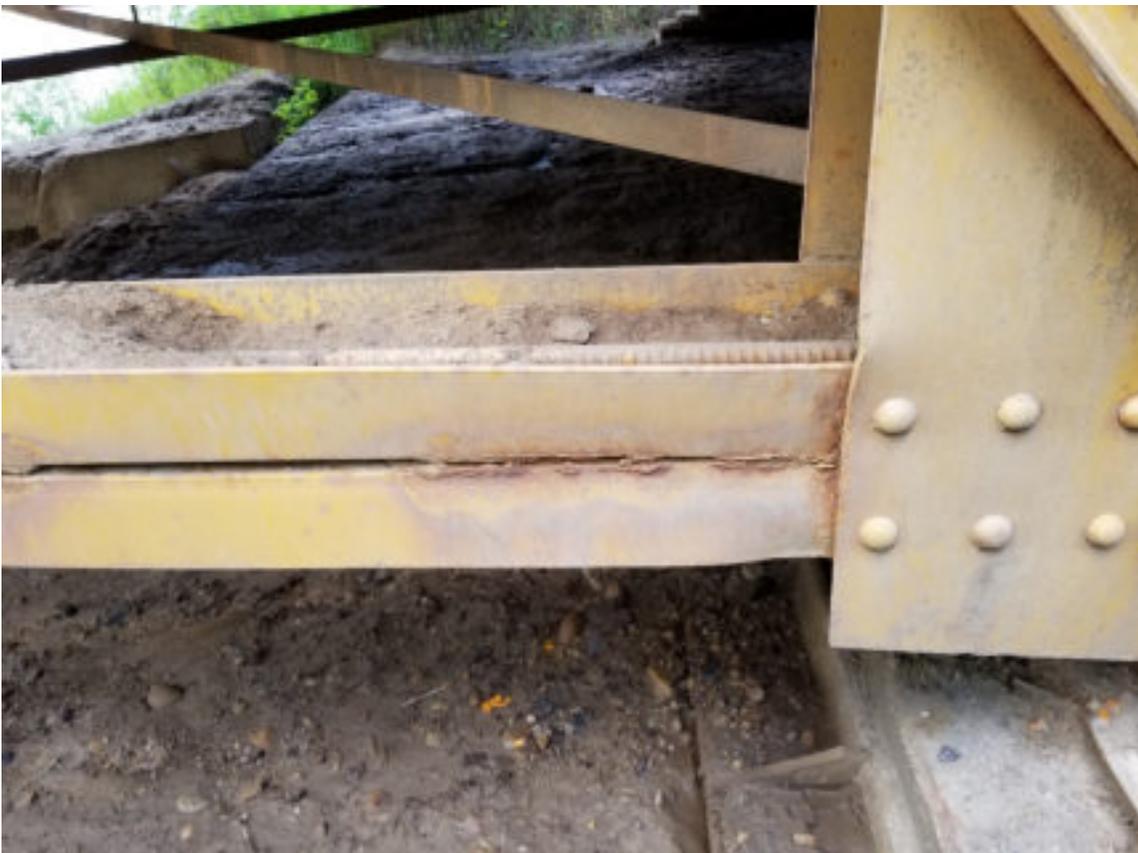
44.  
Span 6 L0L1E bottom chord and L0E gusset buckling from improper jacking of truss.

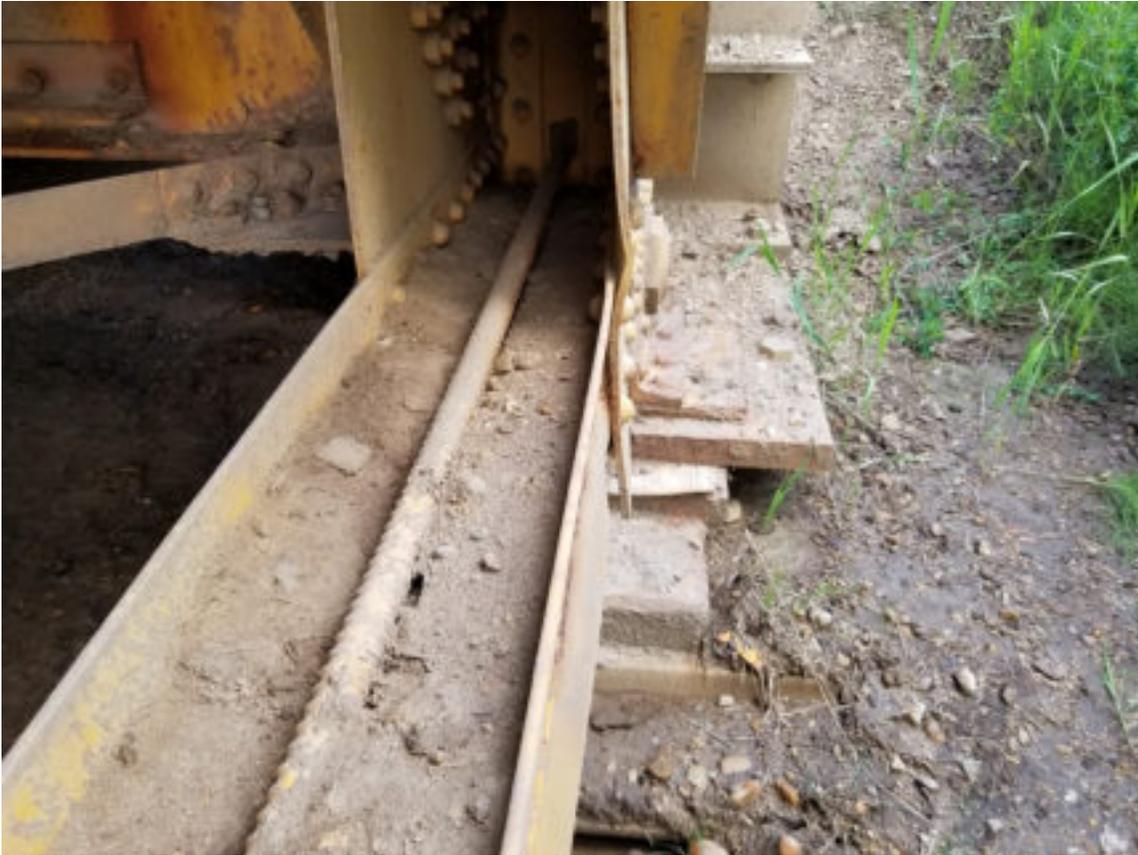
45.  
Span 6 L0L1E  
bottom chord and  
L0E gusset buckling  
from improper  
jacking of truss.

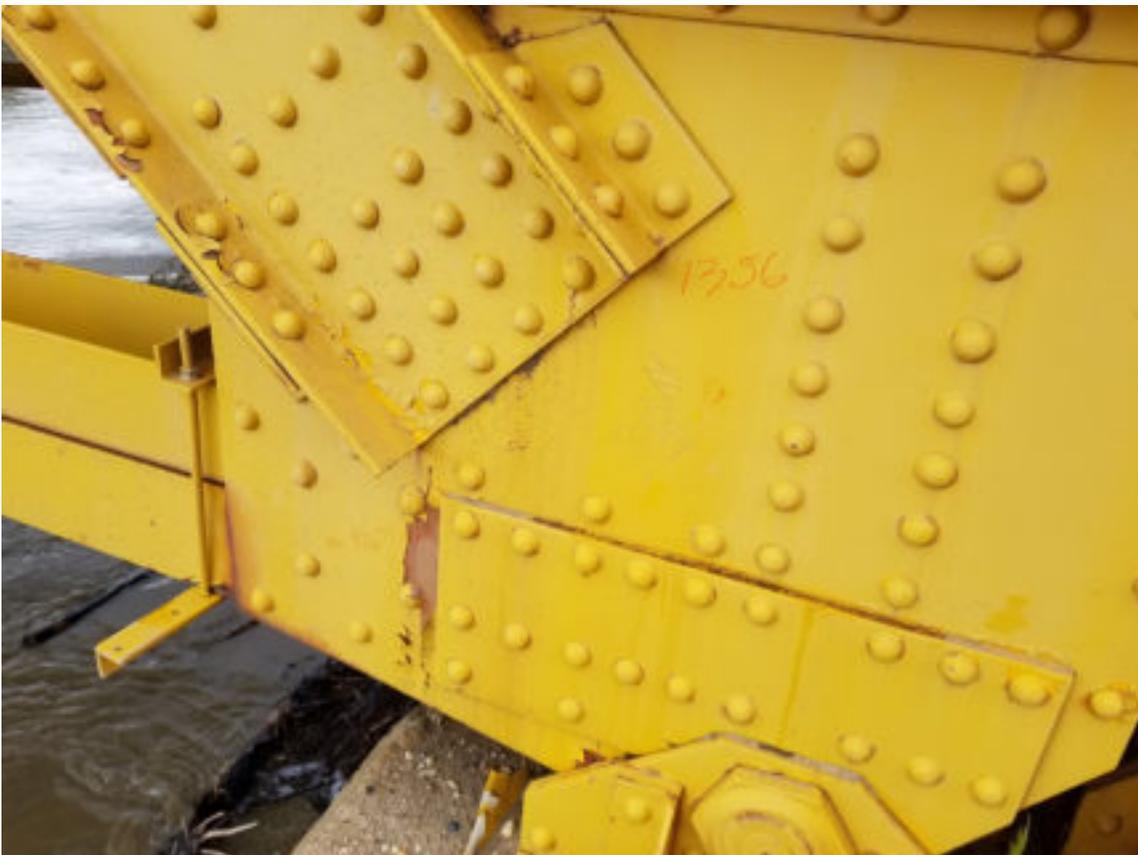
46.  
Span 5 L0E gusset  
plate.  
Gusset plate  
thickness  
measurements:  
13.56 mm  
uncorroded and  
12.01 mm as lowest  
value.
