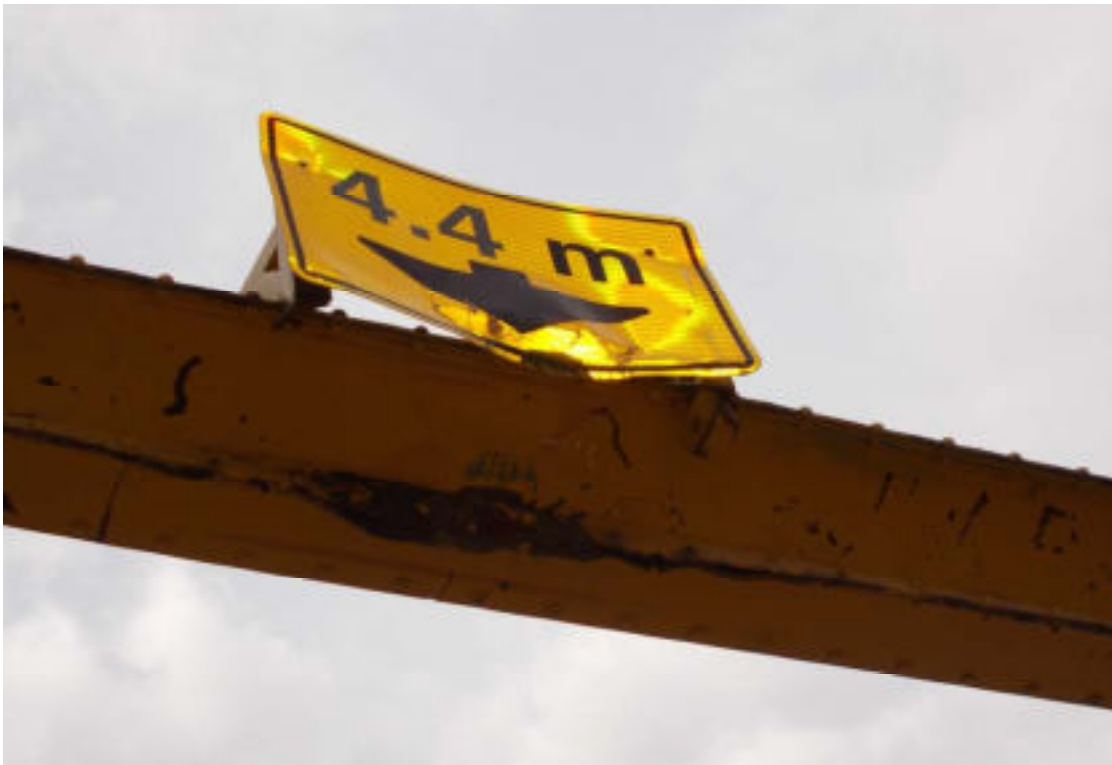
6. Vertical clearance sign and S4 south portal were damaged.

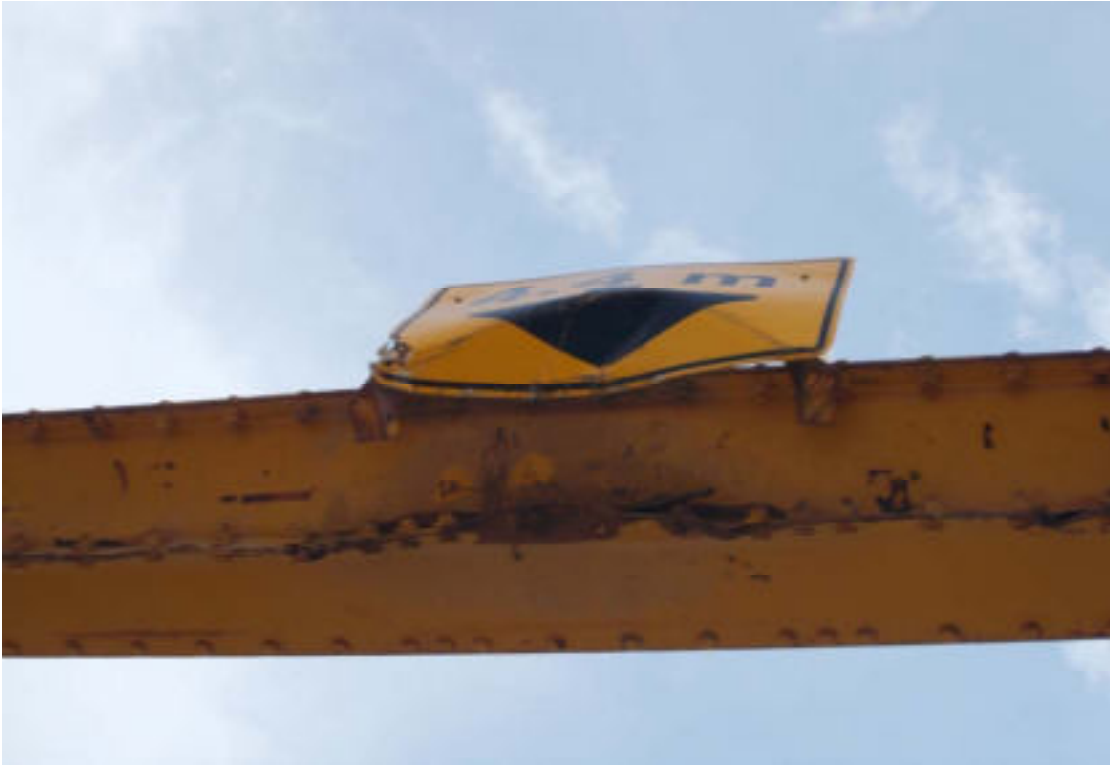
7. Vertical clearance sign and S6 north portal were damaged

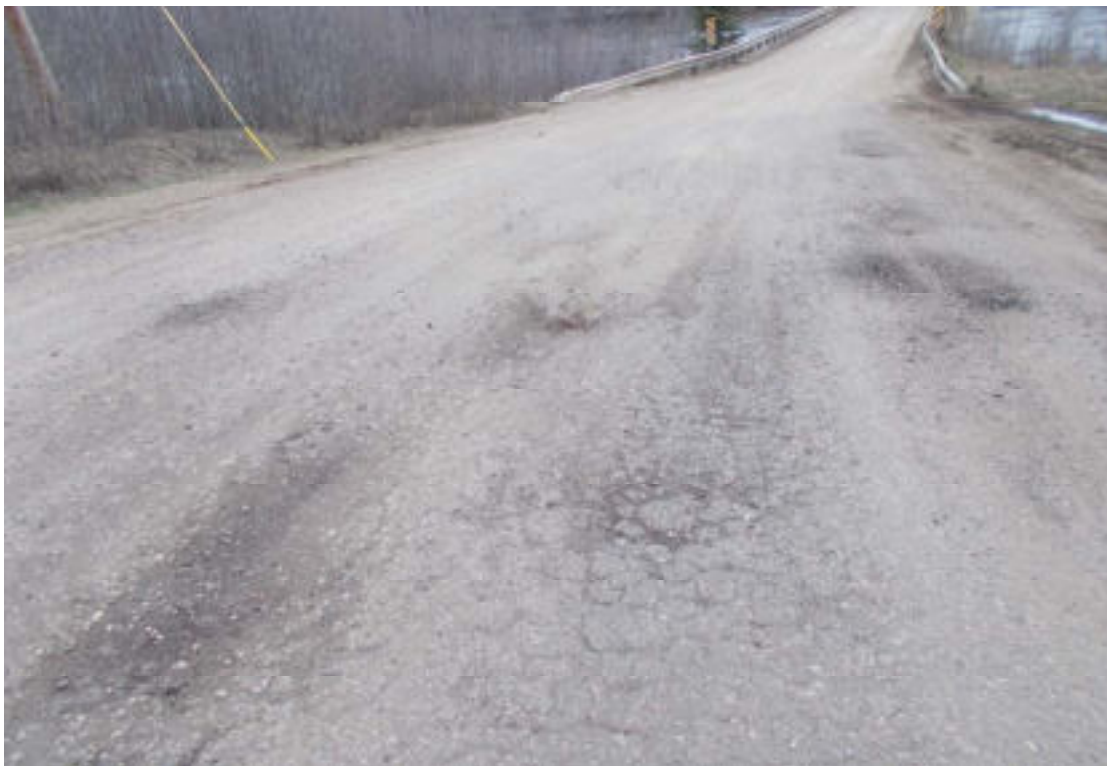
8. Settlement and bump at south approach

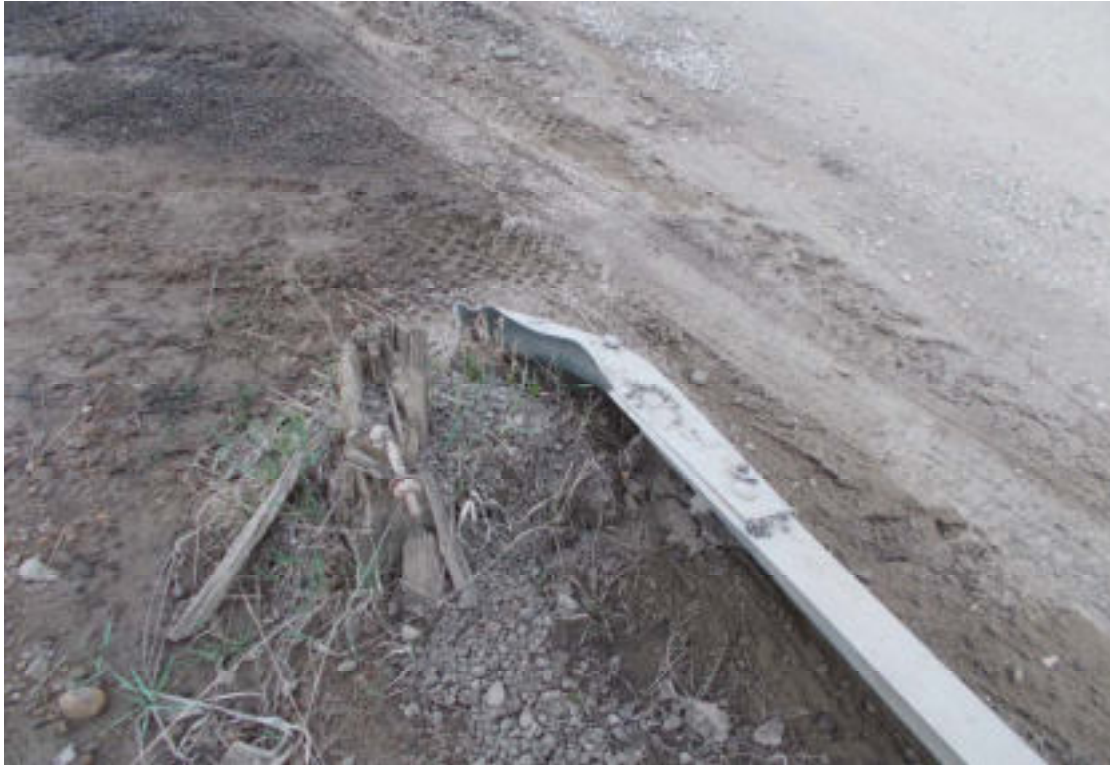
9. SE TD end disconnected from post and post broken

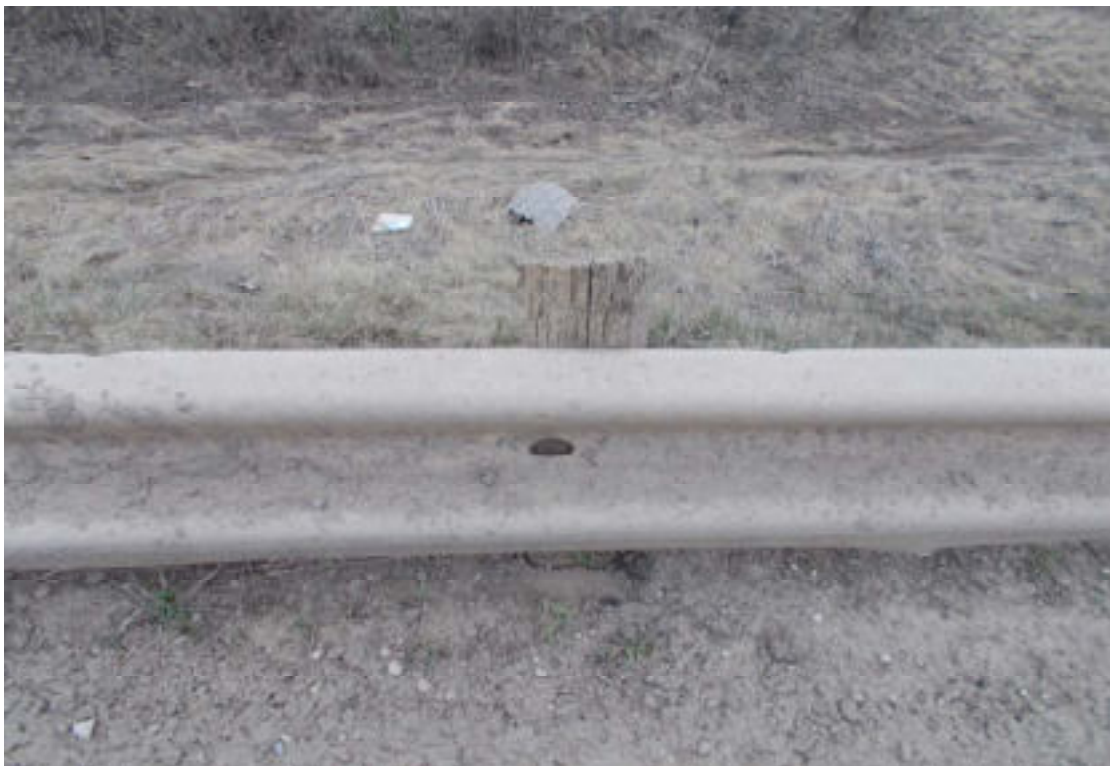
10. One rail to post bolt missing at SW

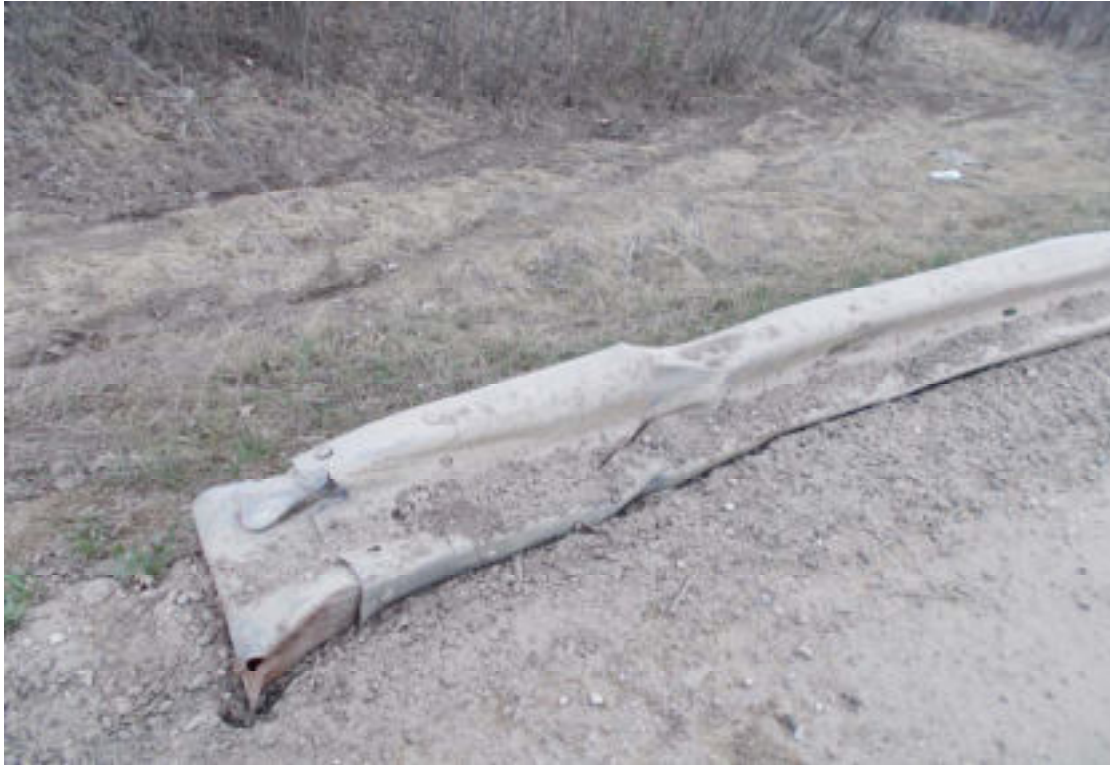
11. SW TD was damaged

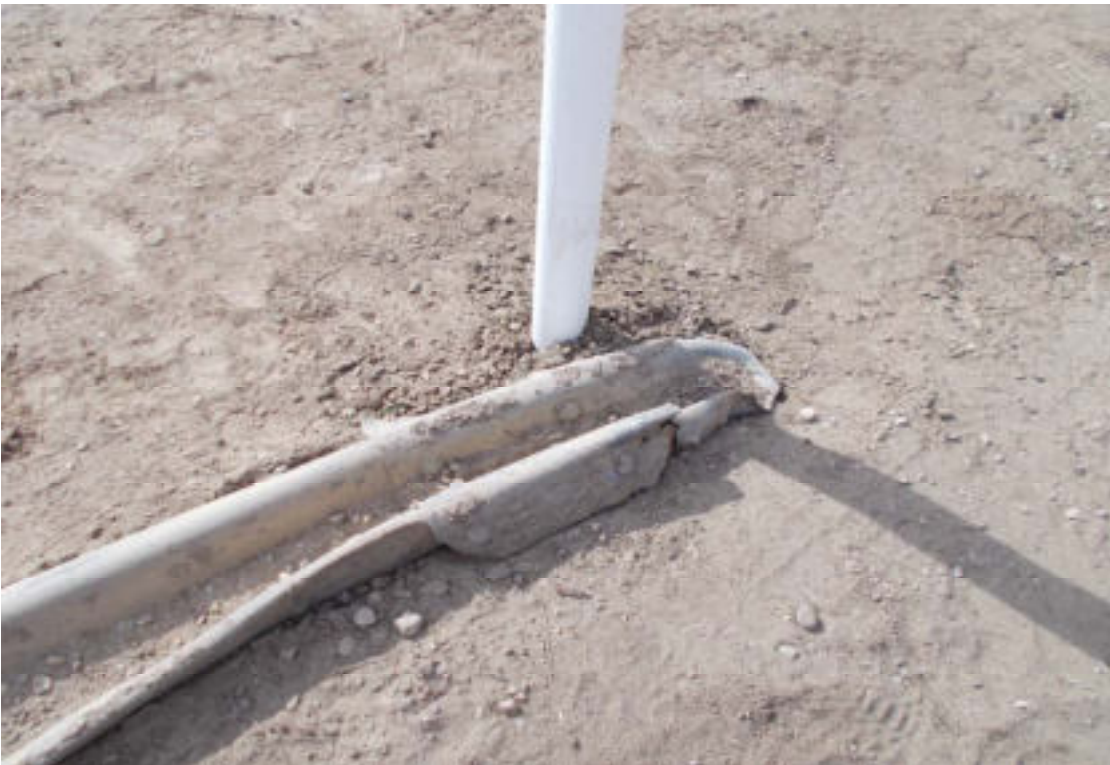
12. NW TD was damaged

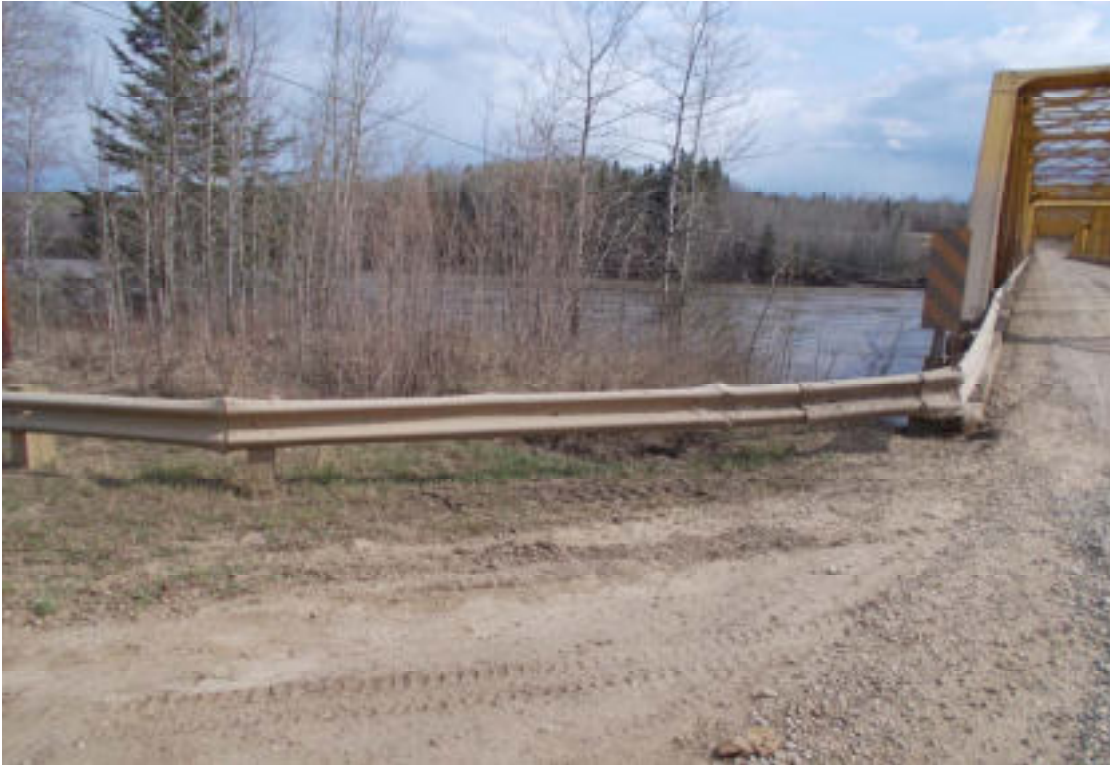
13. 3 posts missing at NE corner

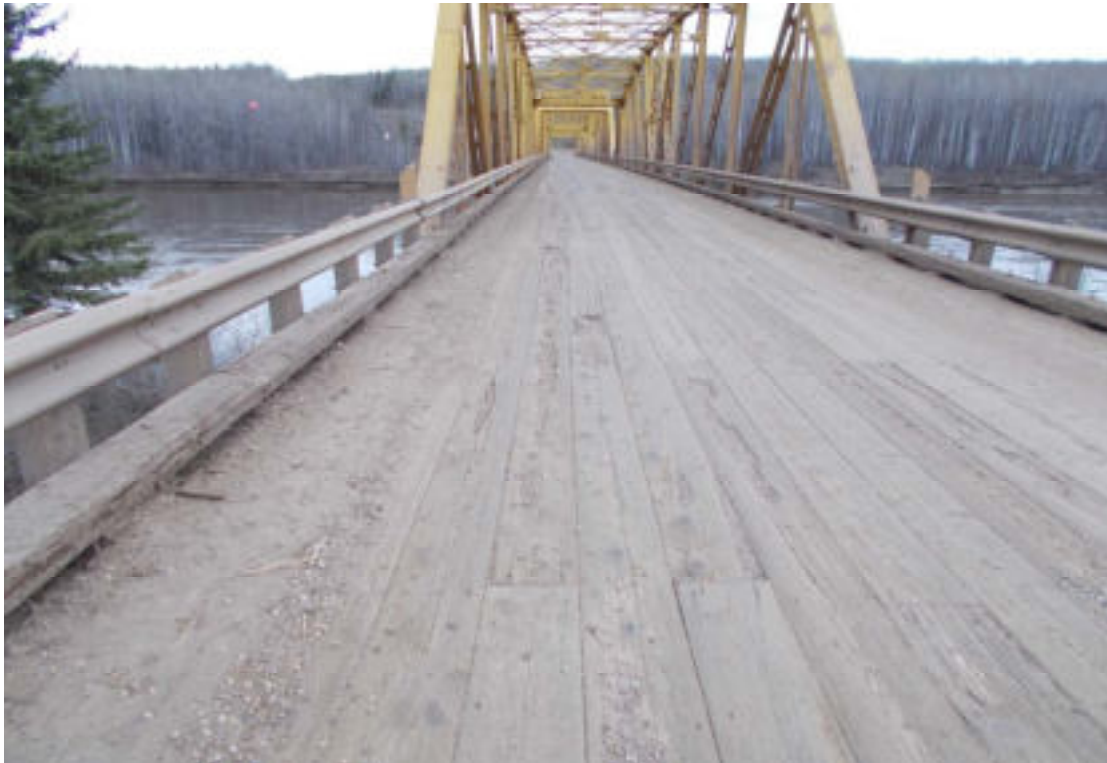
14. Rotten deck at SP2 and SP3

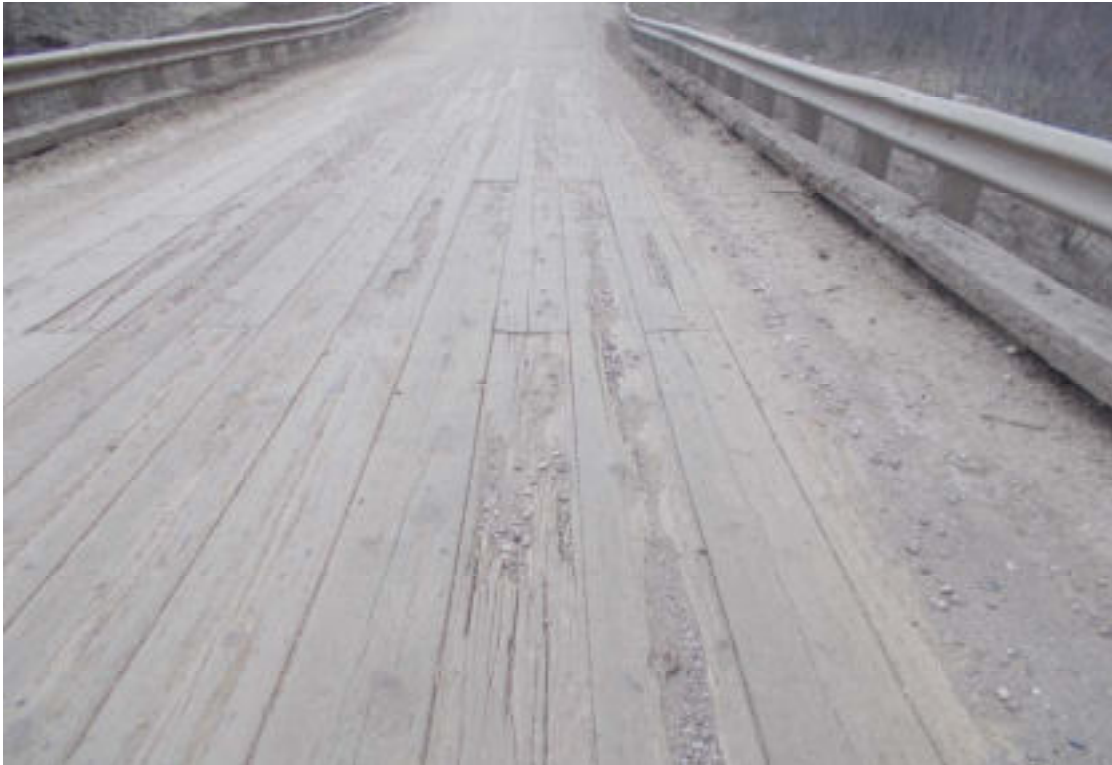
15. Rotten deck planks at SP3

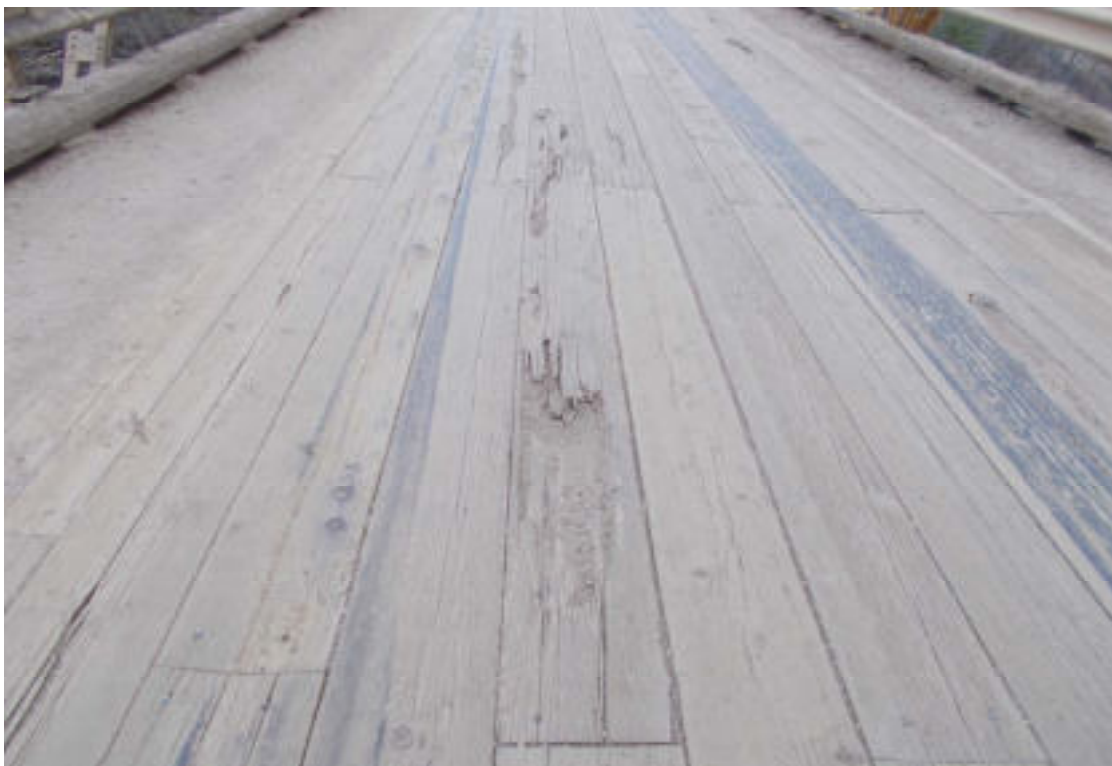
16. Rotten deck planks at SP4

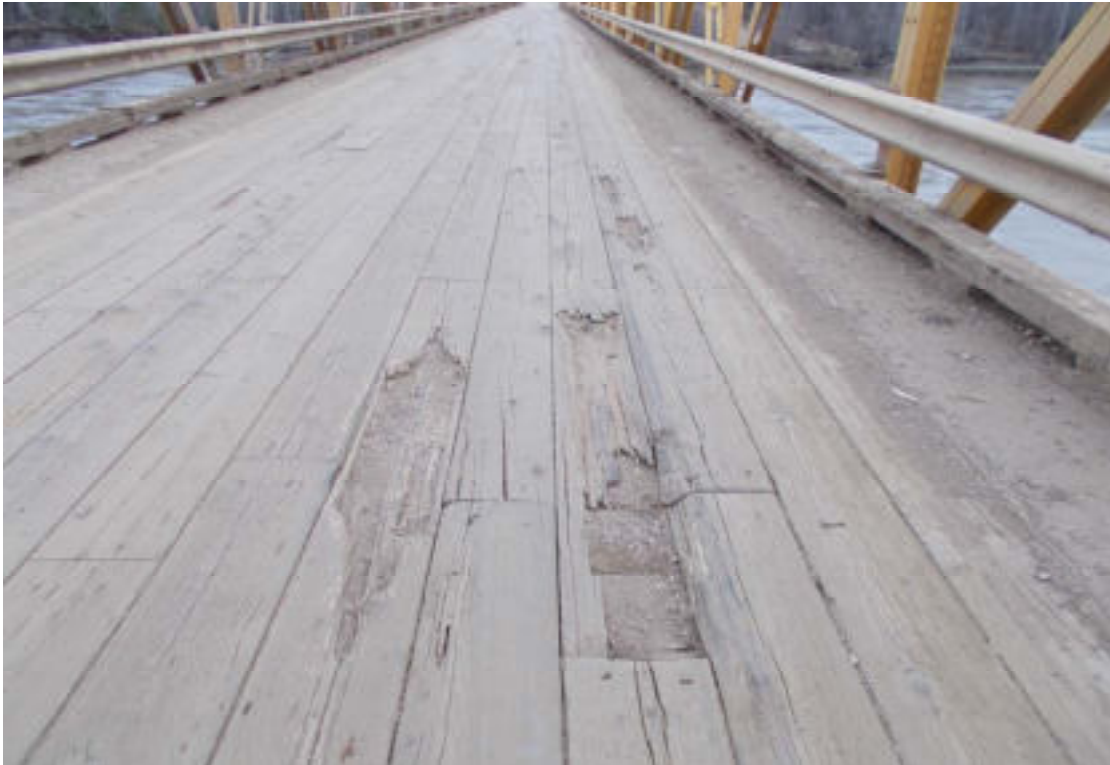
17. Rotten deck planks at SP5

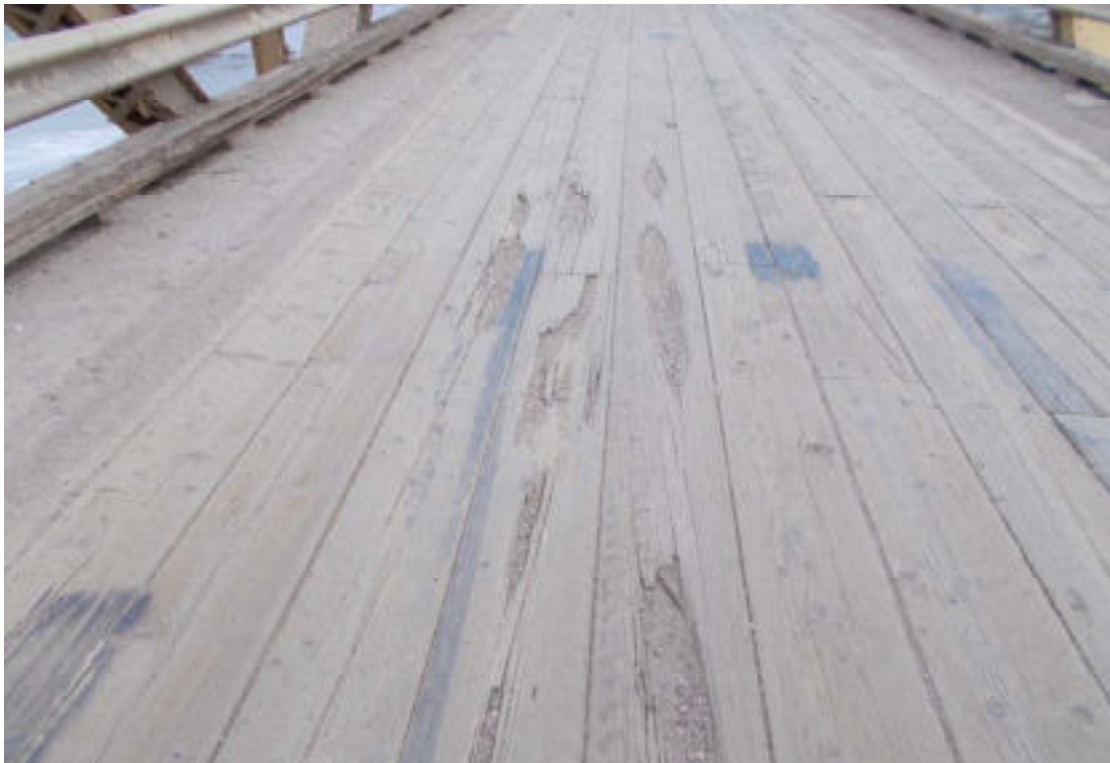
18. Rotten deck planks at SP6

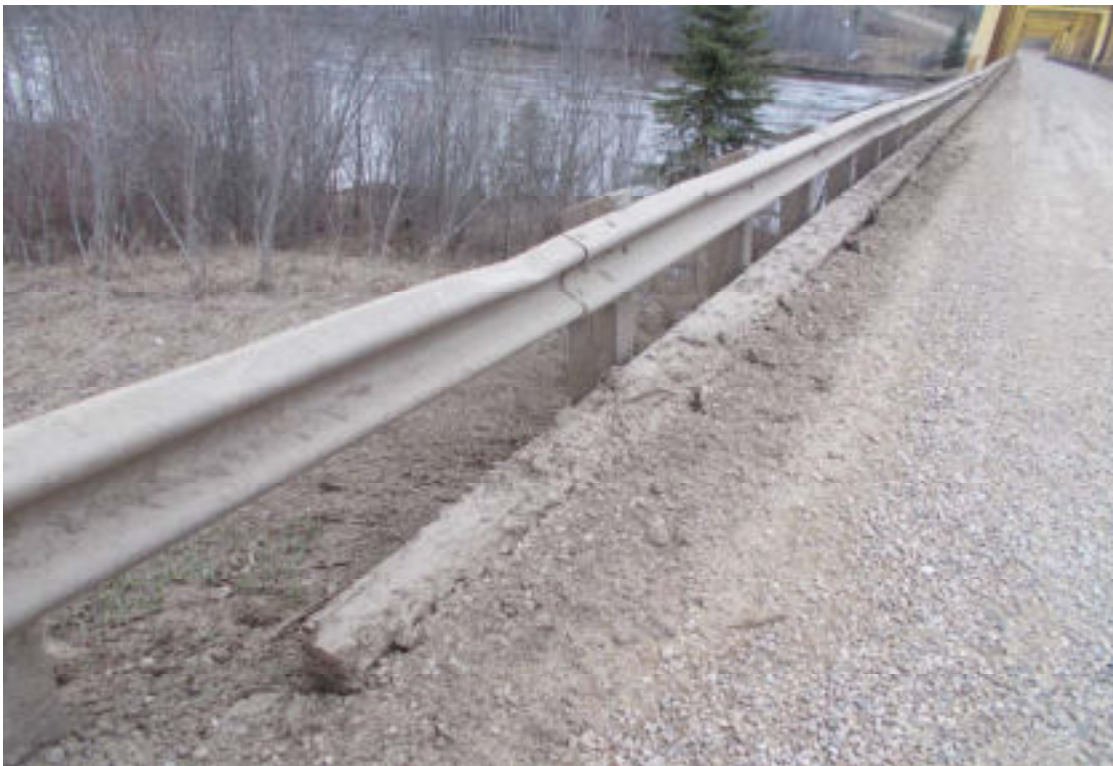
20. S1 SW WG was damaged

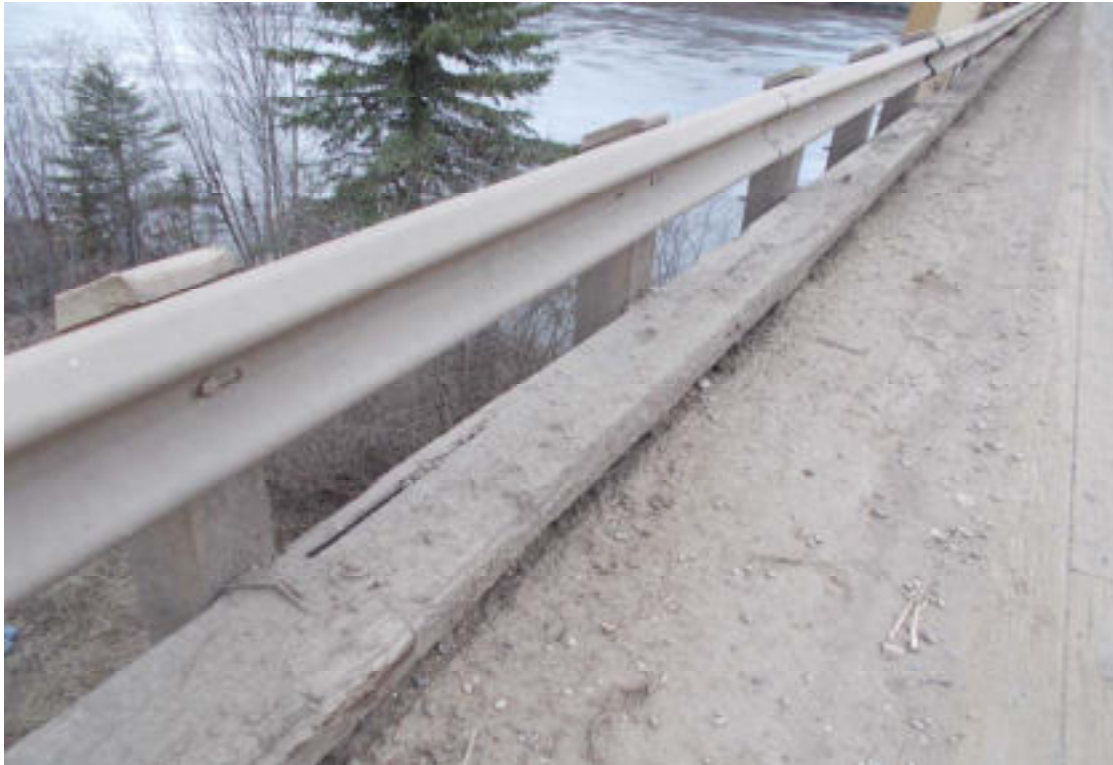
21. S3 one WG at west side was damaged

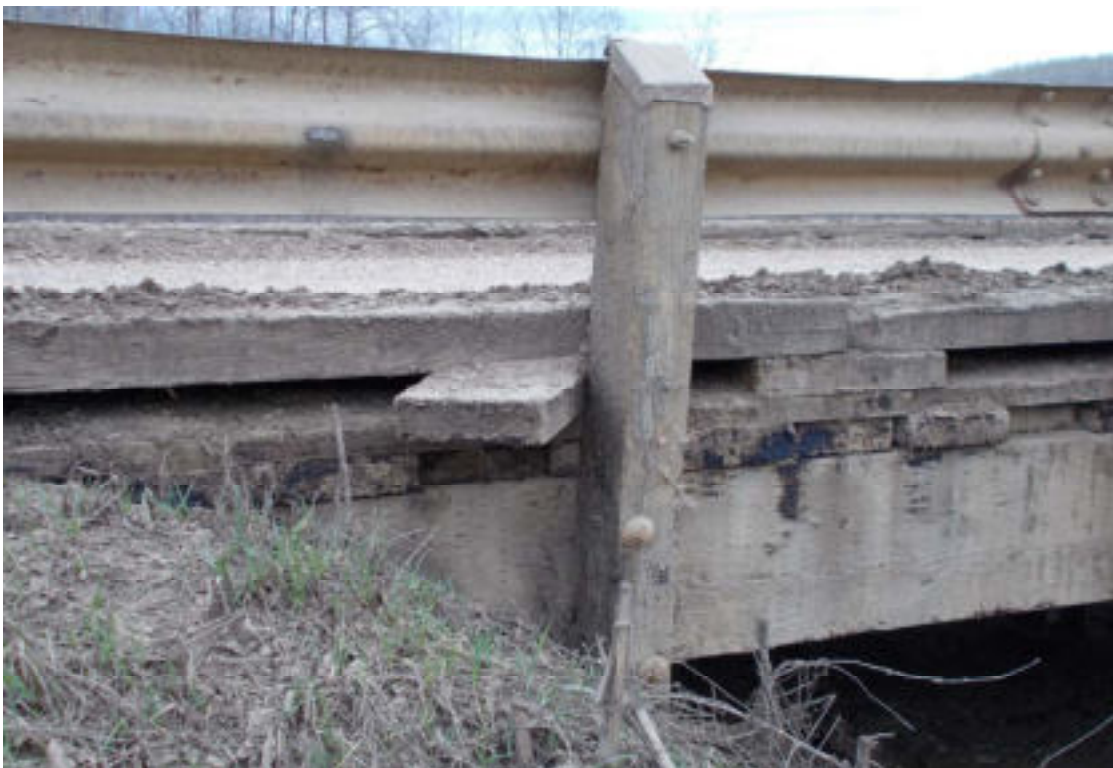
22. S1 SE one blocking rotated out

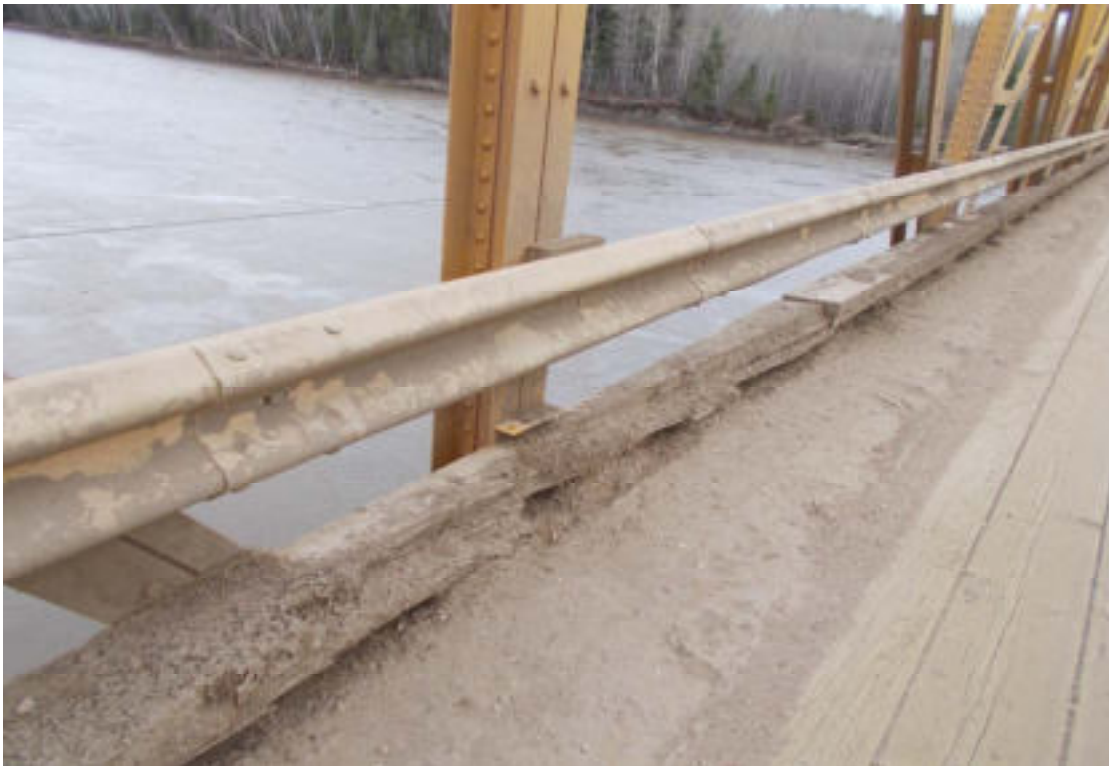
23. S5 one WG was damaged at east side

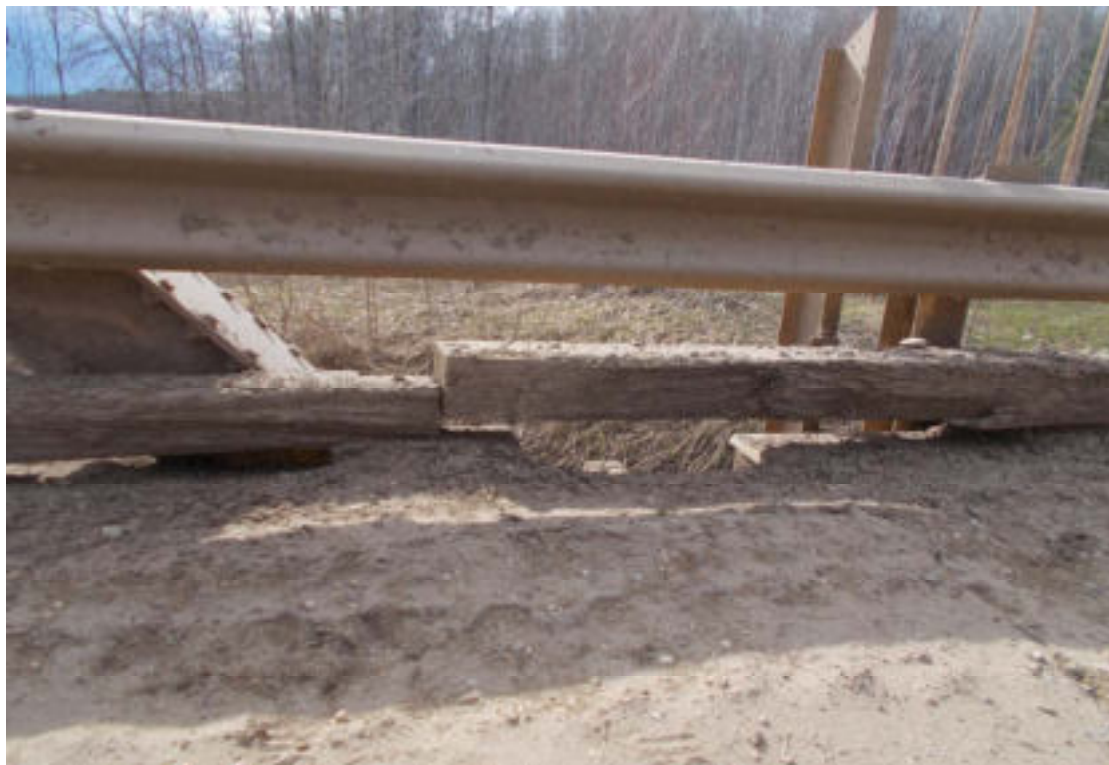
24. S7 one WG at west side lifted up

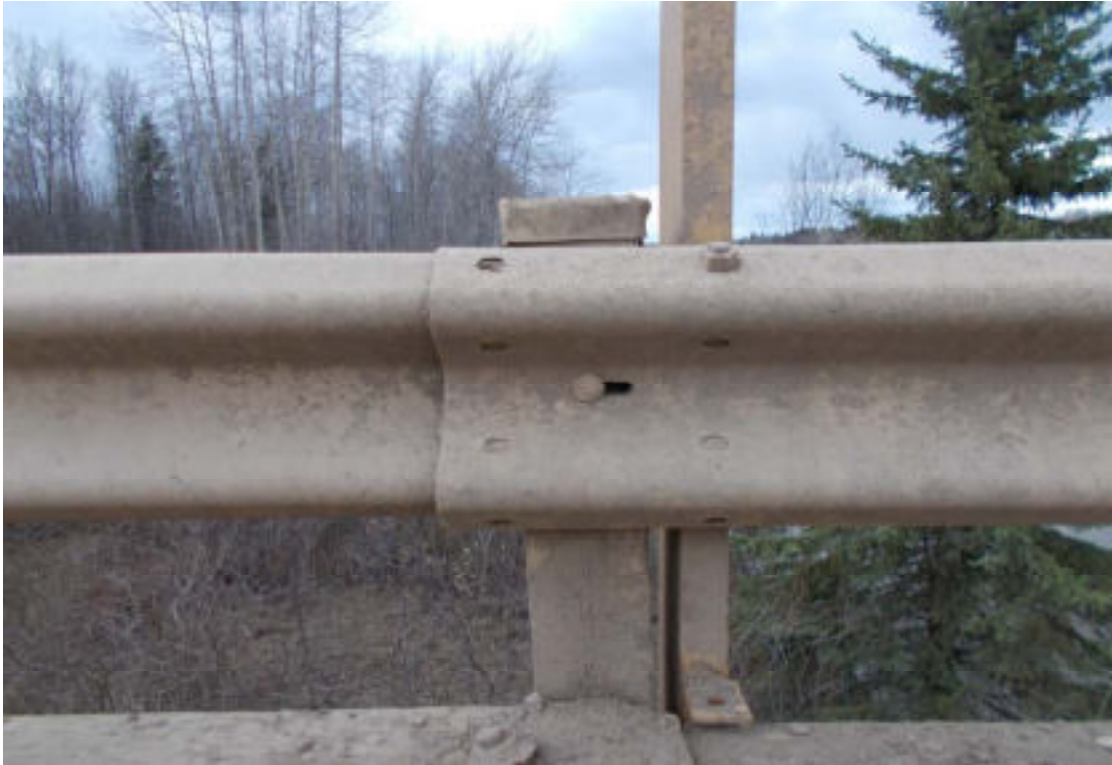
25. 7 splice bolts at S3 NW

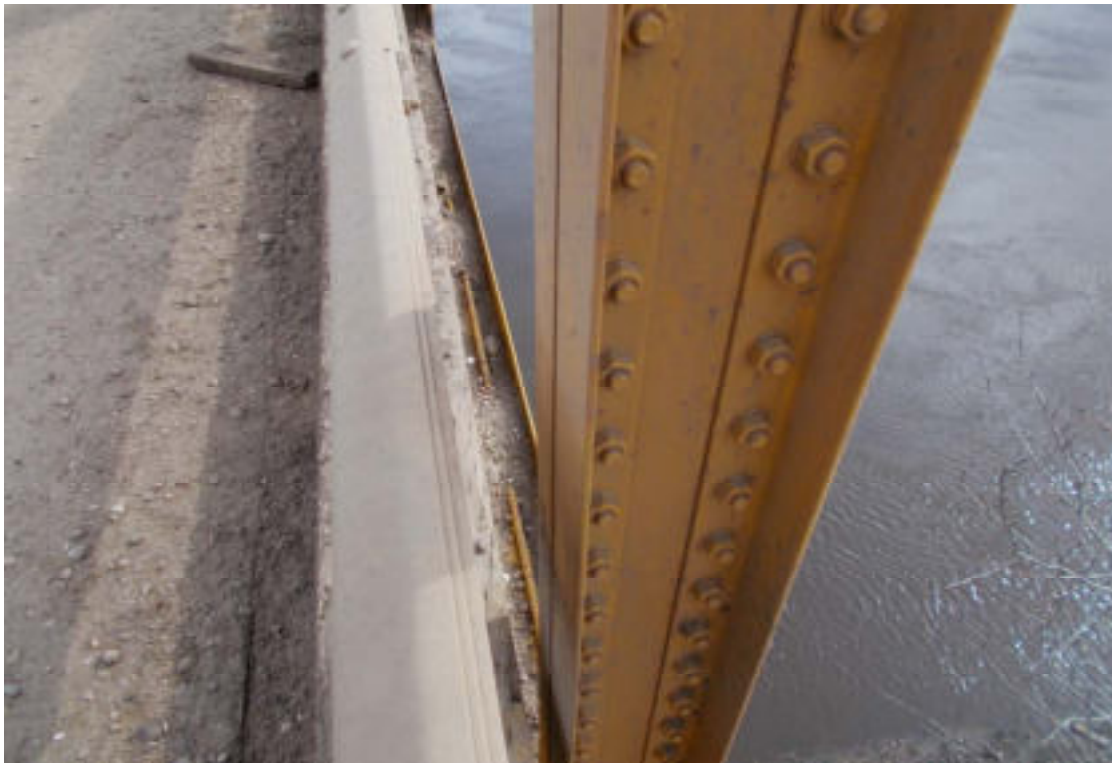
26. One spacer missing at SP6 west side - typical at multiple locations

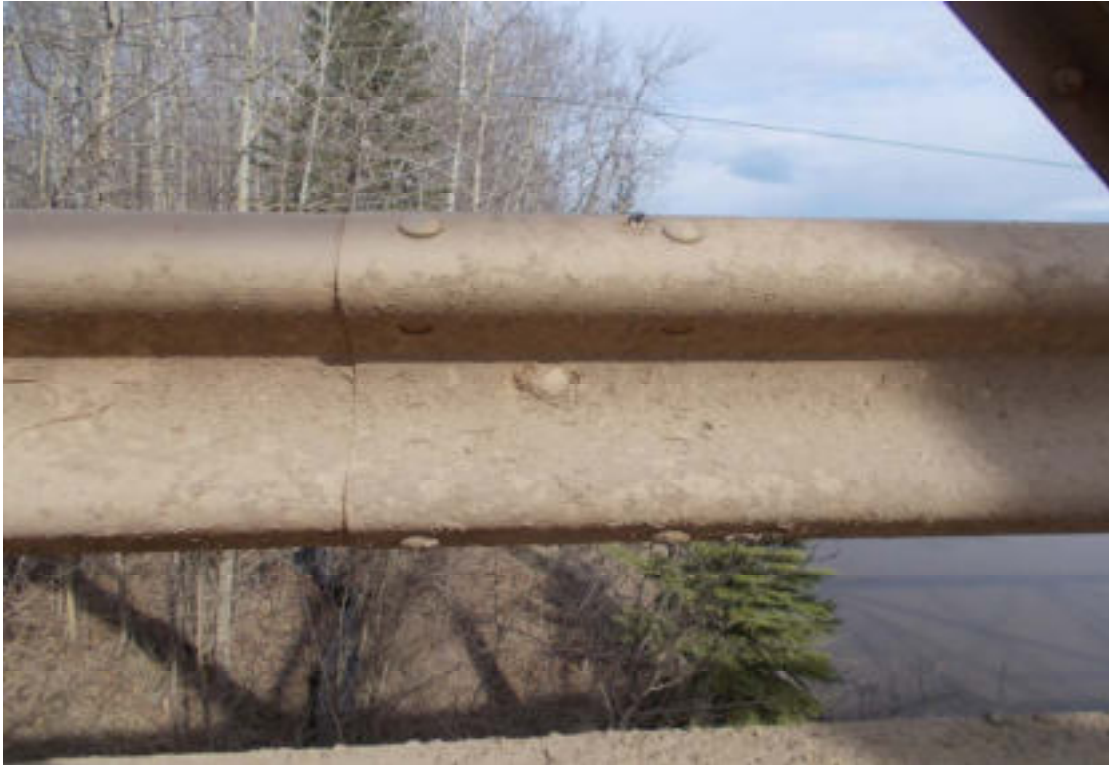
27.4 splice bolts missing at SP6 east side - typical at multiple locations

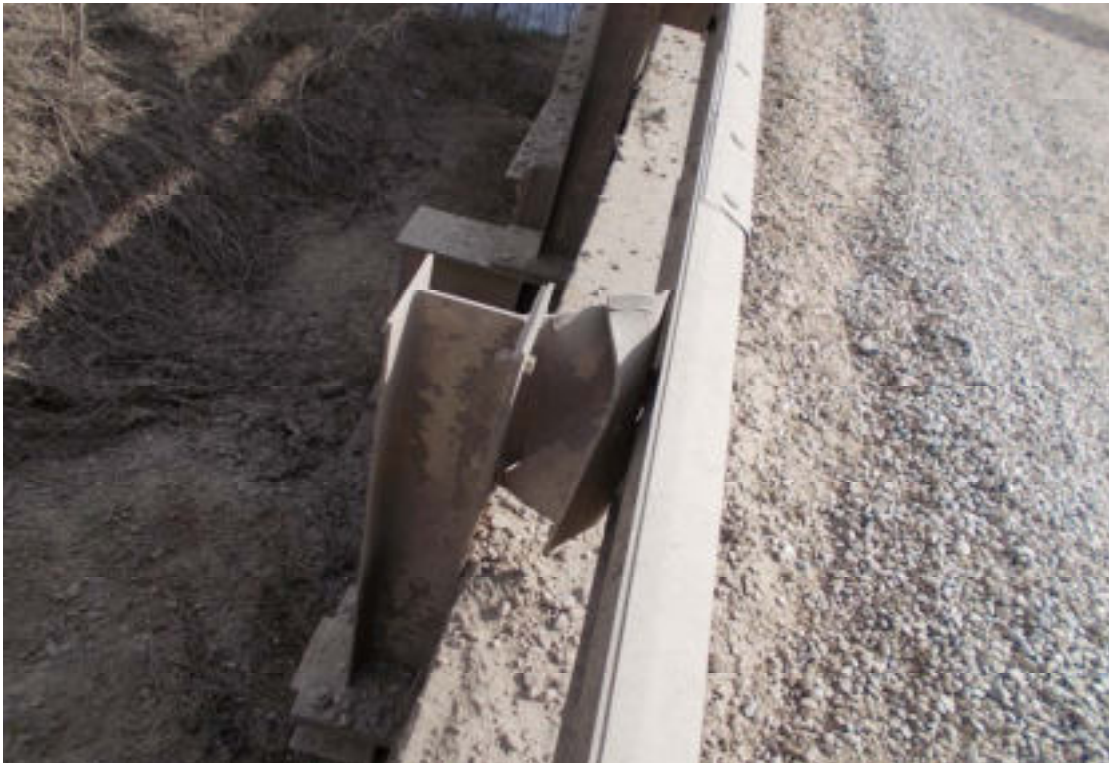
28. One spacer bent at SP7 east side

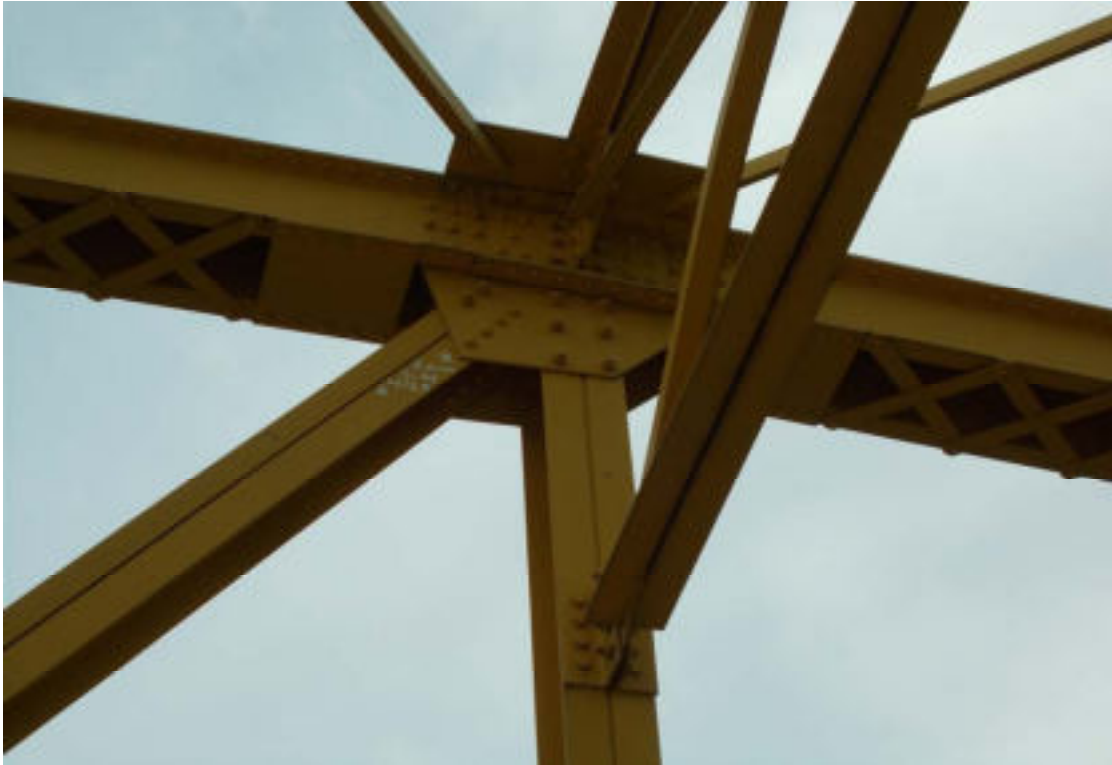
29. 3mm long crack was marked on SP4 U7L6E near U7

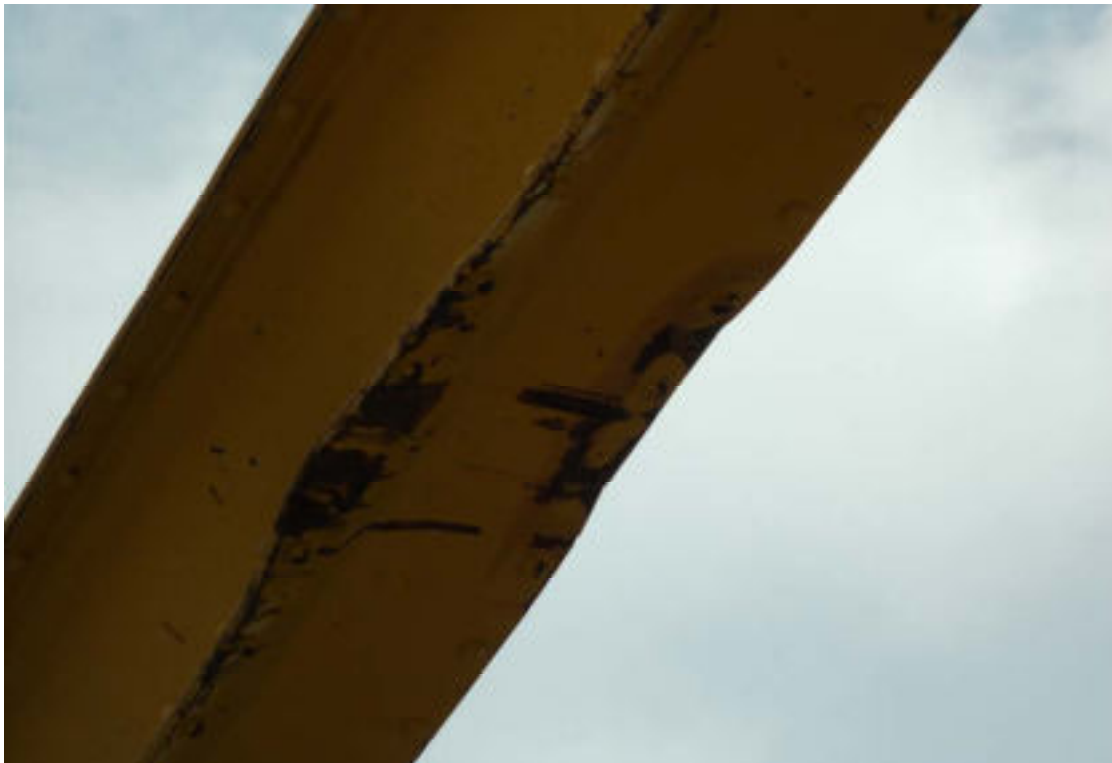
30. SP4 north portal was damaged

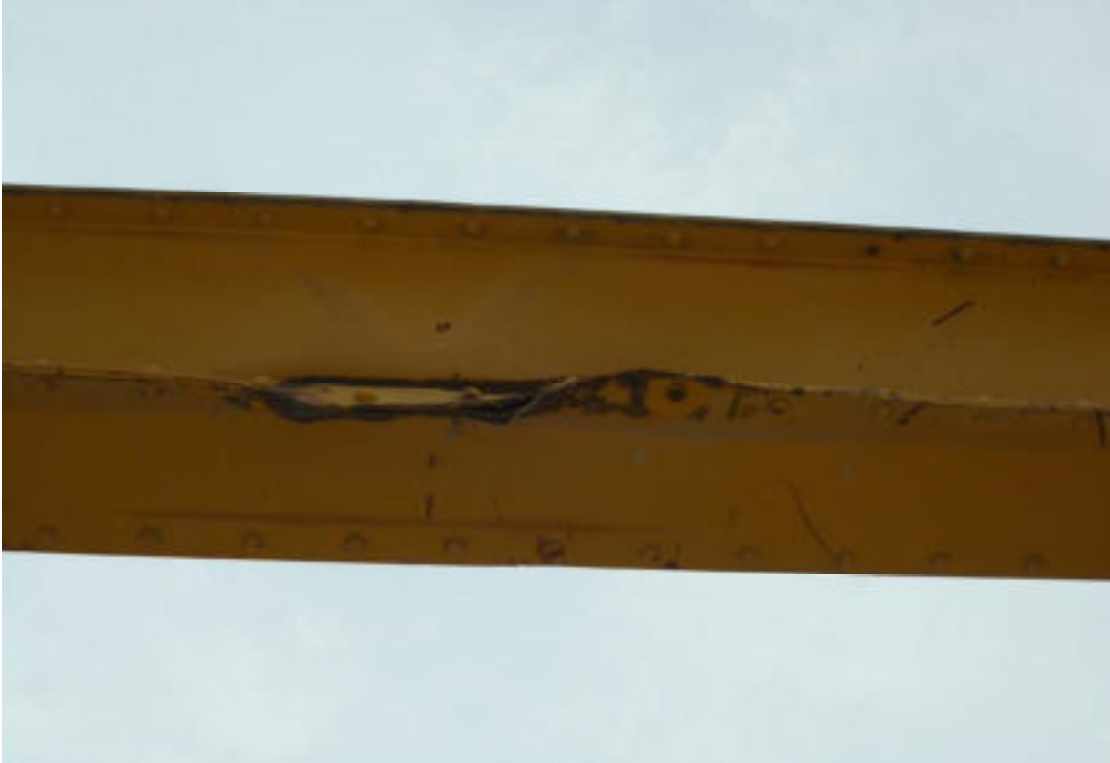
31. SP6 south portal was damaged

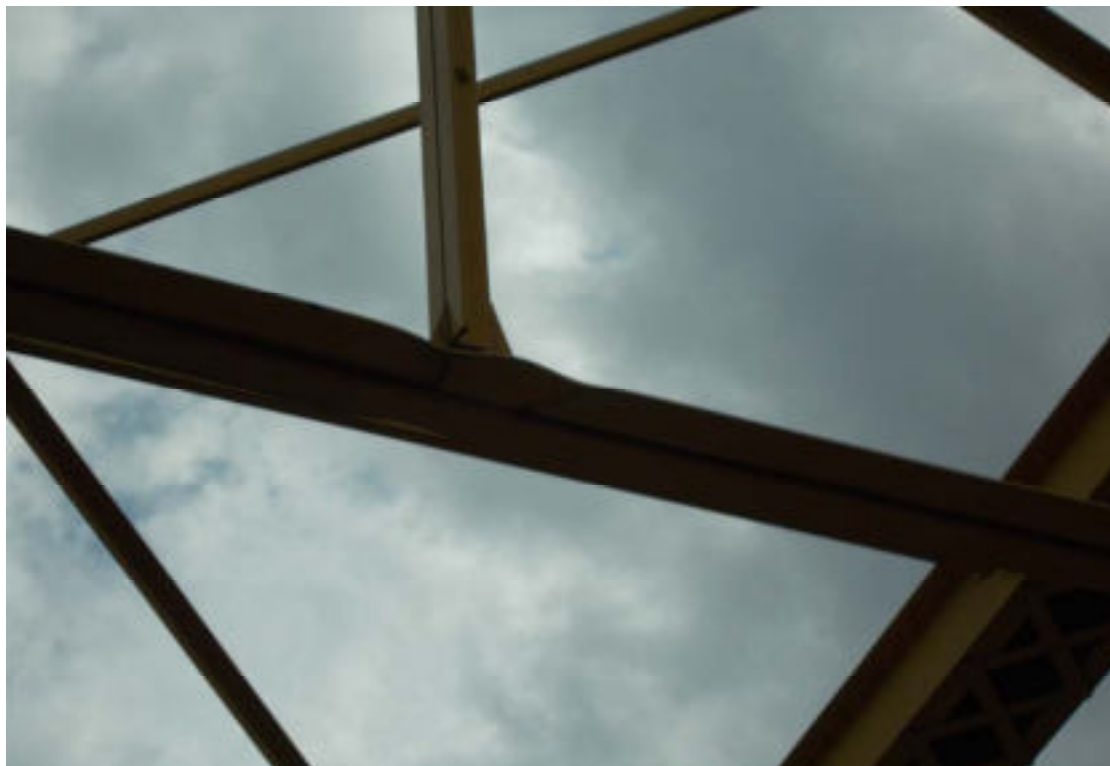
32. SP5 U7U7 bottom bracing was damaged. Typical at multiple locations

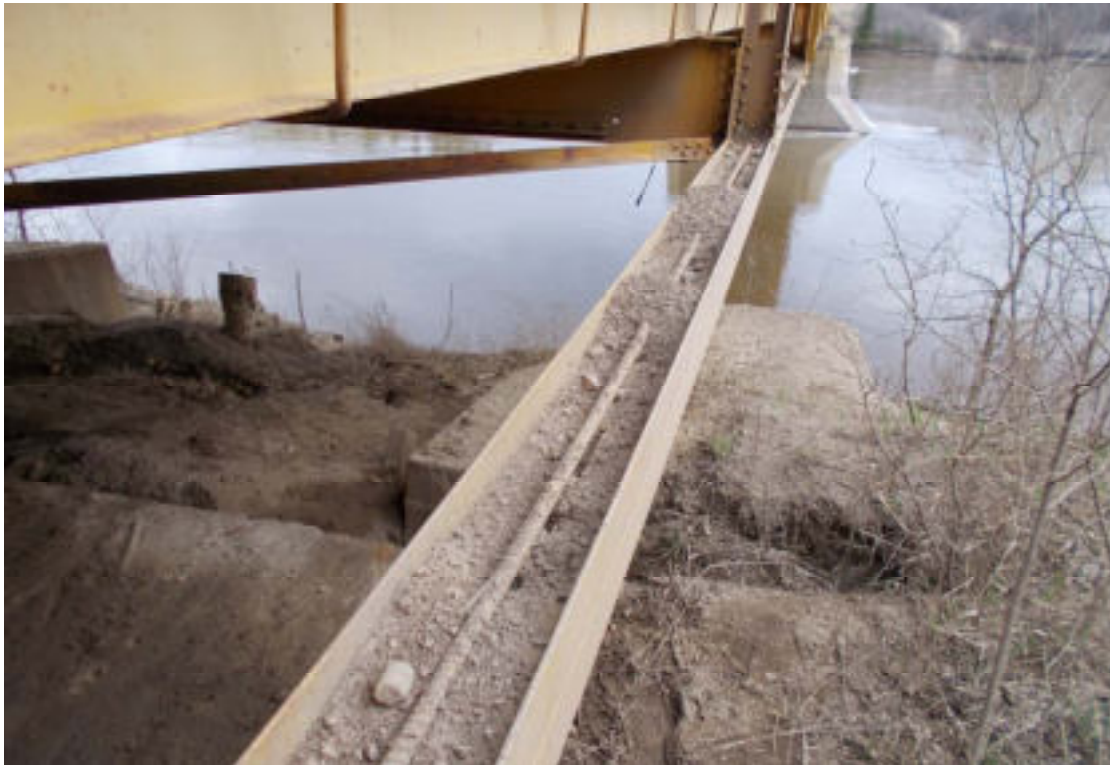
33. Dywidag bar at SP6 west bottom chord. Dirt on bottom chord
