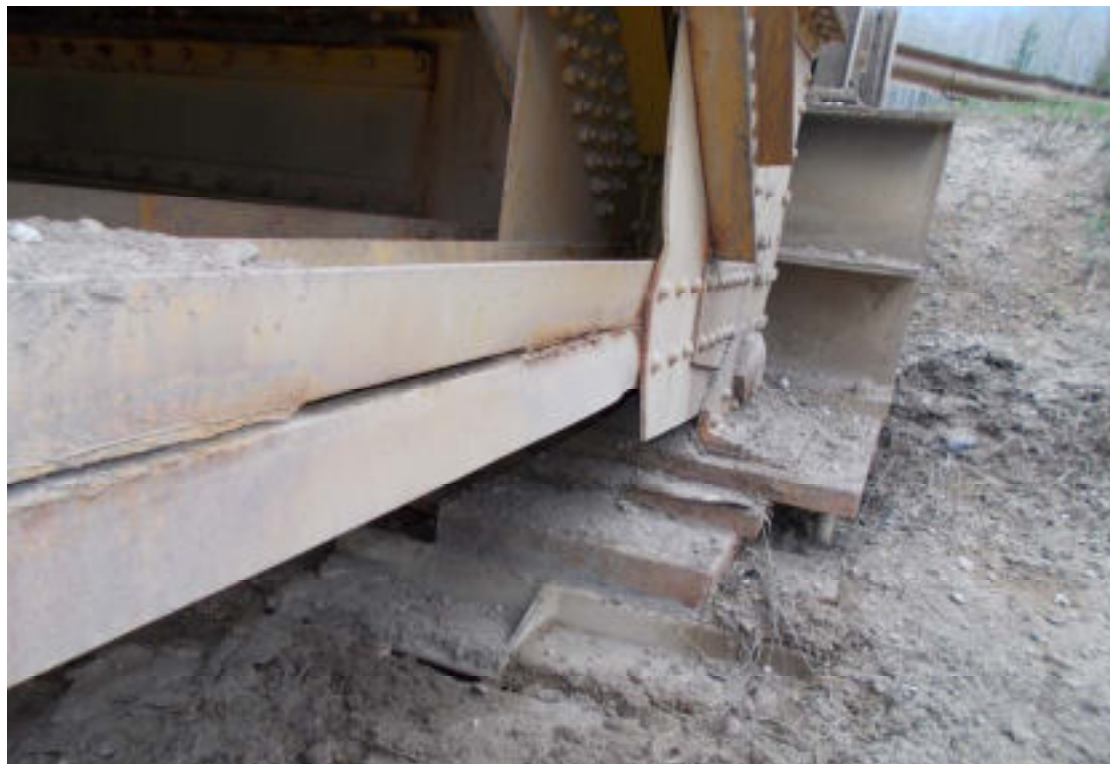
34. SP6 NE bottom chord twisted

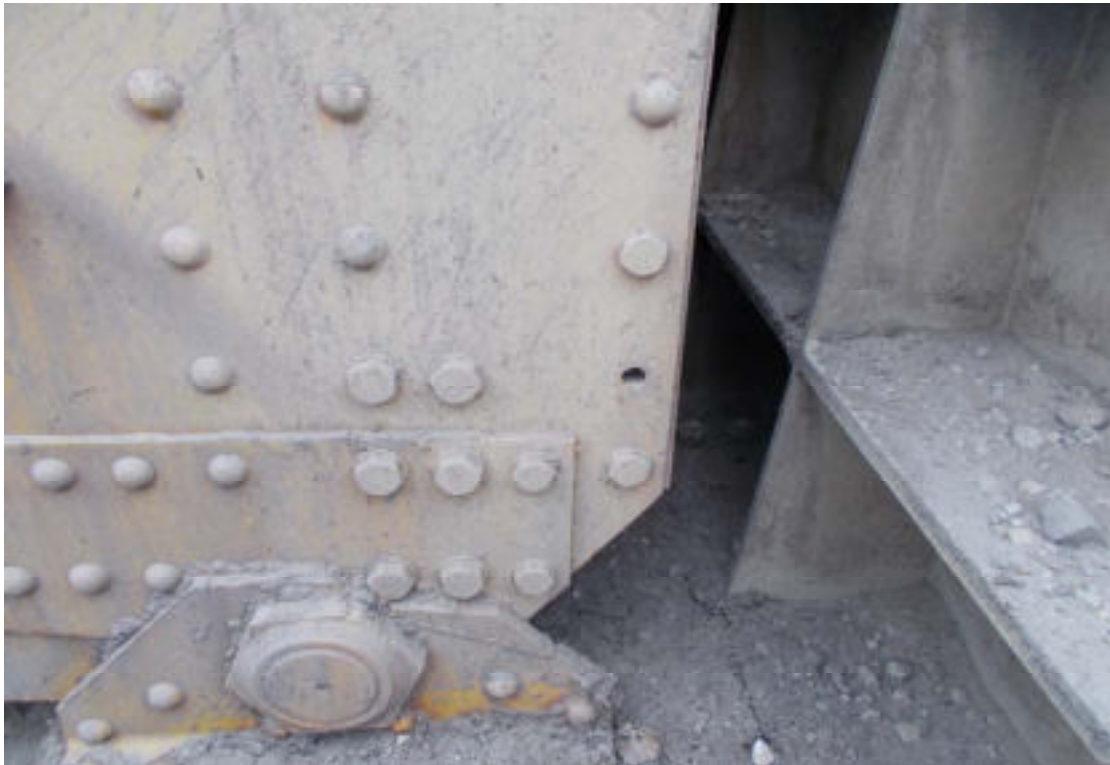
35. One bolt missing at SP6 gusset plate near bearing

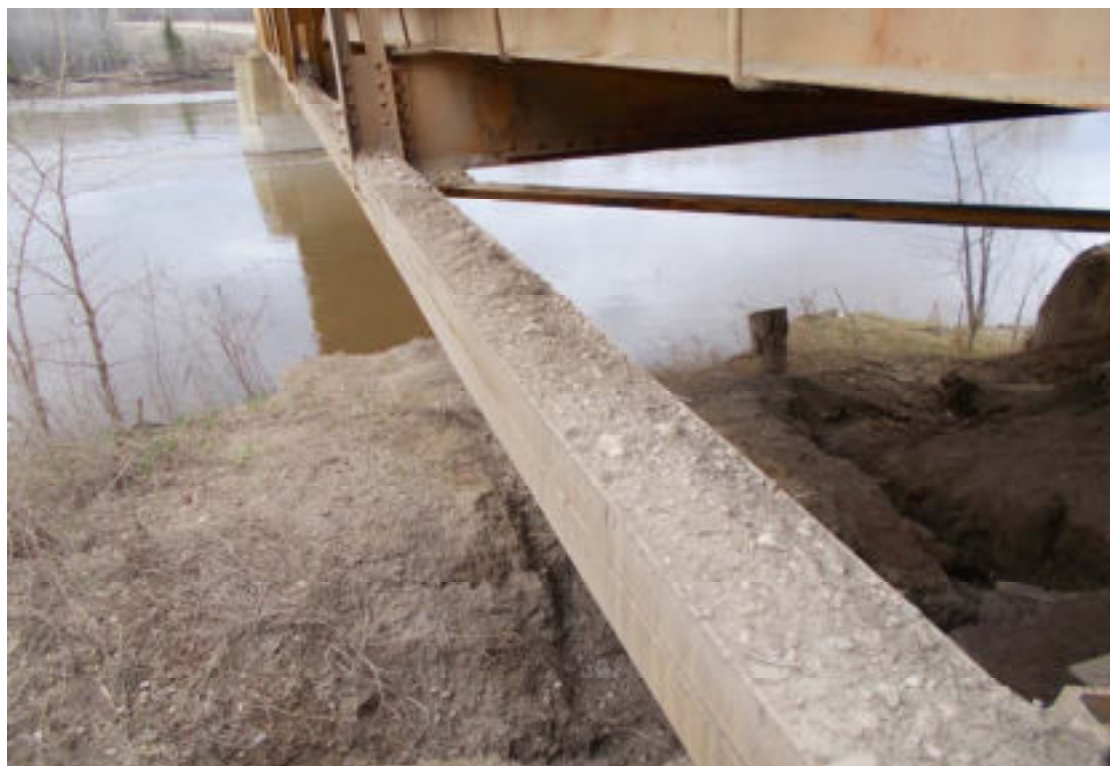
36. SP6 east bottom chord is full of dirt

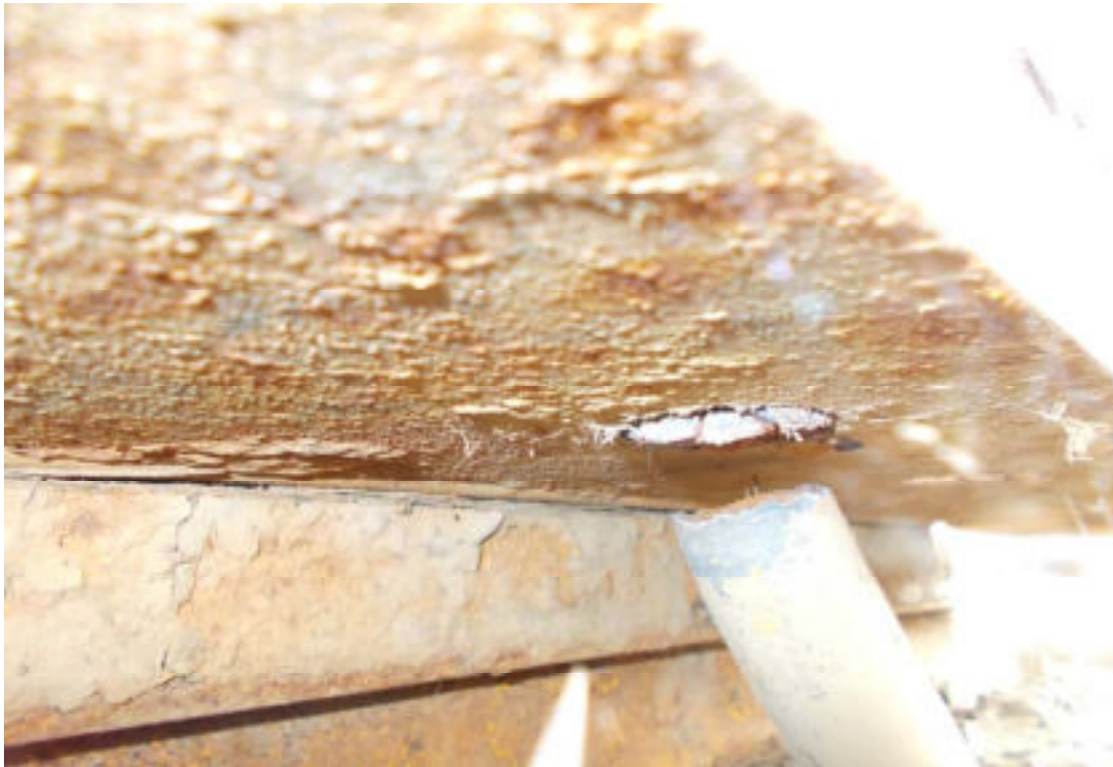
37. One bearing A/B at P6 west bearing sheared off

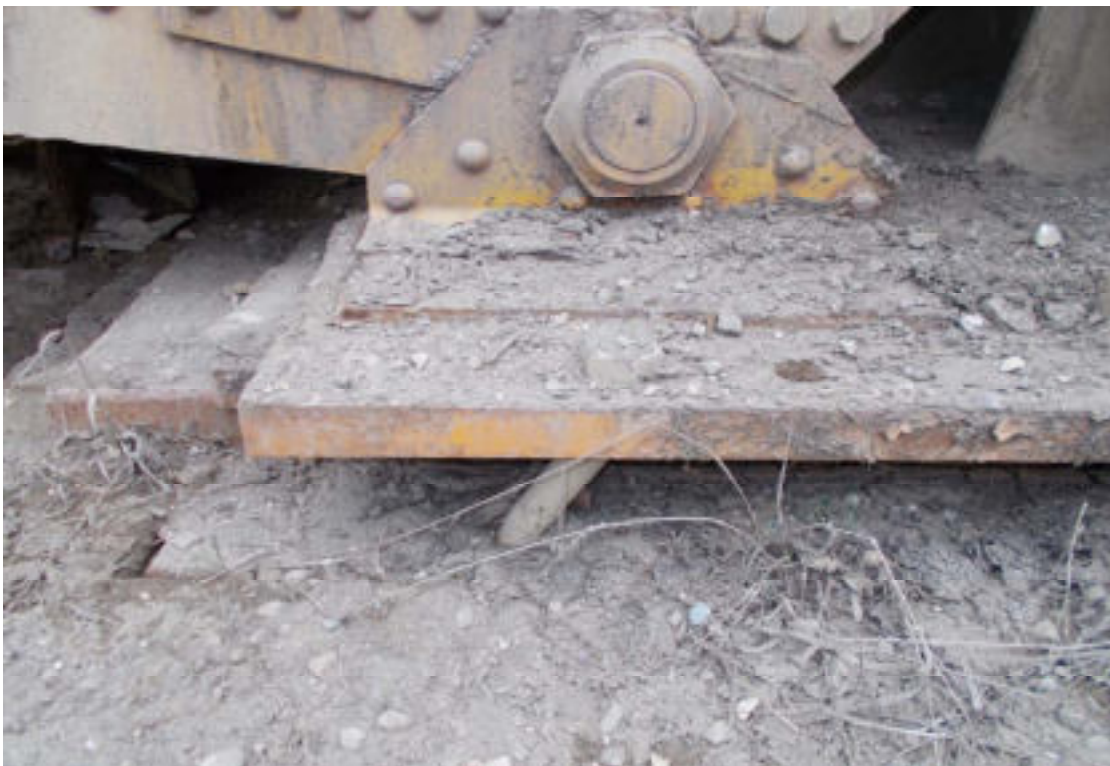
38. One A/B at P6 east bearing bent. Possibly due to north hill and P6 moving towards river

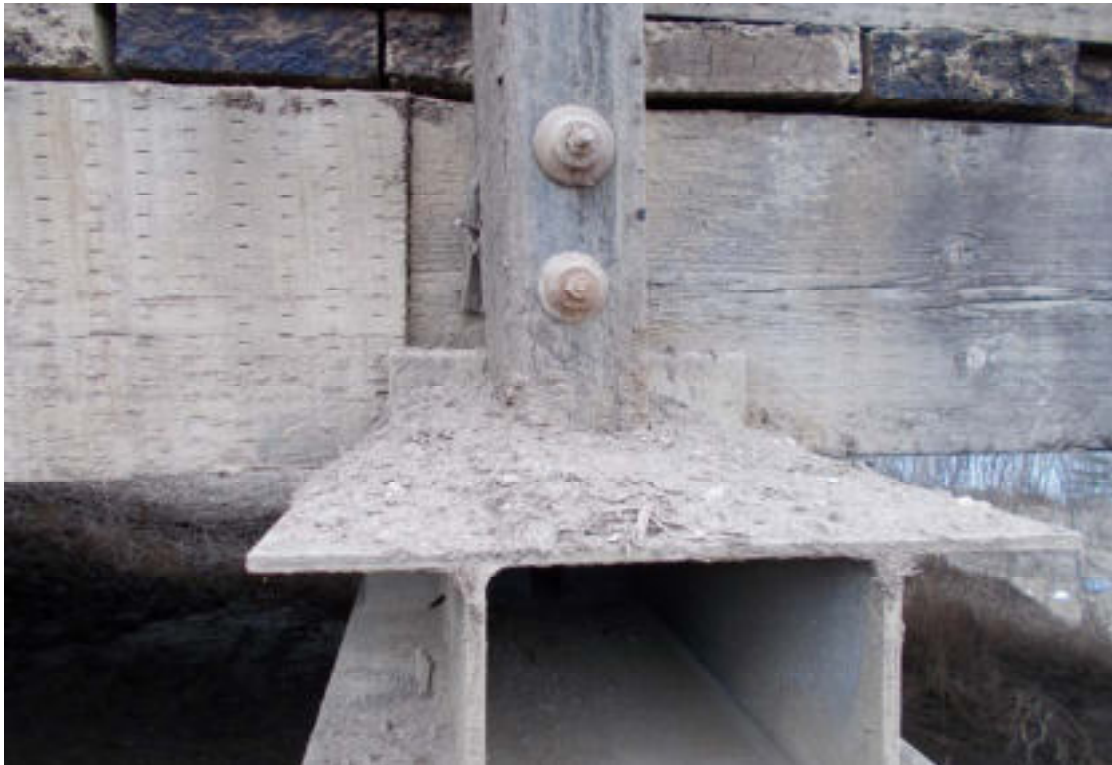
39. SP1 Stringer 11 (left side) bearing approx 95mm on Pier 1

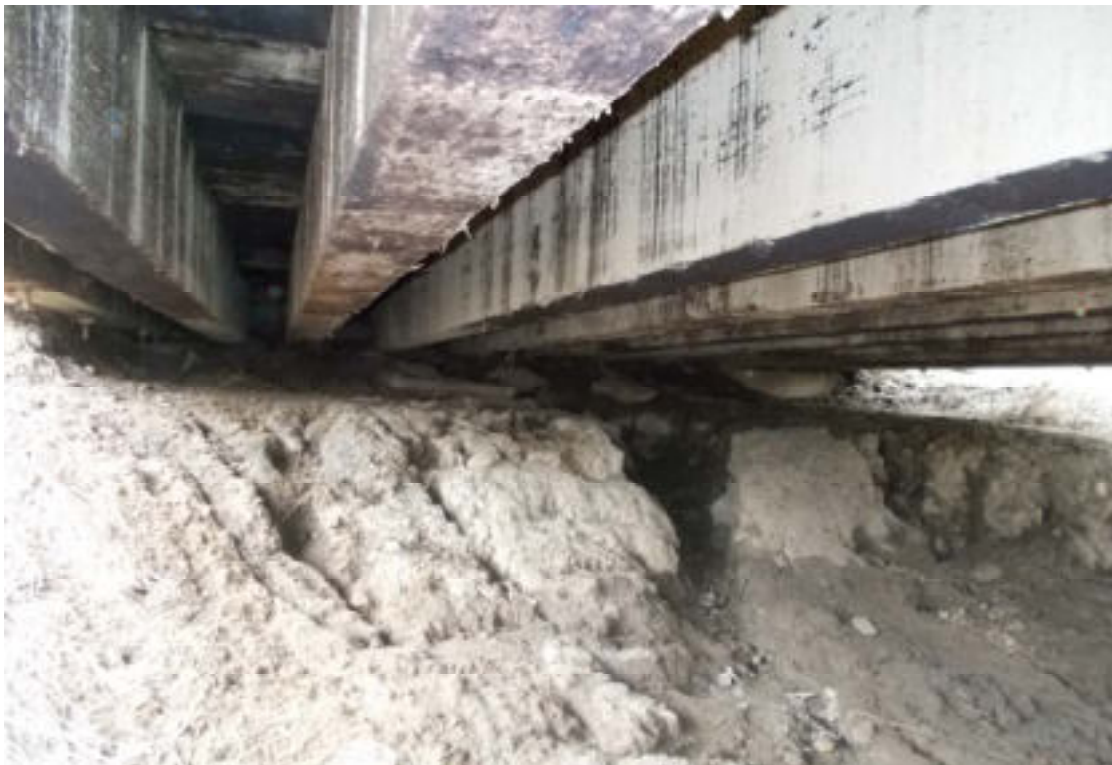
40. A1 and SP1 looking south. Erosion gullies

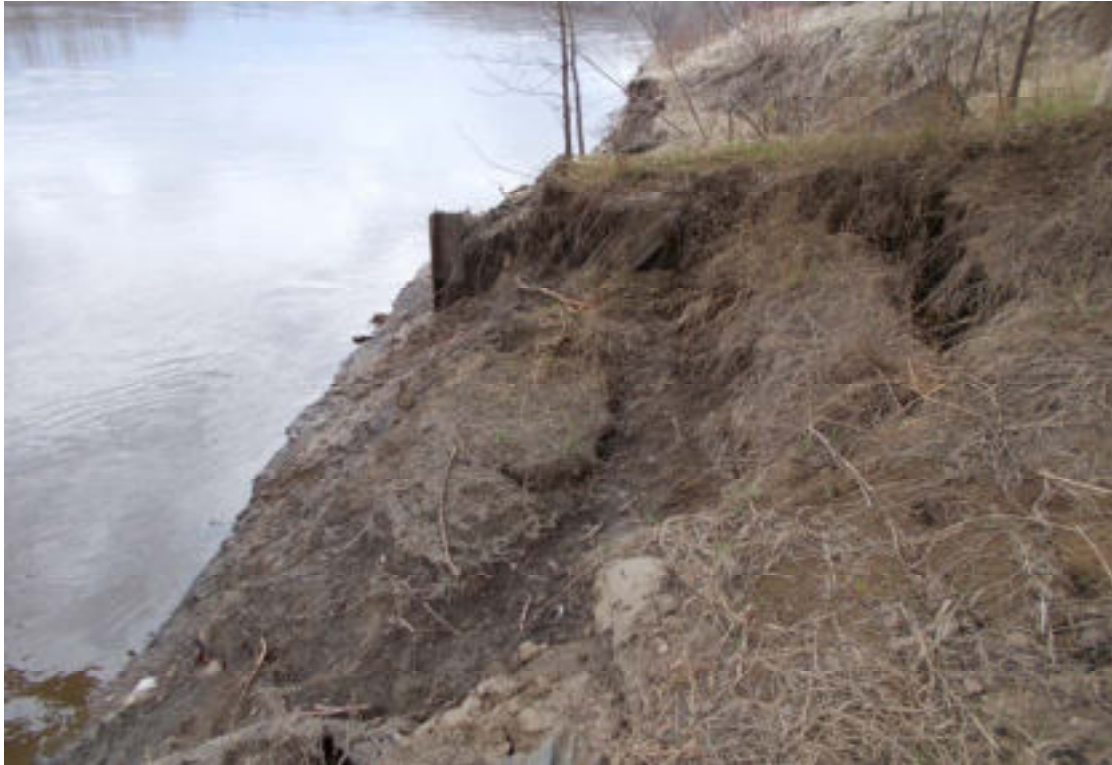
43. North hill is sloughing

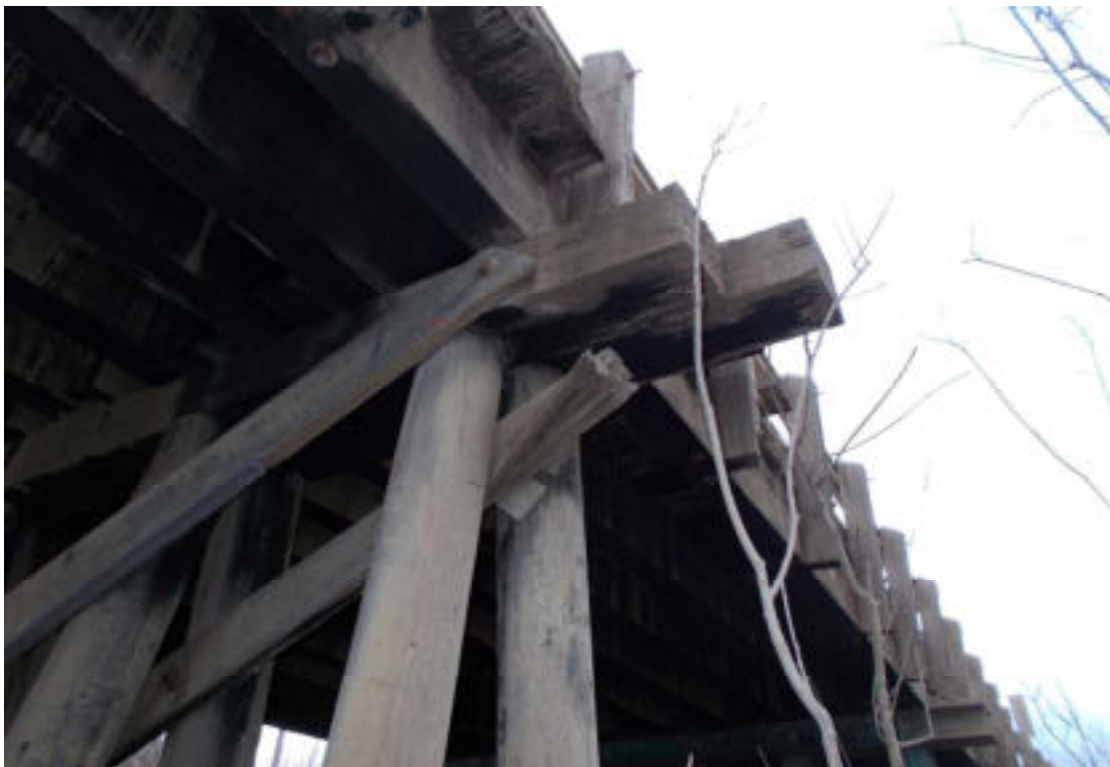
46. One timber bracing at P2 west end rotten

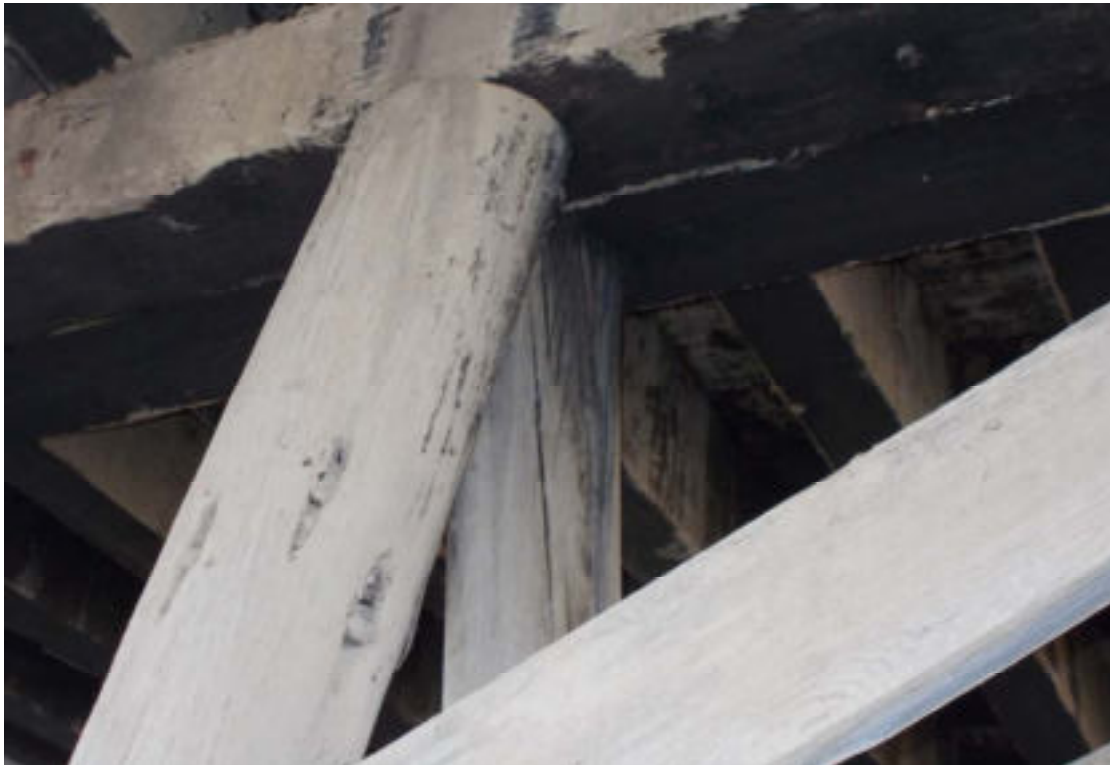
47. Wide checks at Pier 2 timber piles - typical

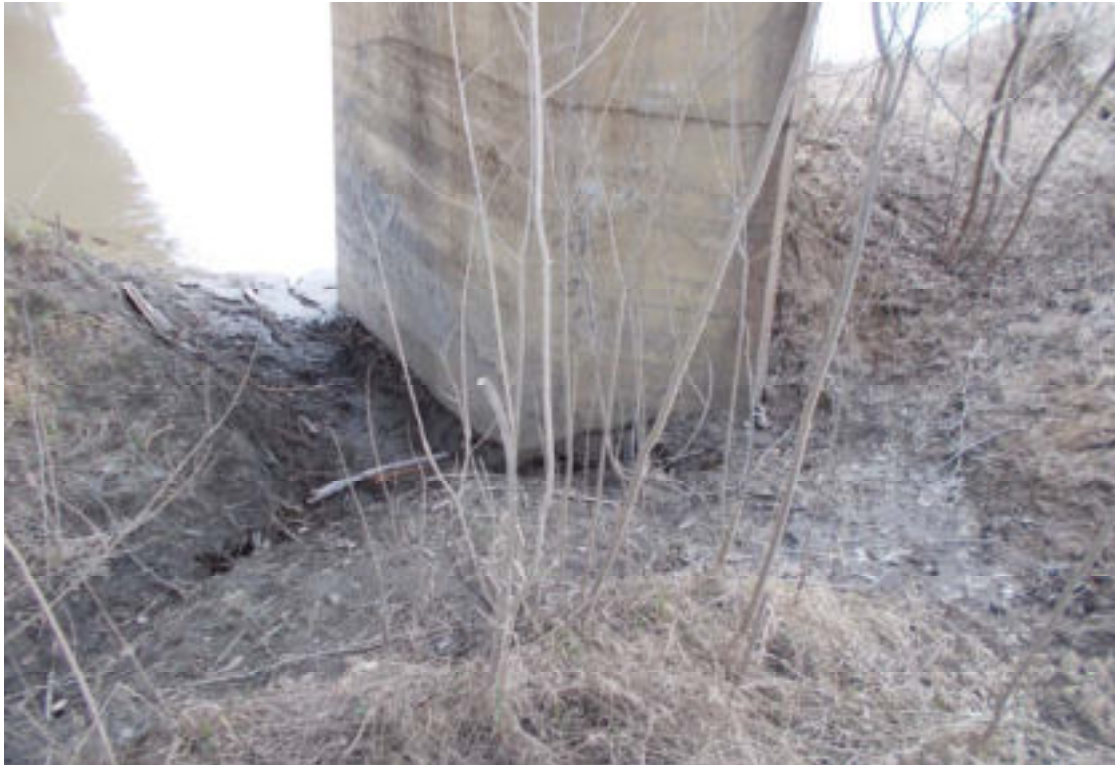
49. Erosion around Pier 3

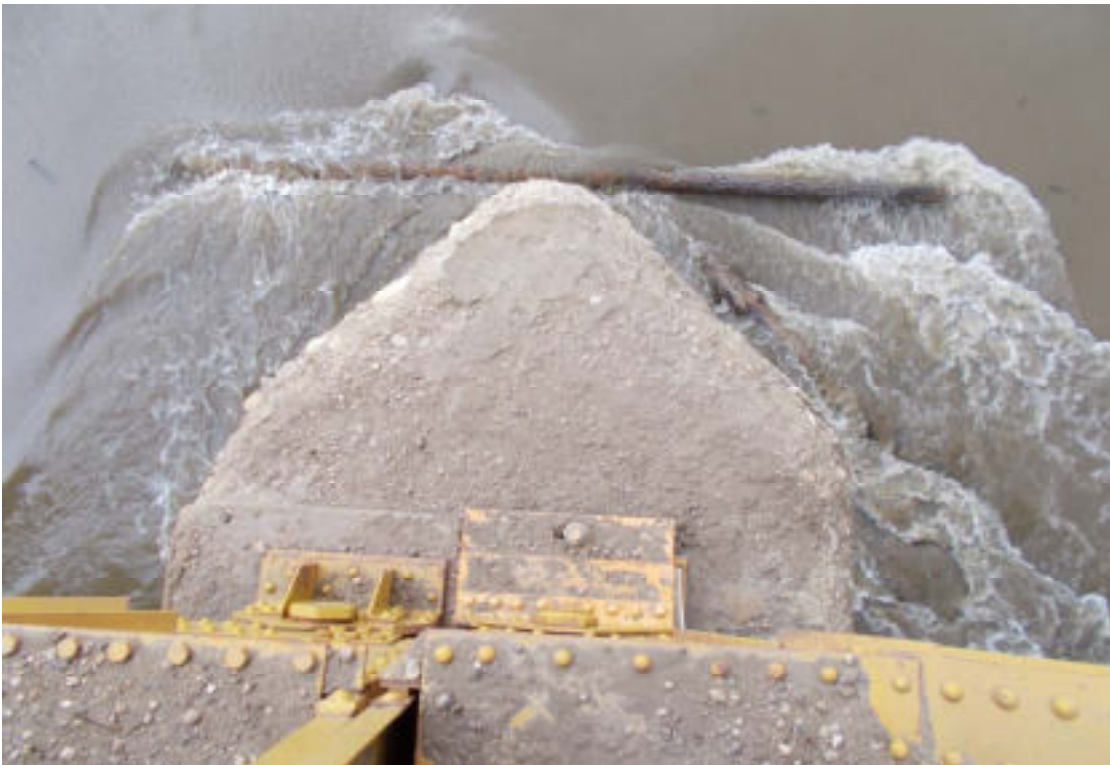
52. P4 west top with heavy scaling

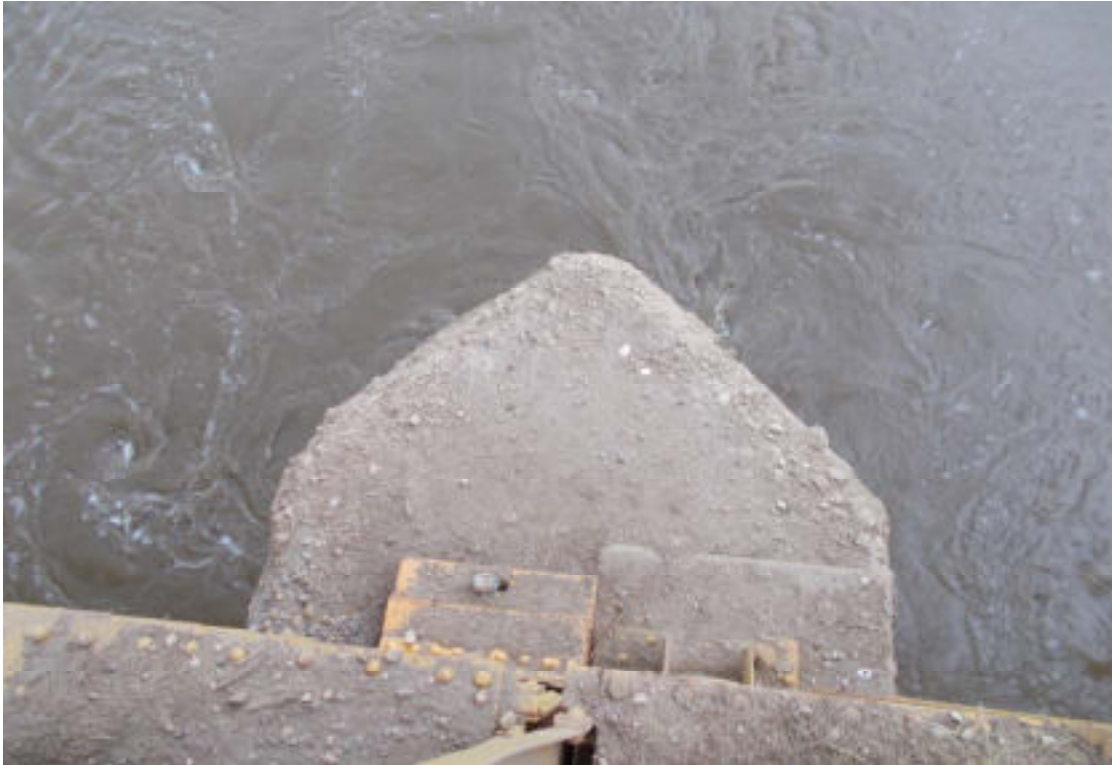
53. P4 east top with heavy scaling

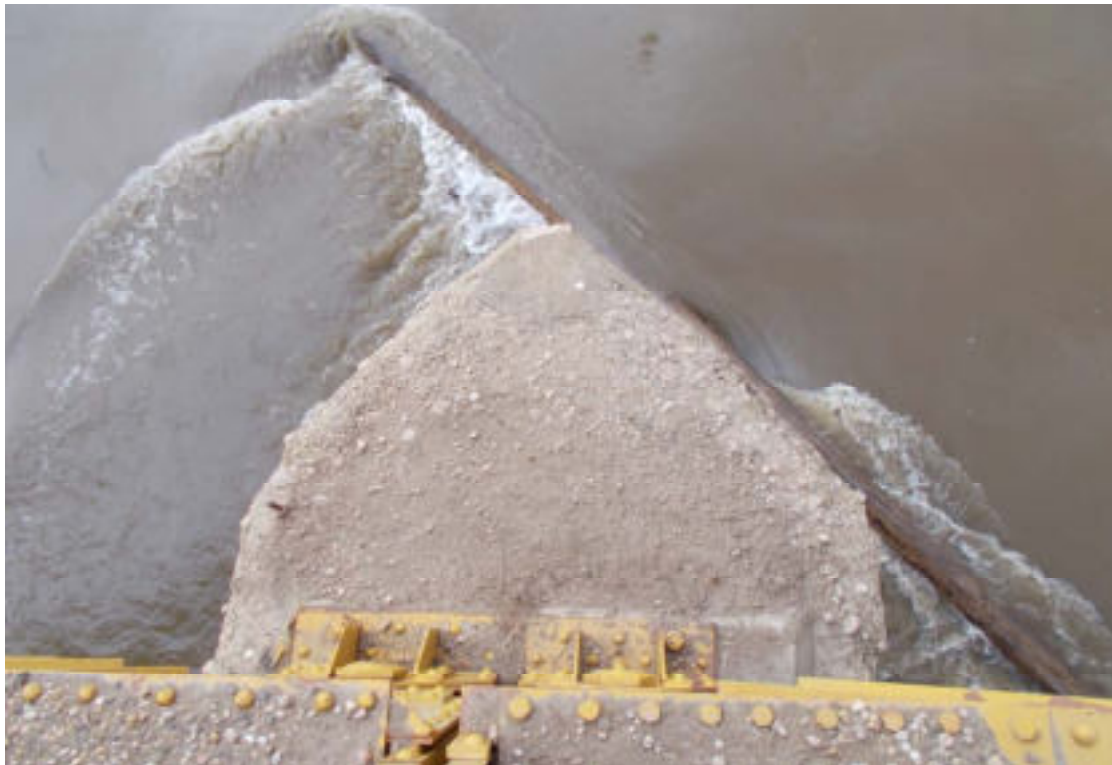
54. P5 west top with heavy scaling

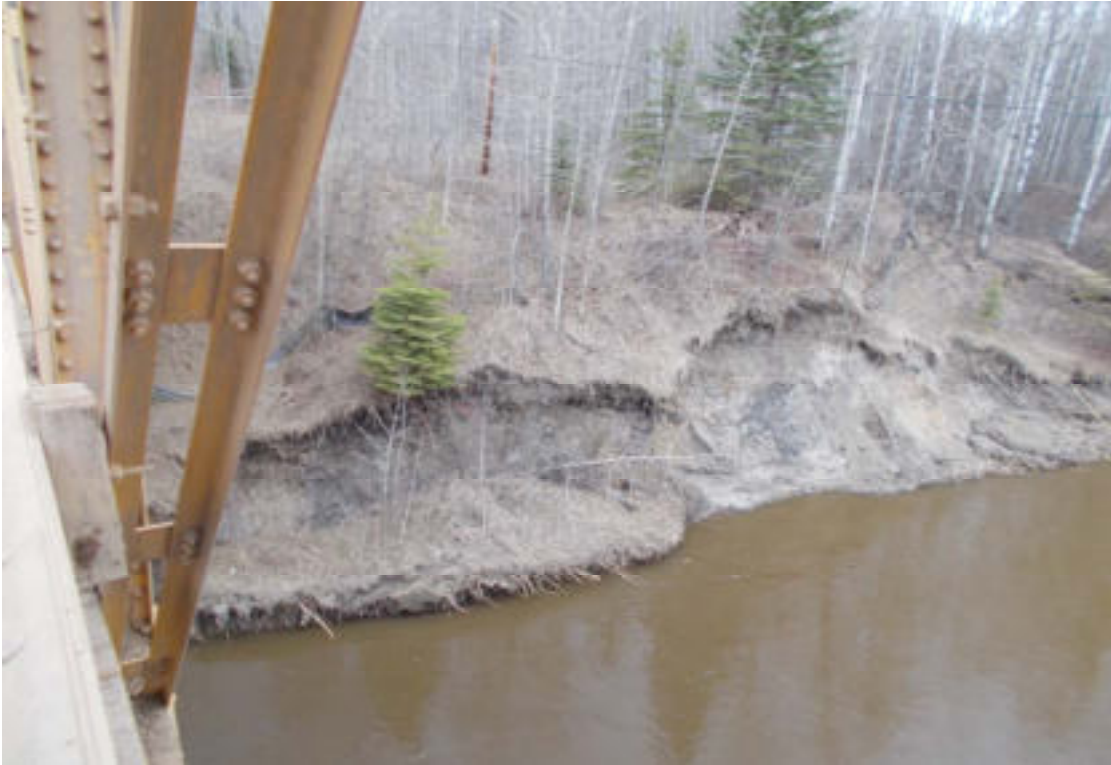
55. NE hill is sloughing
