BF 71600 – Athabasca River Bridge on Local Road, 1 km north of Smith

Report Date: November 8, 2021

2021 Scour Survey Summary

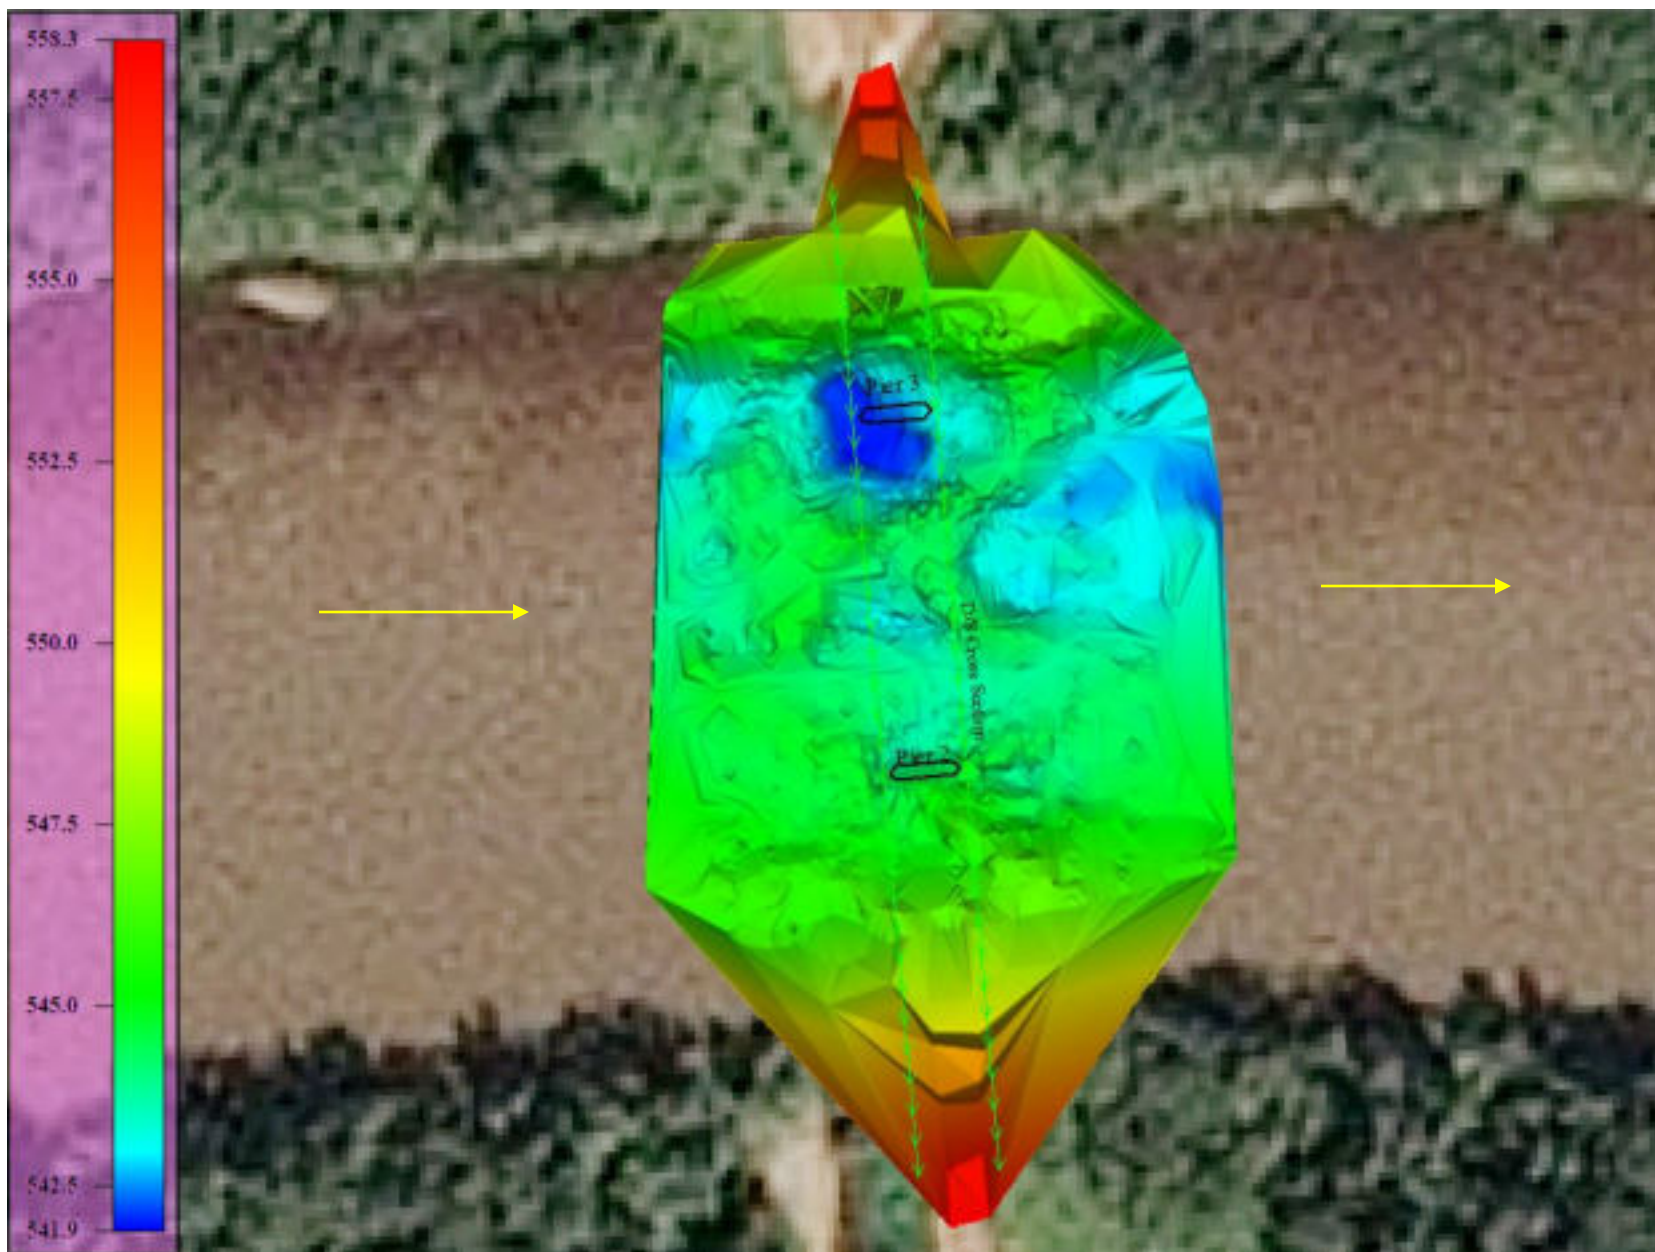
Figure 2 – Triangulated Elevations in 2021

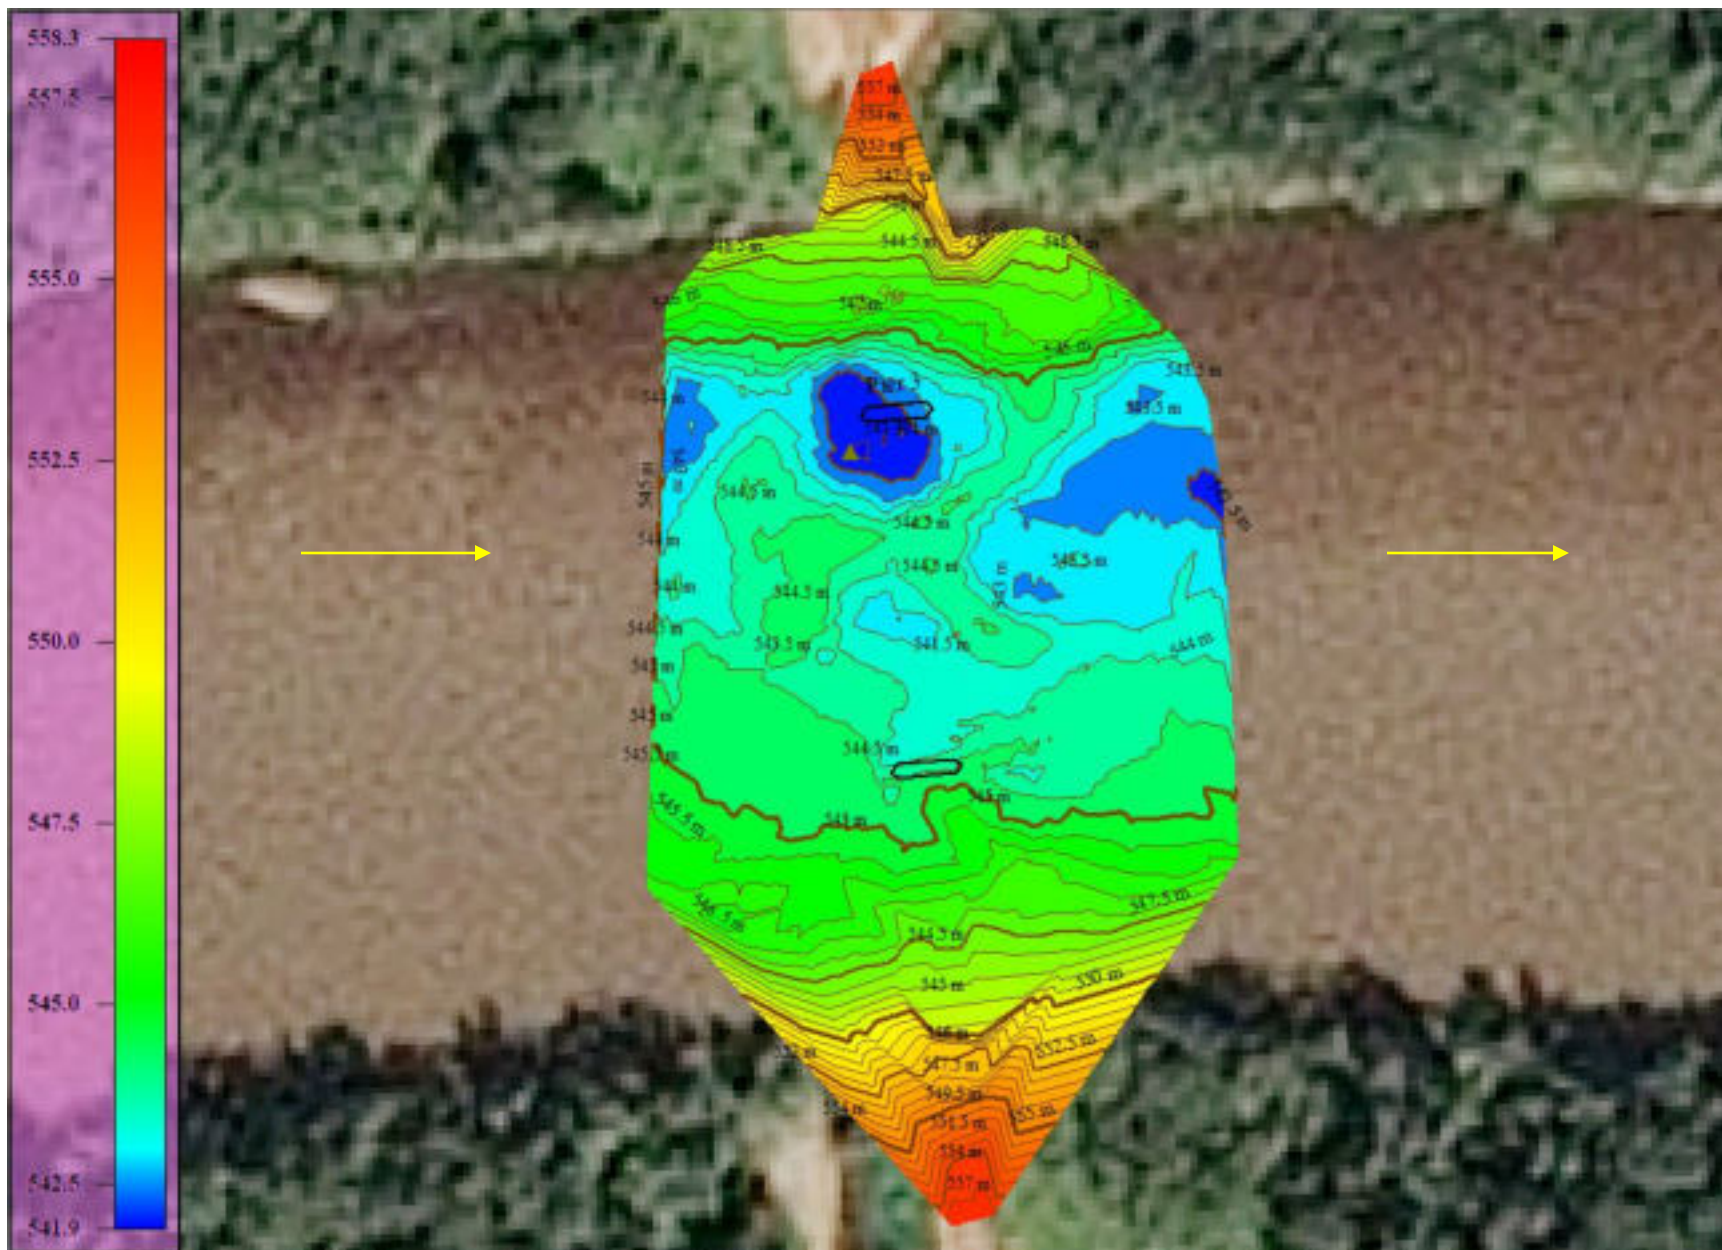
Figure 3 – Contours in 2021

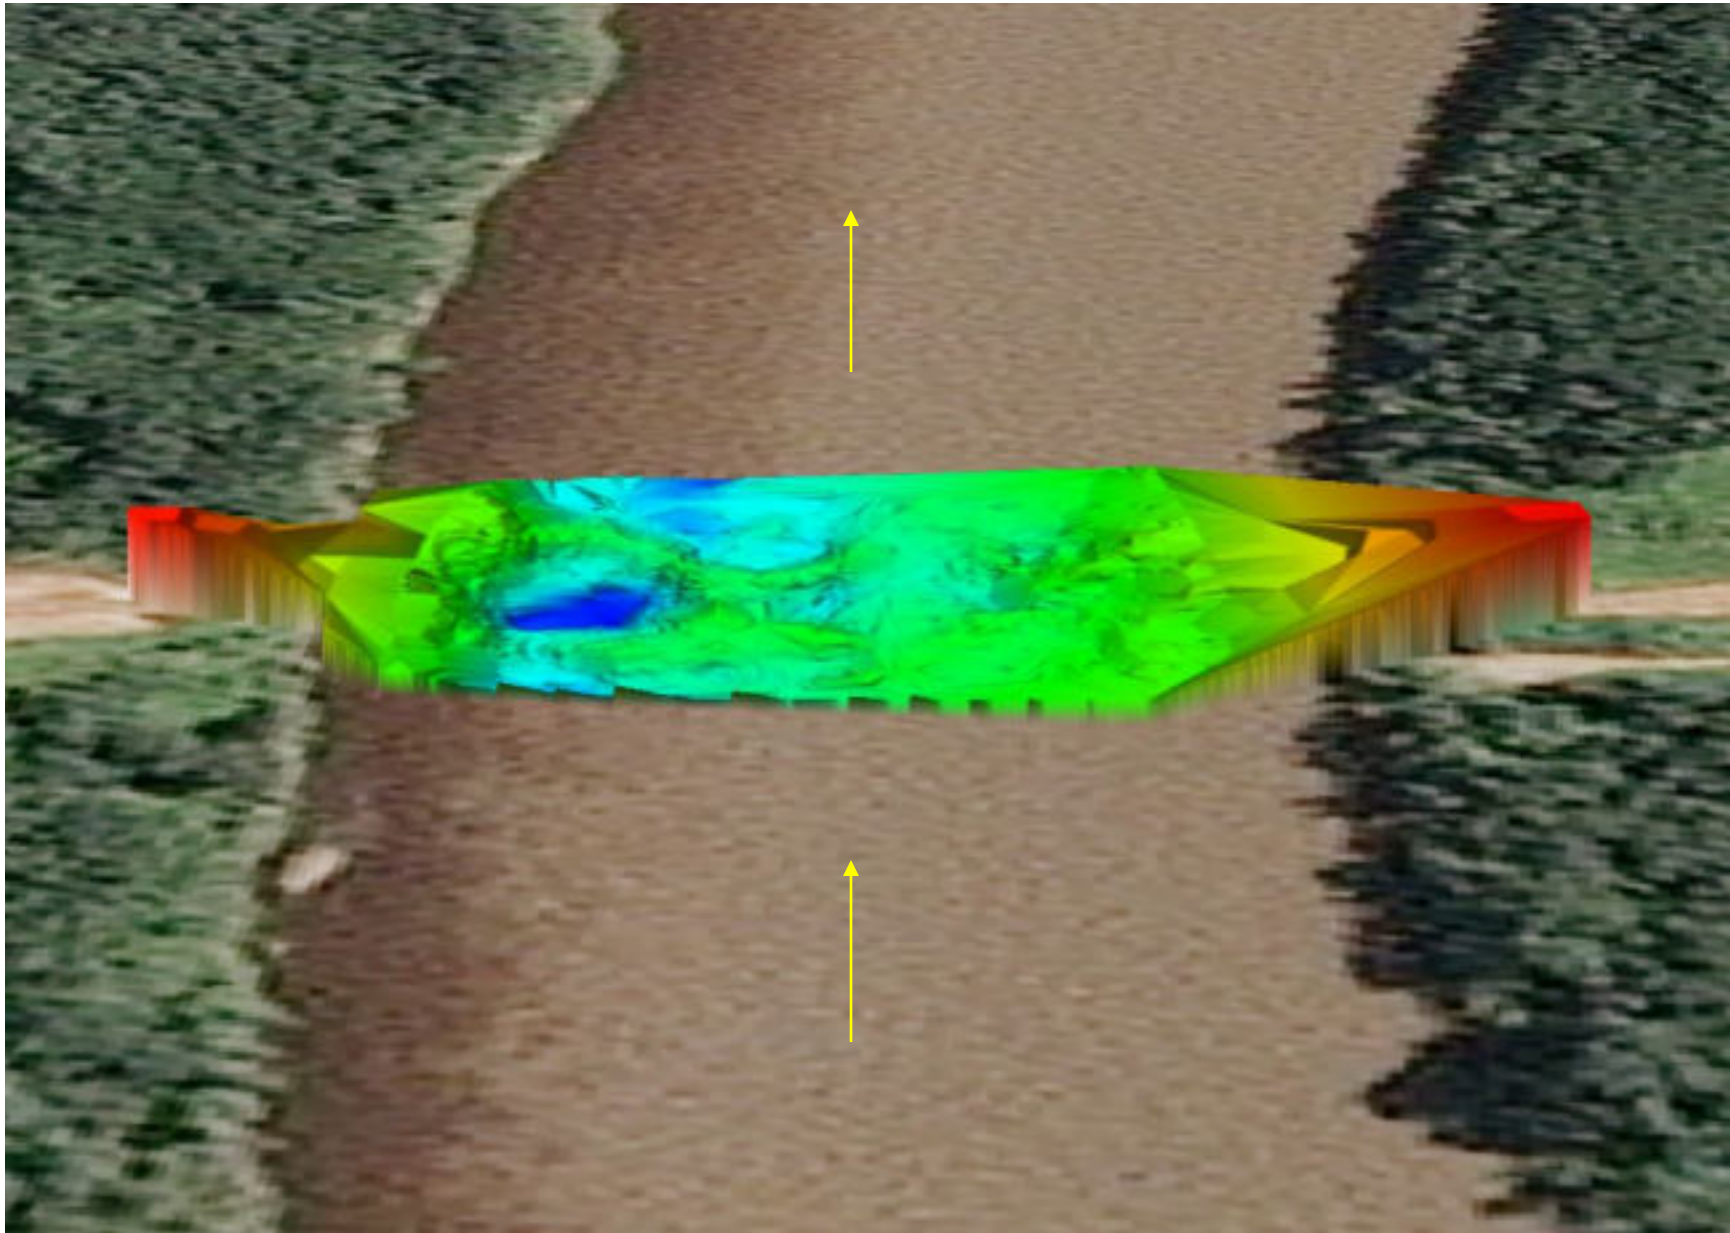
Figure 4 – 2021 Survey 3D view

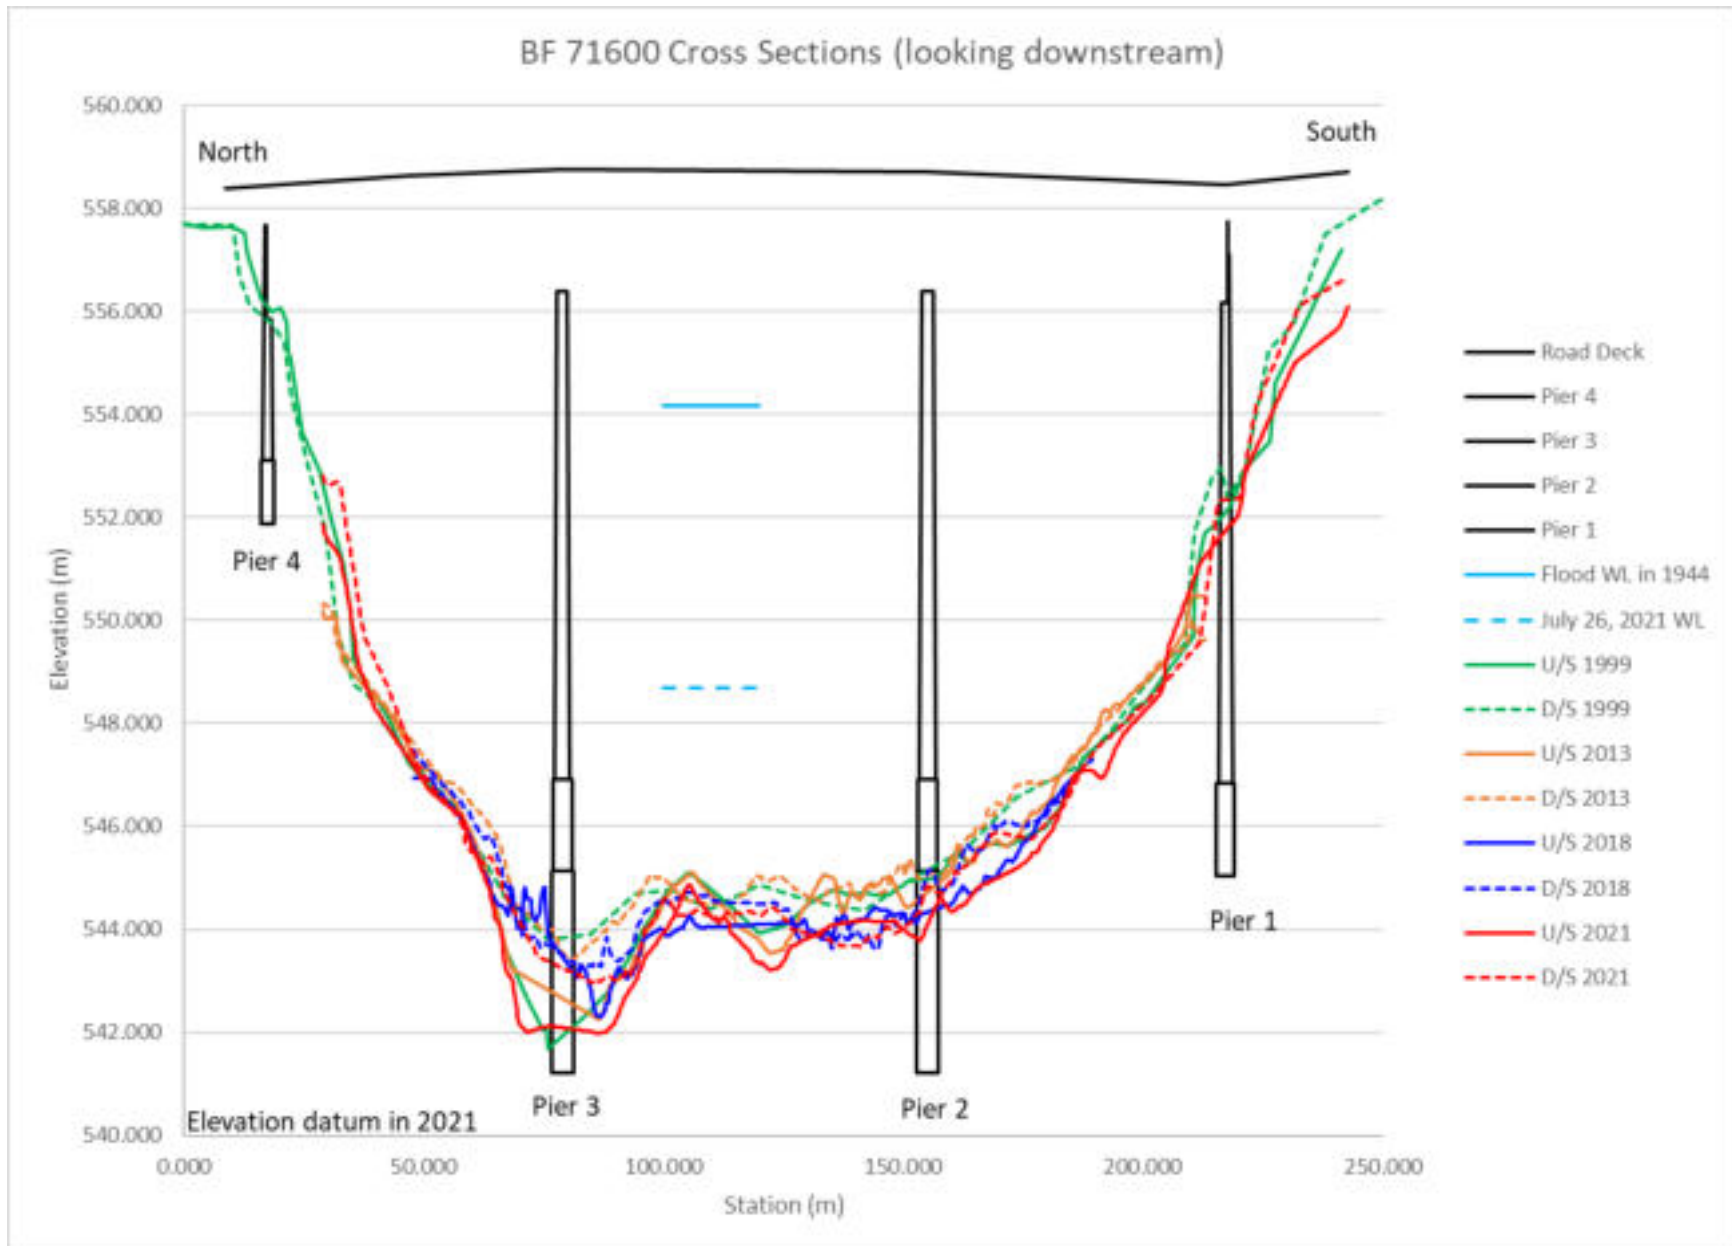
Figure 5 – Cross Sections

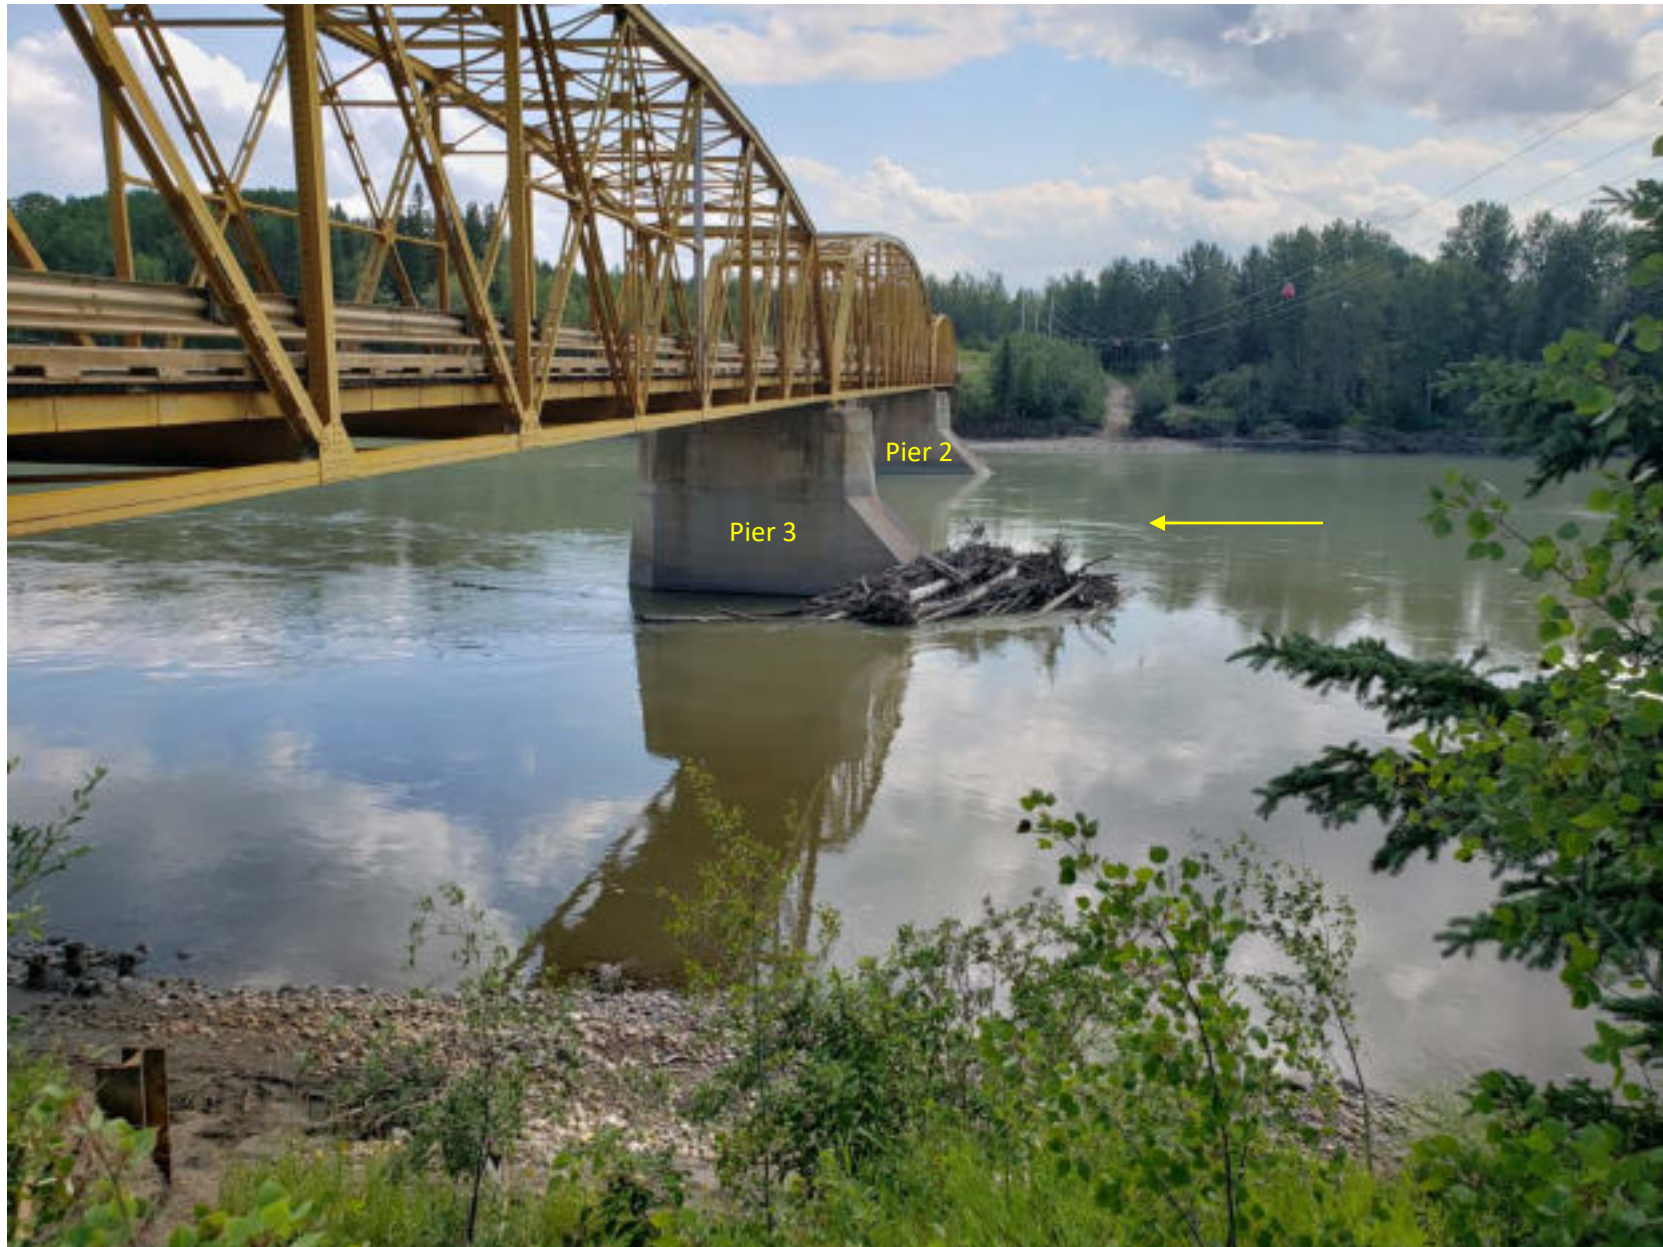
Site Photo 1 – upstream face of the bridge

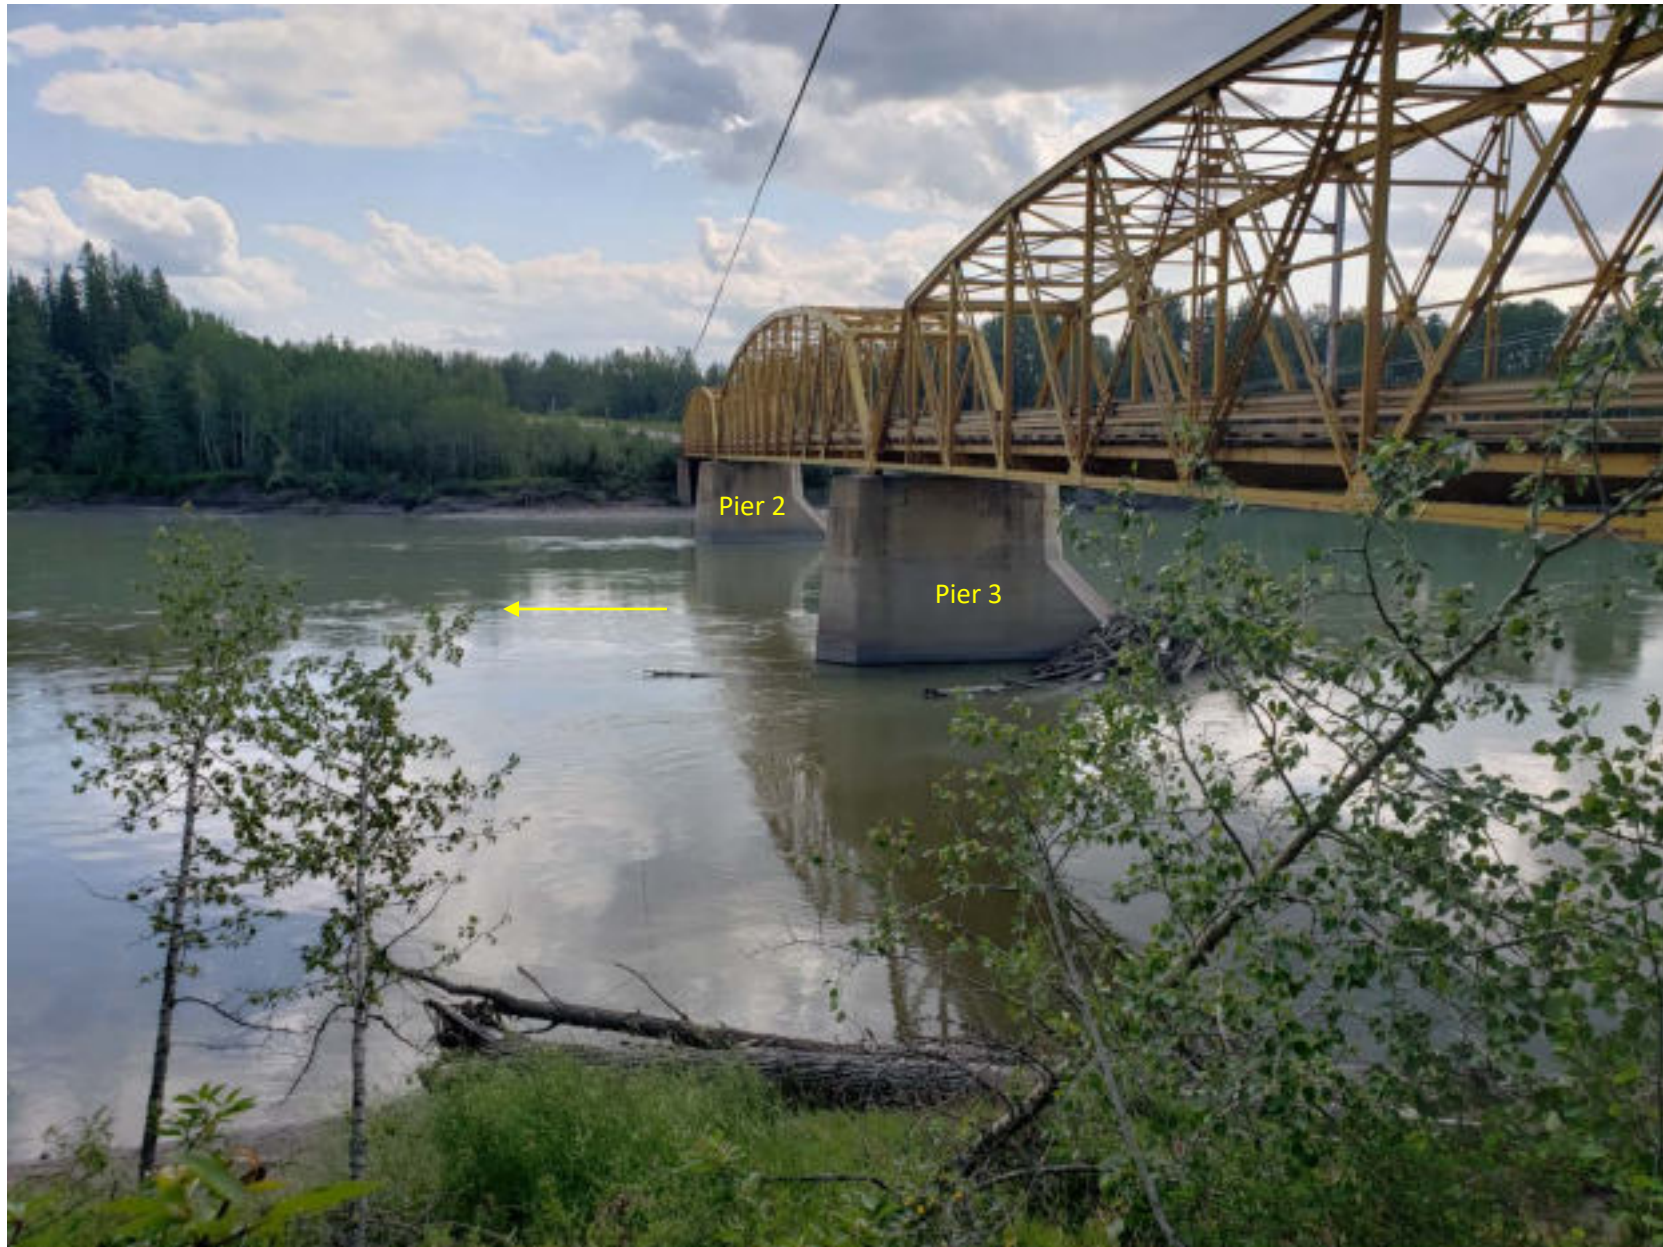
Site Photo 2 – downstream face of the bridge

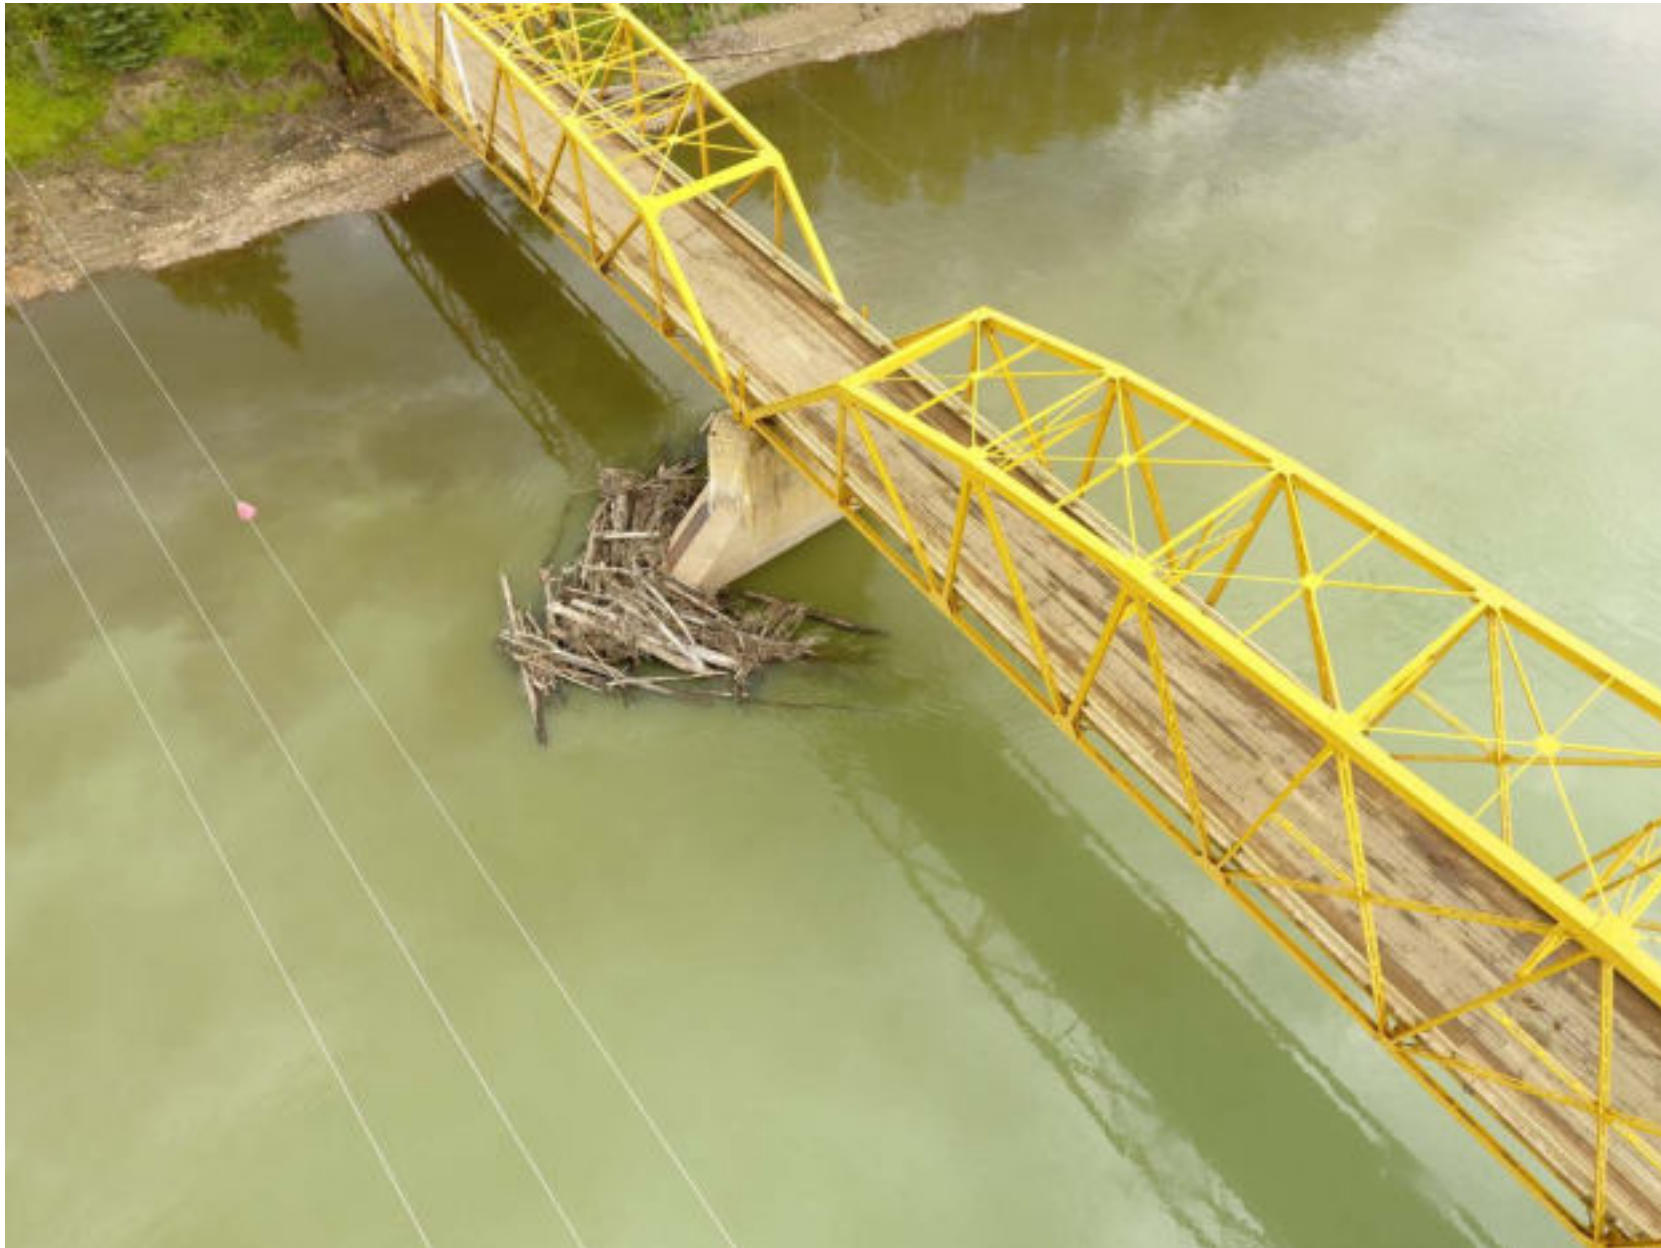
3. Pier 3 – drifts were found at the pier nose during survey. The condition was not ideal for data collection around the pier, but the surveyor was able to angle the sonar sensor trying to get as close as possible around the pier nose to collect the data. Comparing the survey data and results in 2018, the scour around the pier has been worsened significantly in the last few years and it is comparable to the conditions in 1999. Assuming the natural streambed elevation at 544.6 m, the general scour depth at the pier nose is approx. 2.6 m, which is close to the blue clay layer as indicated on the as-built drawings. The scour area of approx. 20 m x 12 m is located just upstream of the pier nose and along the right side of the pier. The remaining cover at the pier nose is approx. 0.8 m above the footing bottom elevation.

Site Photo 7 – Drifts at Pier 3

The scour identified at Pier 3 has been progressing significantly since 2018. The scour depth is getting close to the 1999 results. While the channel could potentially infill over time during low flow conditions; however, it appears that drifts are also found to be an ongoing issue at Pier 3 as there were records and photos in which drifts were identified in 2008, 2013, 2017 and 2021. The accumulation of drifts could likely accelerate the scour development at the pier nose; therefore, timely removal is recommended. It is also recommended to increase the inspection frequency to every 3 years for now and the next survey should be scheduled in 2024 to closely monitor pier scour for this site. It is imperative that drift removal be completed prior to the next survey. An additional survey and inspection is also recommended should a major flood event occurred before the next schedule to ensure that the piers are not severely damaged or extensive scour does not occur after the flood.
