<b>Issue Date:</b>	October 31, 2022	<b>File No.:</b>	2021-3190-00
<b>To:</b>	Barry Kolenosky, CAO	<b>Previous Issue Date:</b>	N/A
<b>From:</b>	Sydney Reinbolt, M.Eng., P.Eng.	<b>Project No.:</b>	2021-3190
<b>Client:</b>	Municipal District of Lesser Slave River No. 124		
<b>Project Name:</b>	BF71600 - Athabasca River Bridge		
<b>Subject:</b>	Load Rating

## Attachment 1 – BF71600 Photosheet

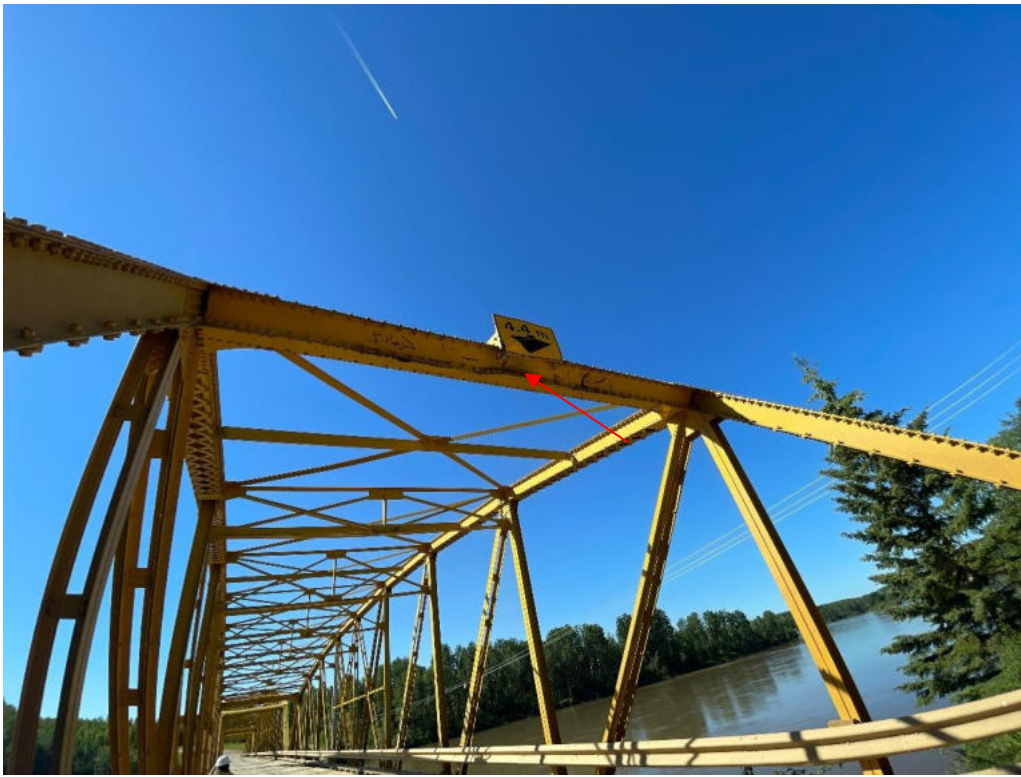
1. S6 - U1U1 damaged

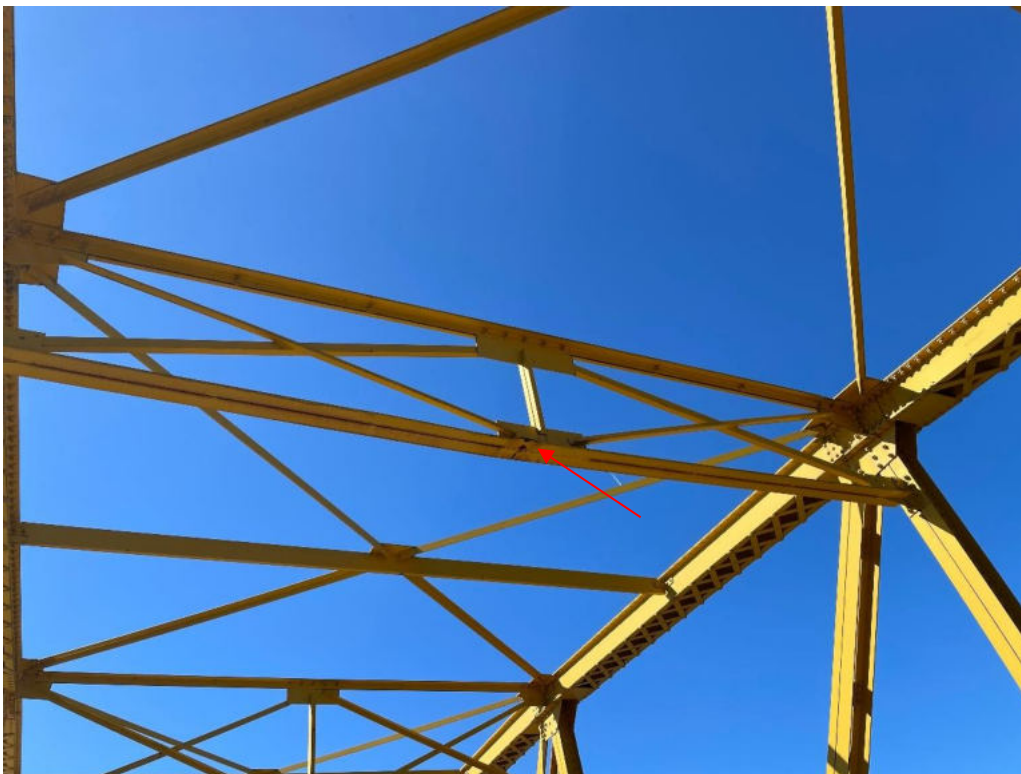
2. S6 - U2U2 damaged

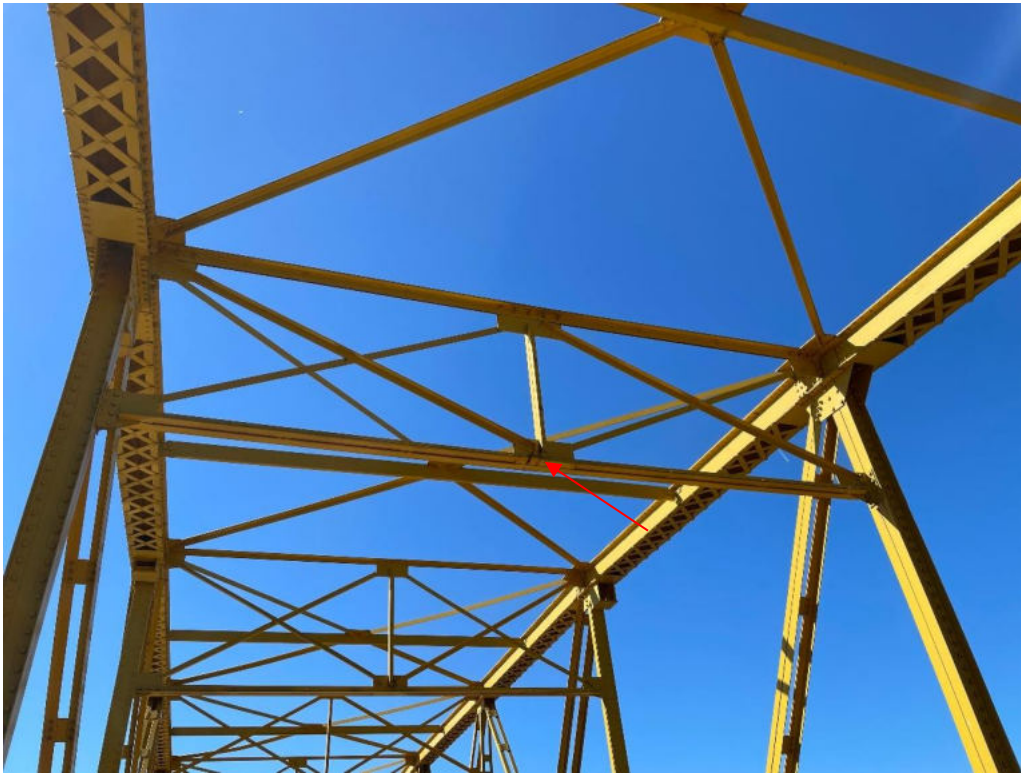
3. S6 - U3U3 damaged

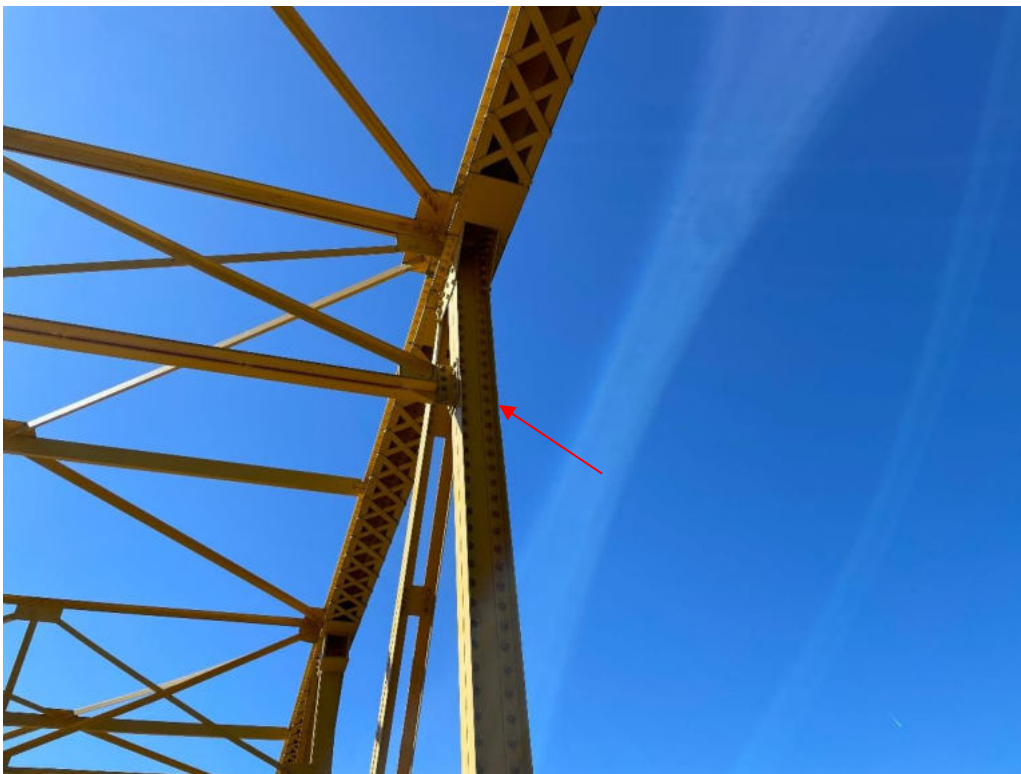
4. S6 - L3U3 damaged

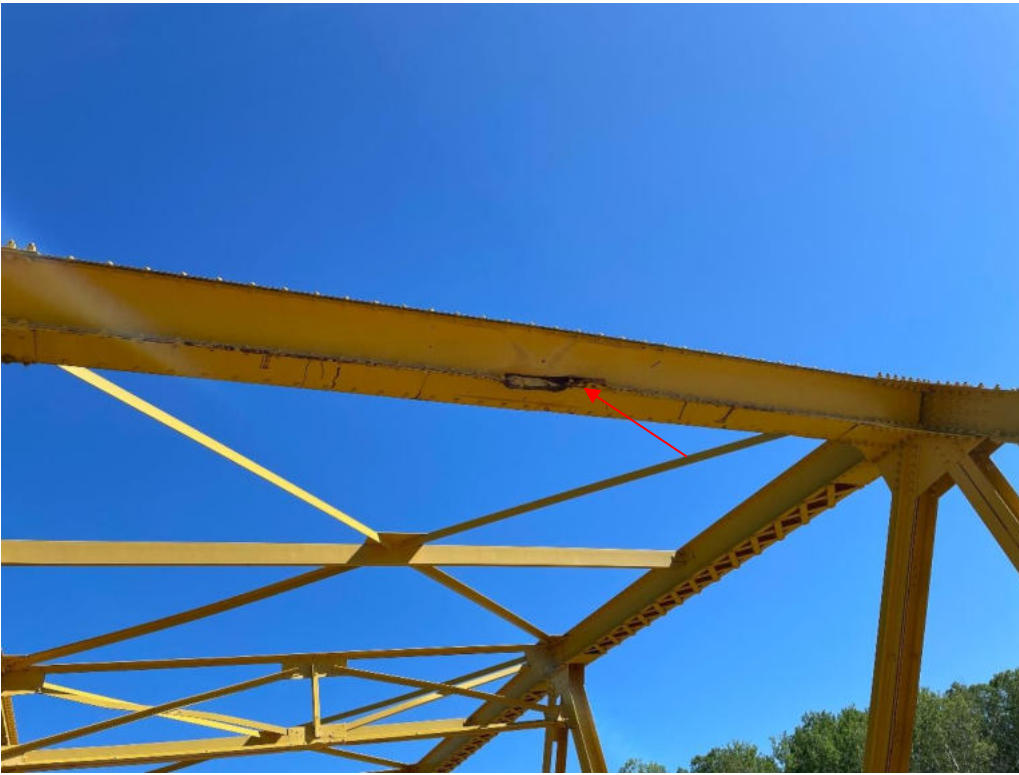
5. S6 -U9U9 damaged

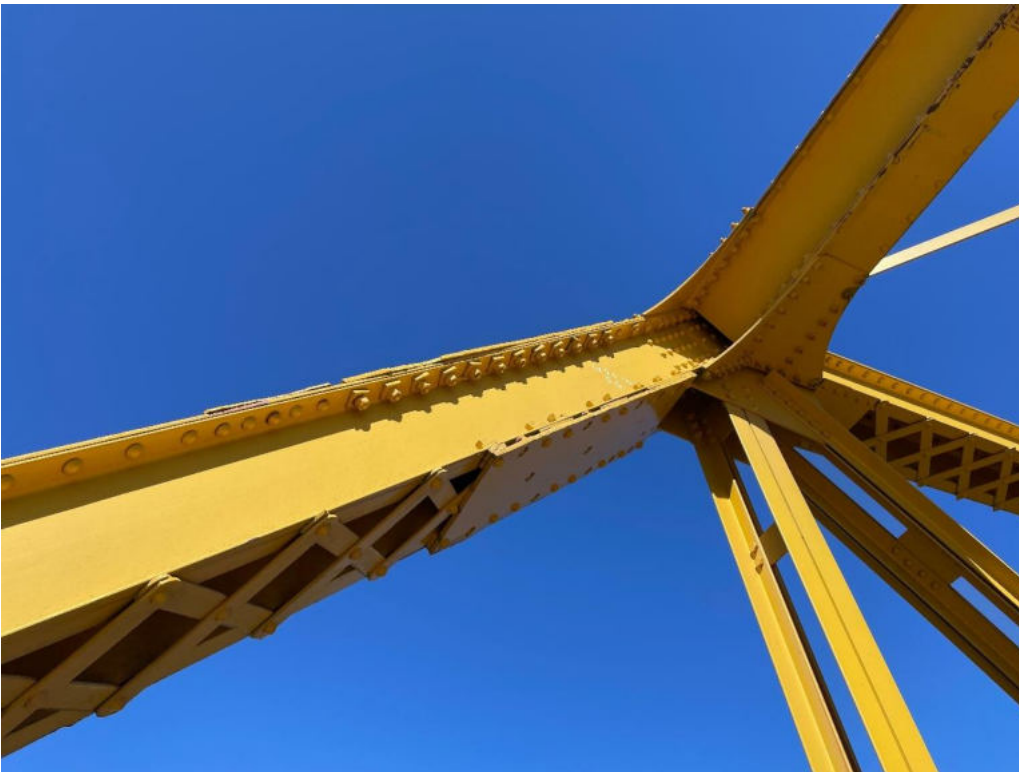
6. S6 - U9L10 W damaged

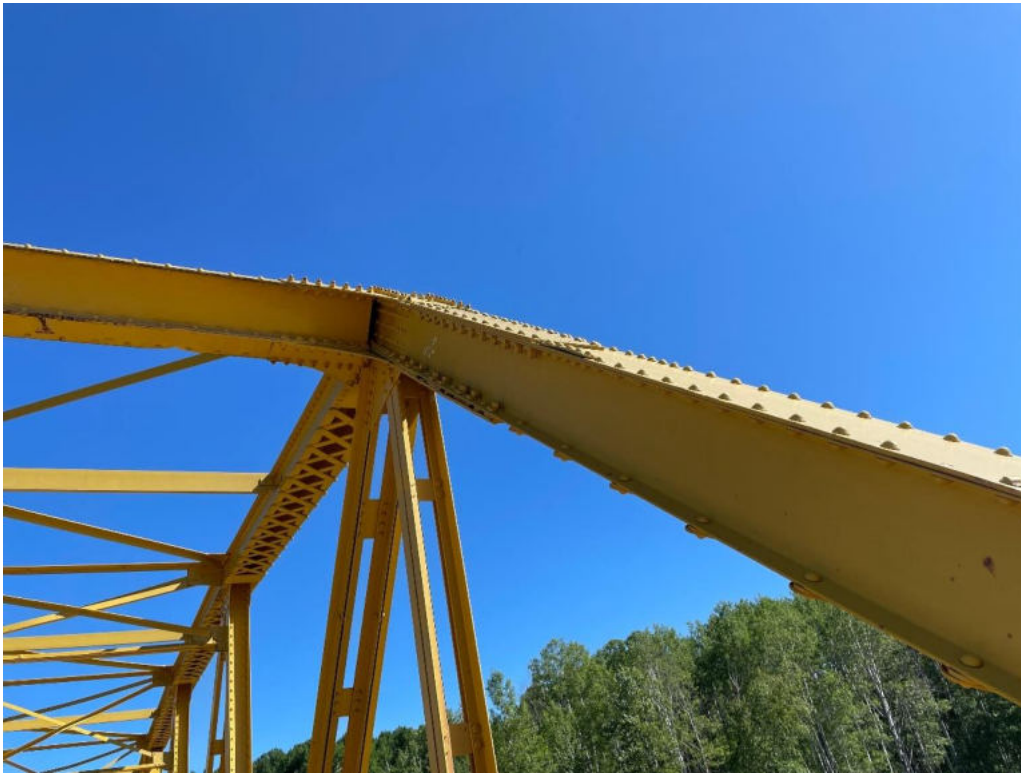
7. S6 - U9L10 E damaged

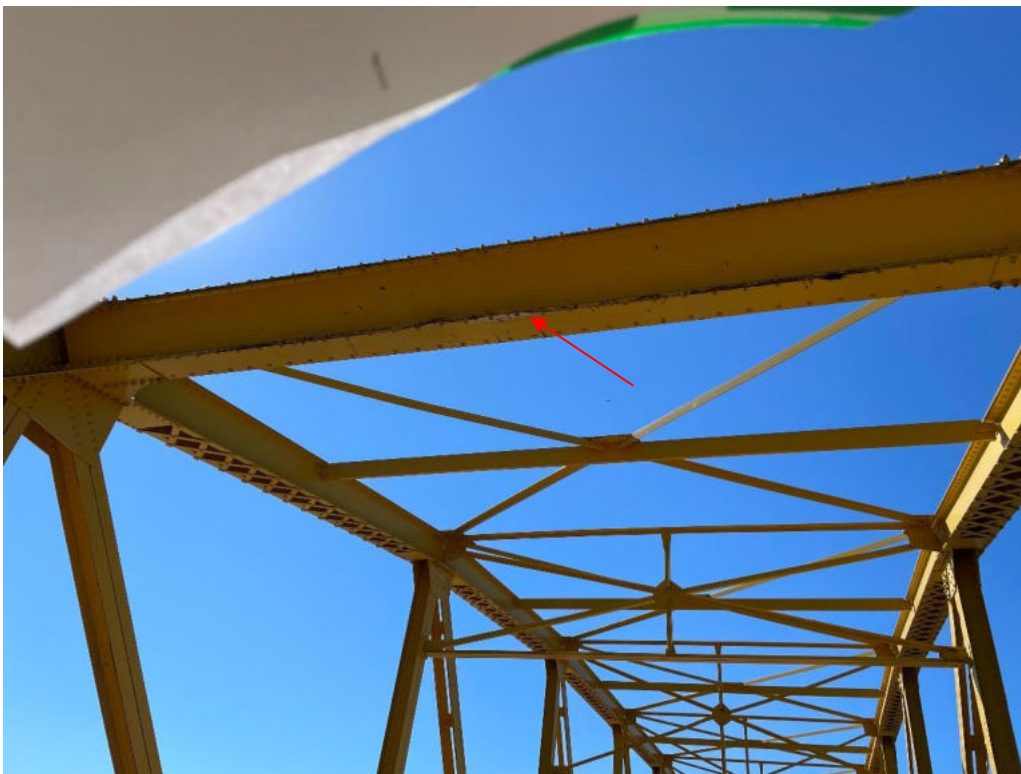
8. S5 - U1U1 E damaged

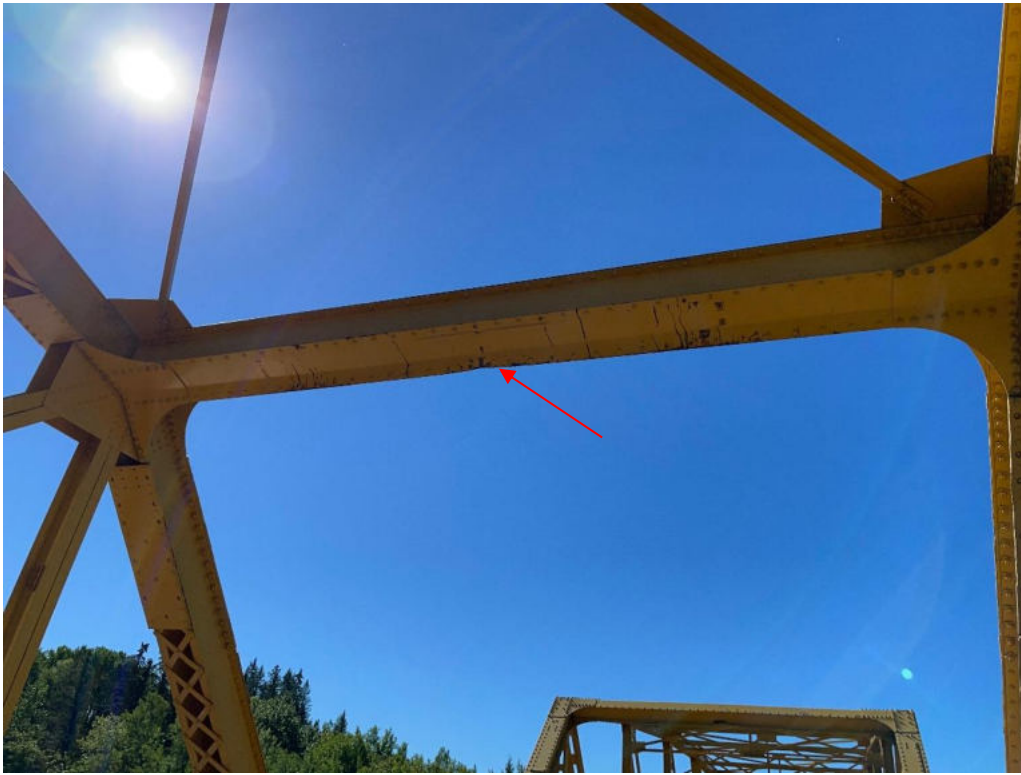
9. S5 - U11U11 E damaged

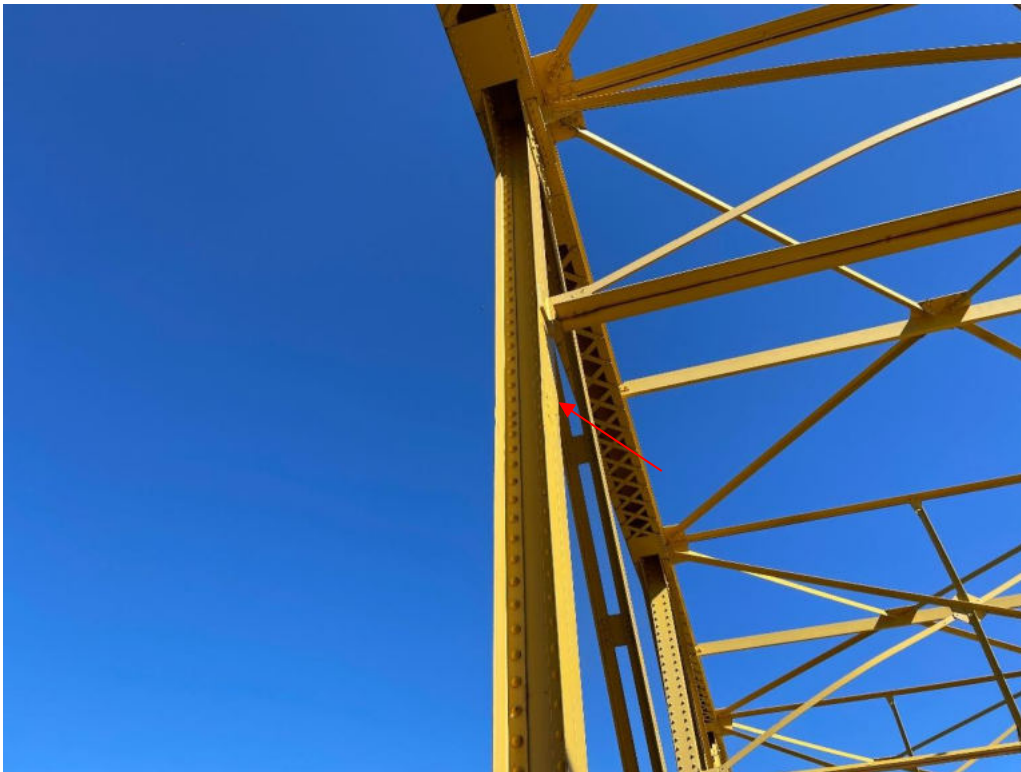
10. S5 - L8U8 damaged

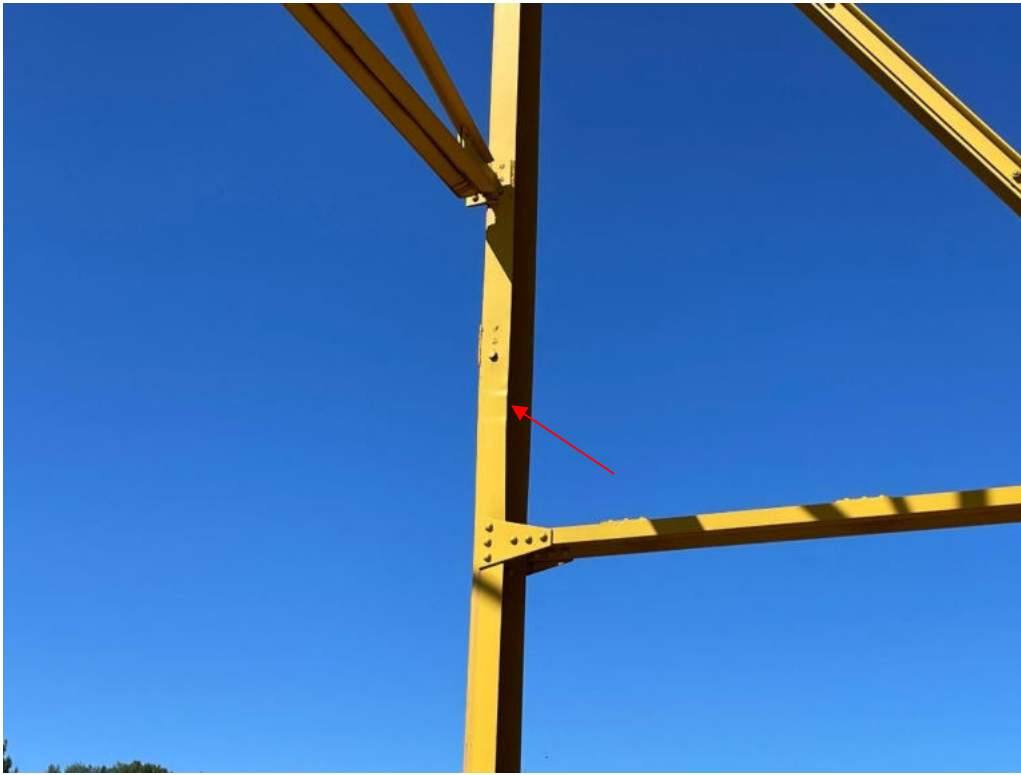
11. S5 - L9U9 damaged

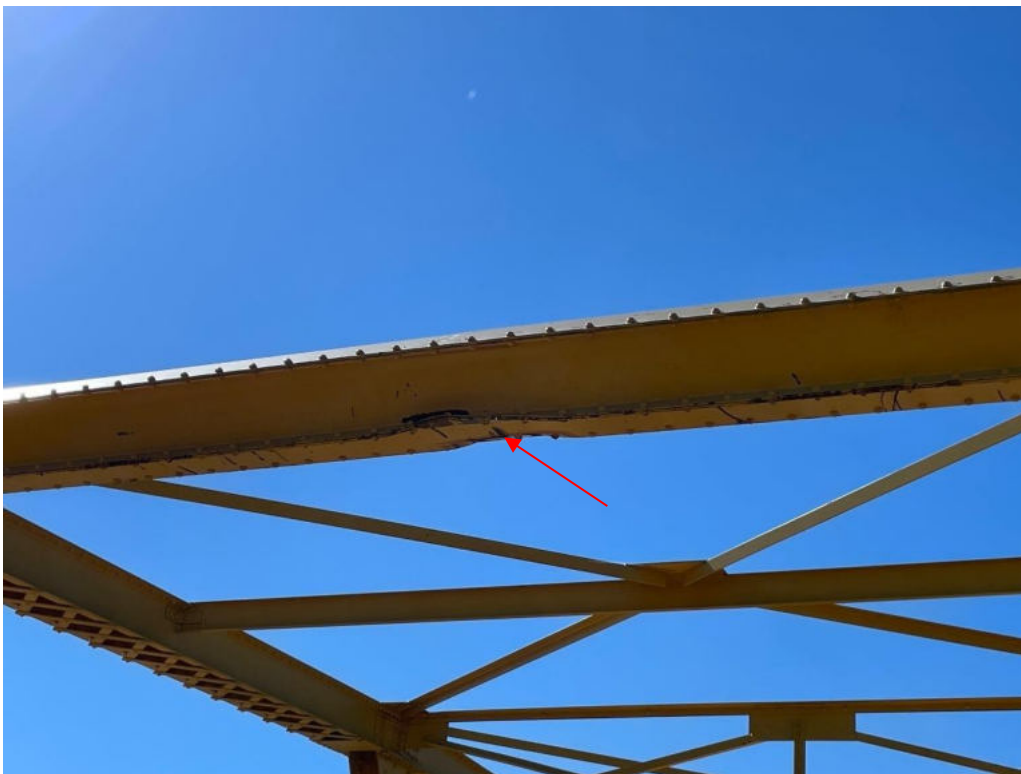
12. S4 - U1U1 damaged

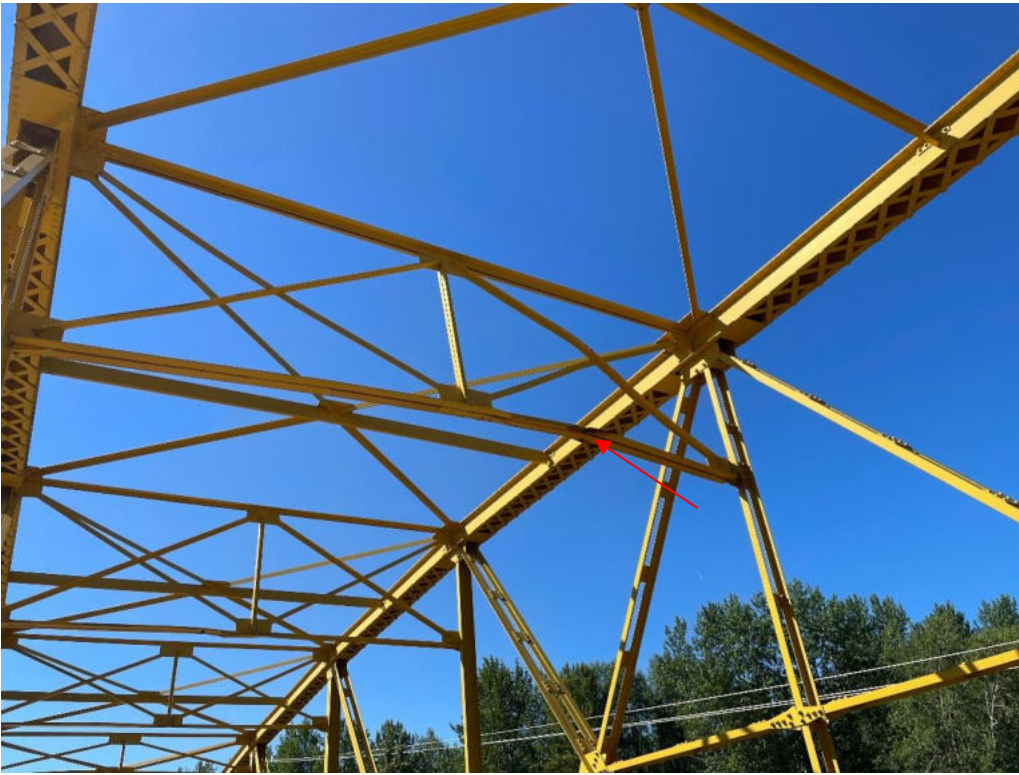
13. S4 - U5U5 damaged

It is recommended to implement the load rating of CS1 (23.5 tonnes), CS2 (41.1 tonnes), and CS3 (53.3 tonnes) on the bridge with appropriate signage for the load restriction and the One Trucked Bridge restrictions. It is recommended to complete the following repairs until the bridge can be replaced: replace span 4 members U7L6 and U5U5, repair the connection weld on span 4 U5L5E, and replace damaged and missing connections throughout.

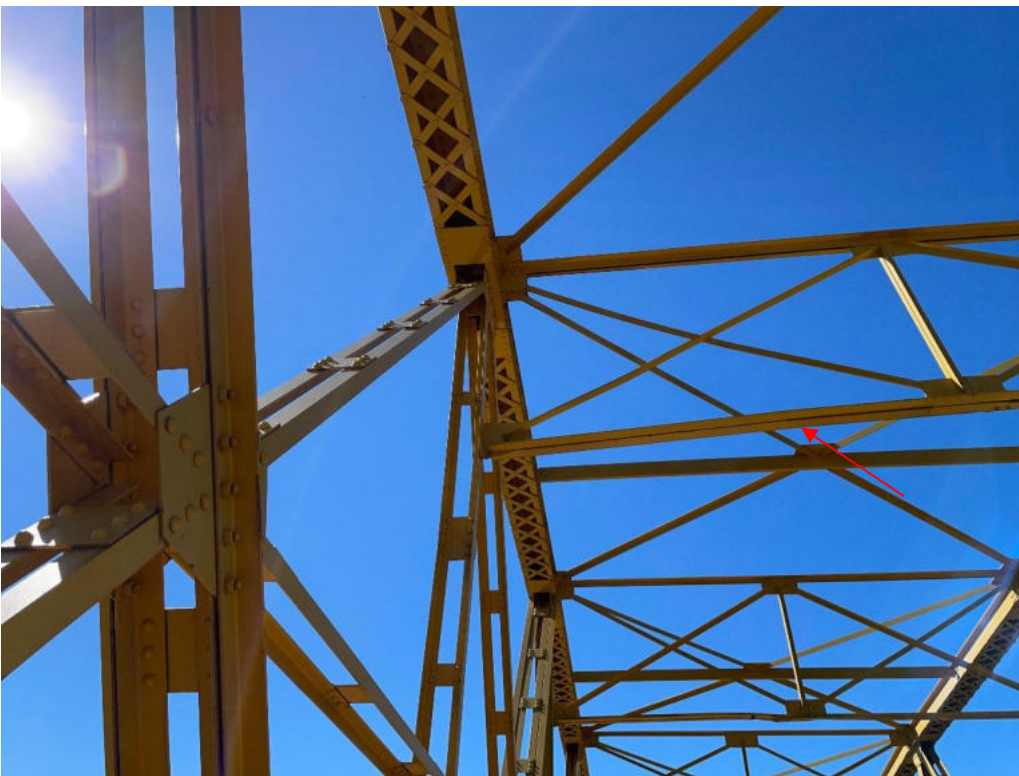
14. S4 - U5L5 E damaged

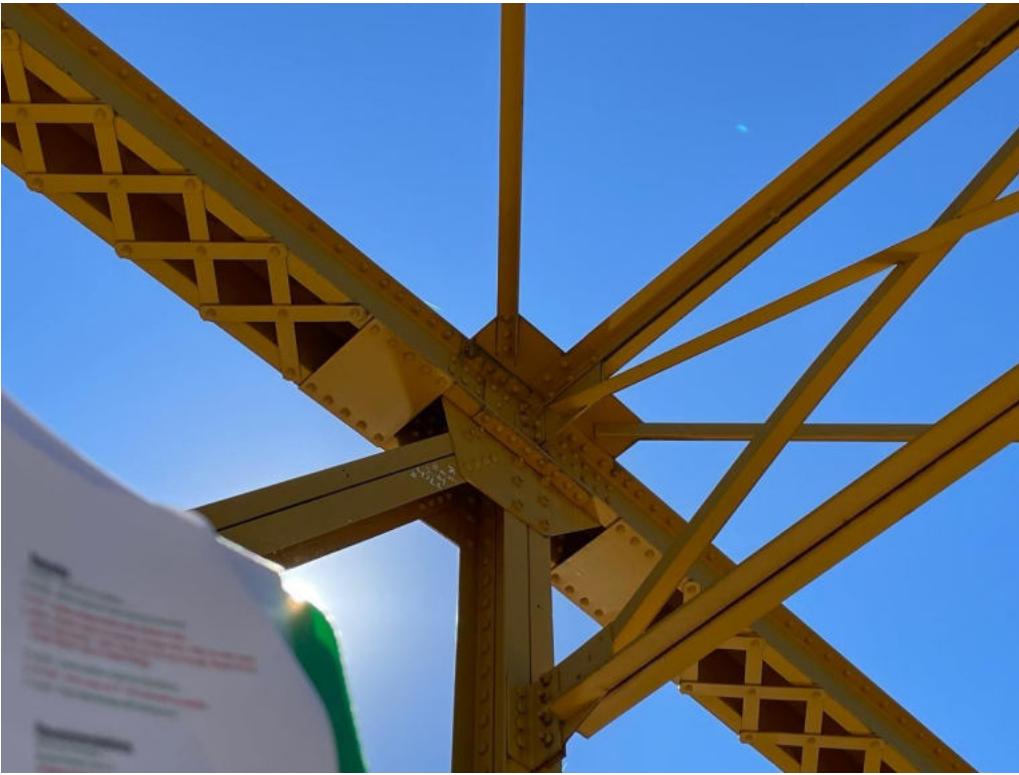
During the initial analysis diagonal member U7L6 on the east truss of span 4 was removed from the model due to the damaged condition of the member, however, this made the model unstable and increased the loading on other members to an unreasonable amount. Therefore, the load rating is based on the assumption that U7L6 will be replaced.

15. S4 - L6U7 E damaged

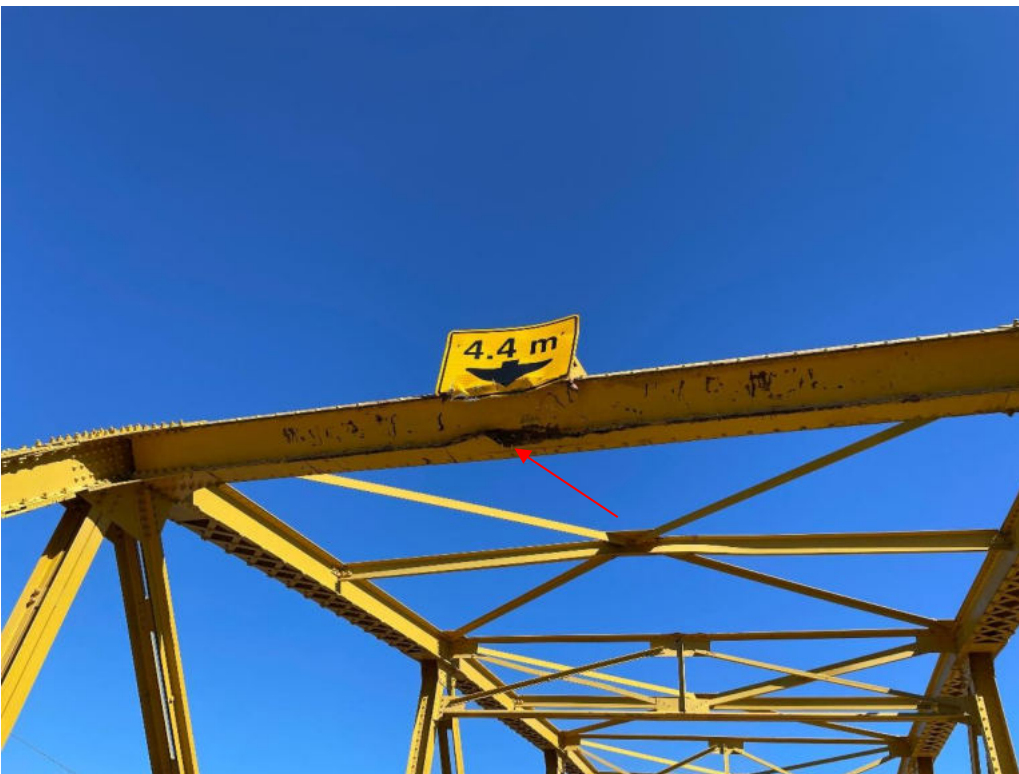
16. S4 - U9U9 damaged
