# BRIDGE ASSESSMENT REPORT

## Municipal District of Lesser Slave River

Bridge File 71600  
Athabasca River

NOVEMBER 2022

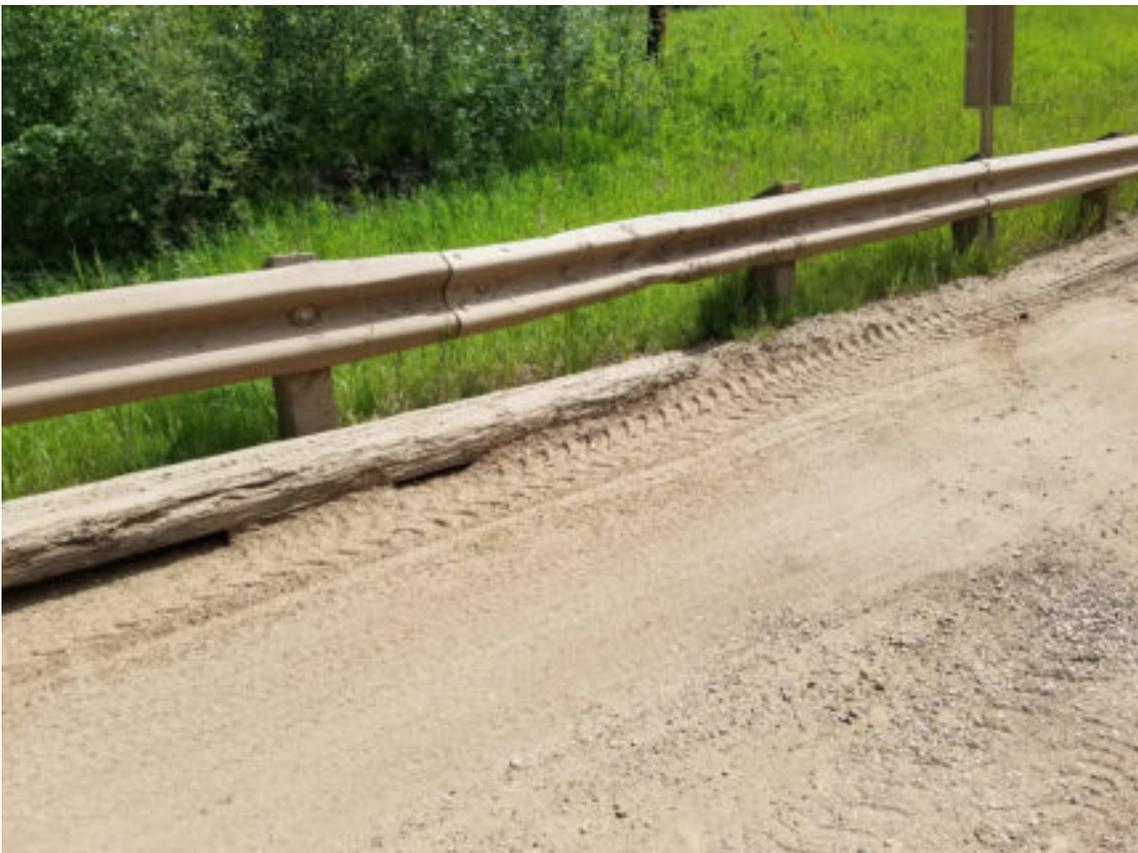
2.  
Abutment 1  
approach east  
guardrail bent.

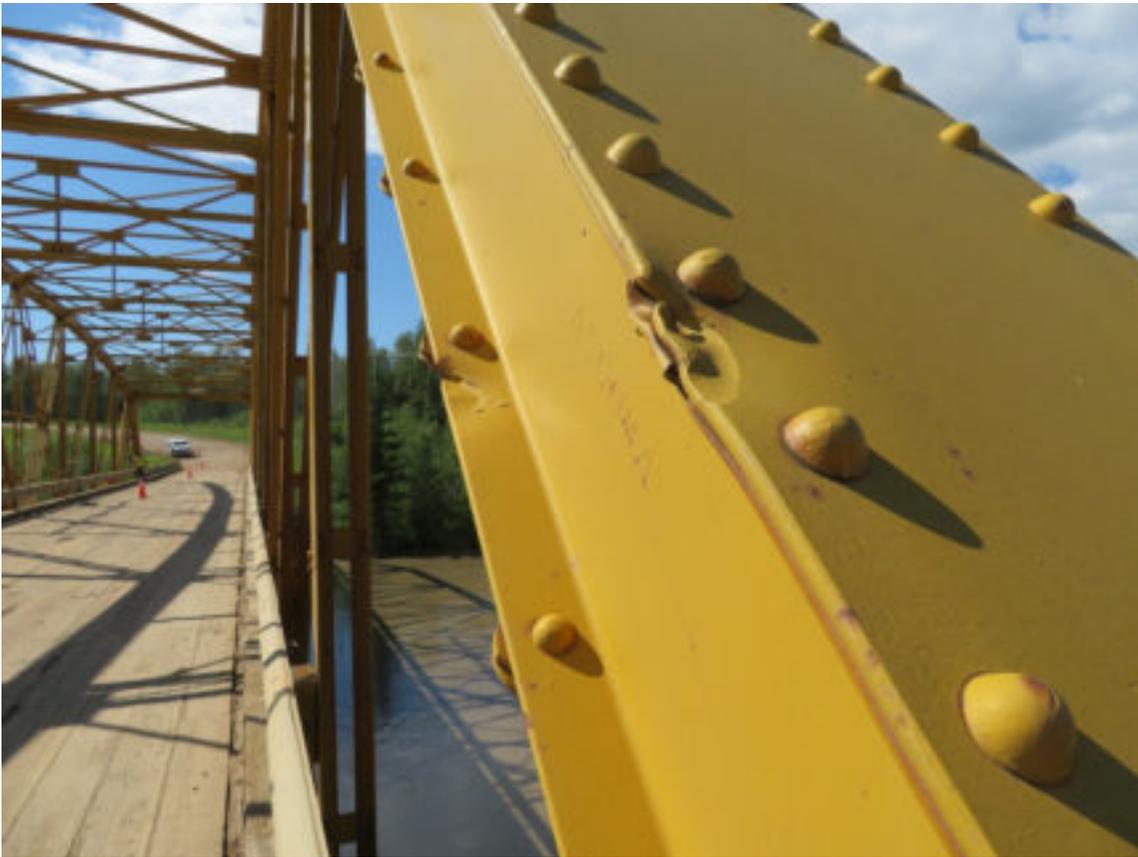
11.  
Span 4 U1L0W  
batter post with  
nicks.

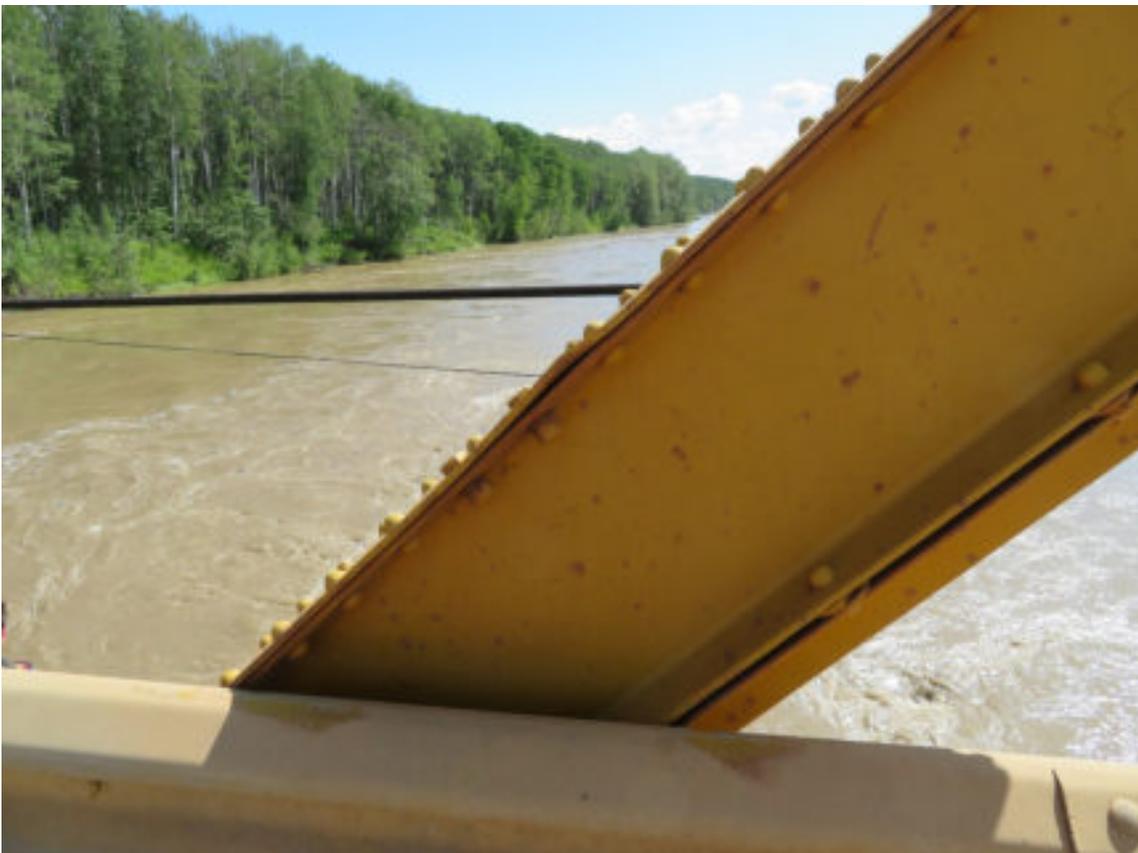
12.  
Span 5 U1L0W  
batter post with  
minor bend.

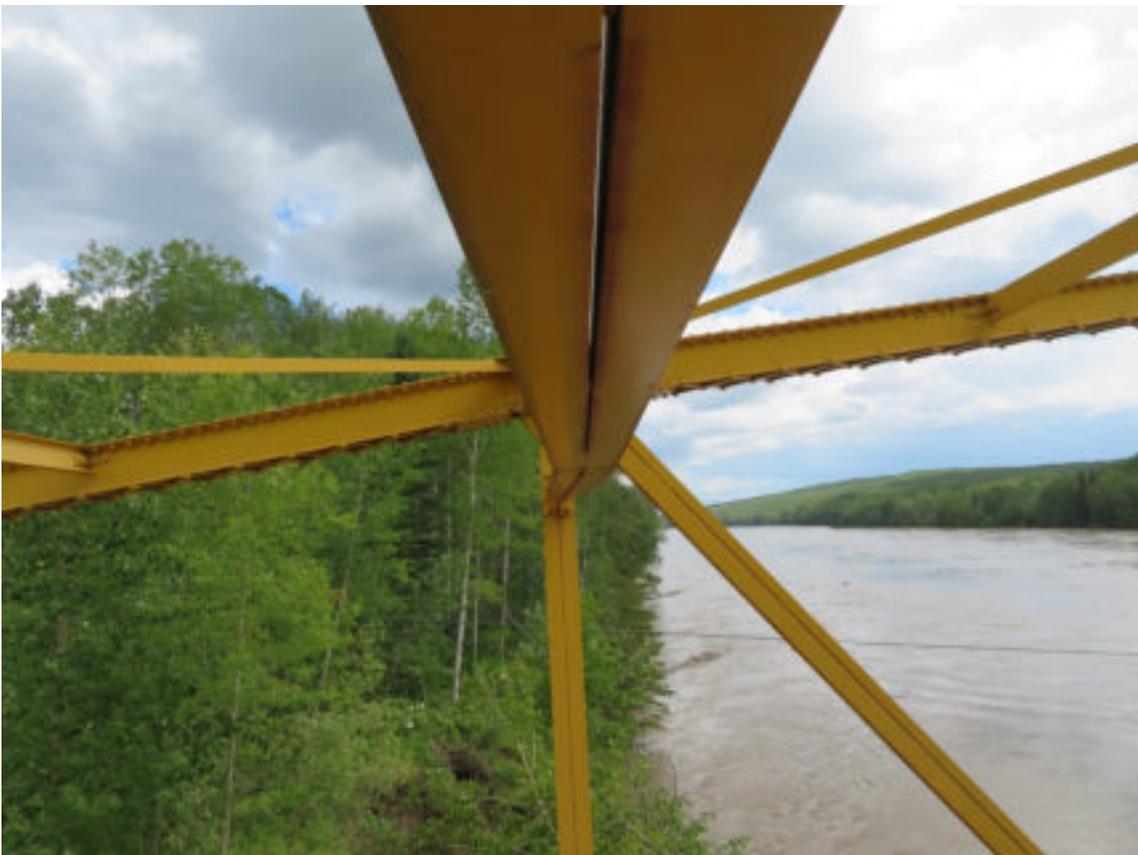
16.  
Span 6 U2U2 sway  
bracing with bend.

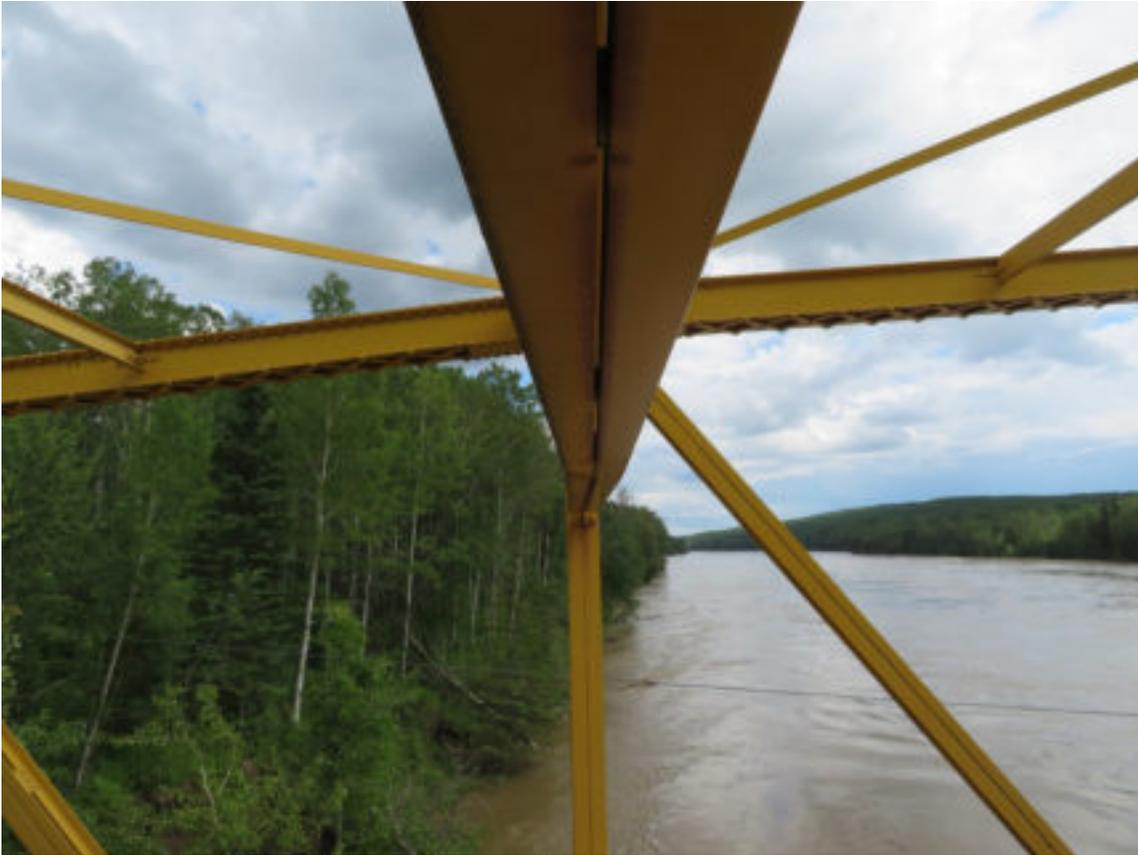
17.  
Span 6 U3U3 sway bracing with bend.

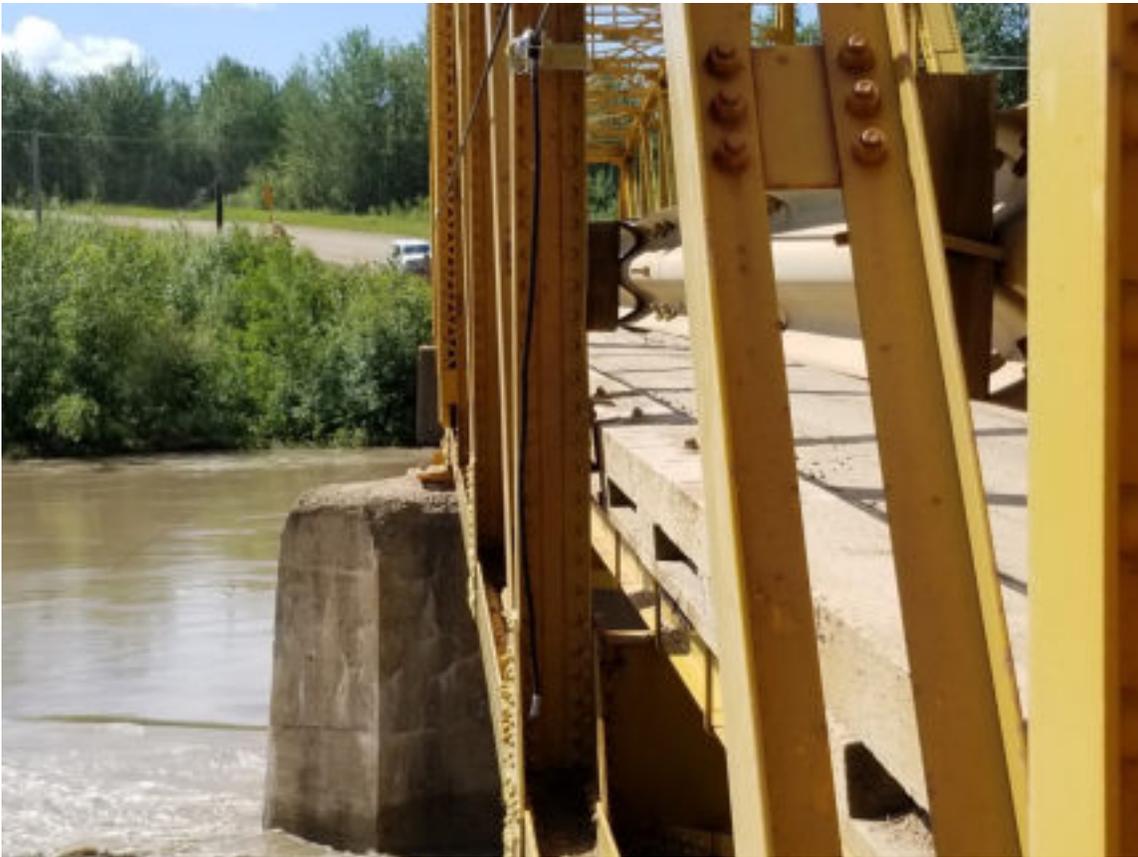
21.  
Span 5 U9L9E  
vertical member  
bent 20 mm.

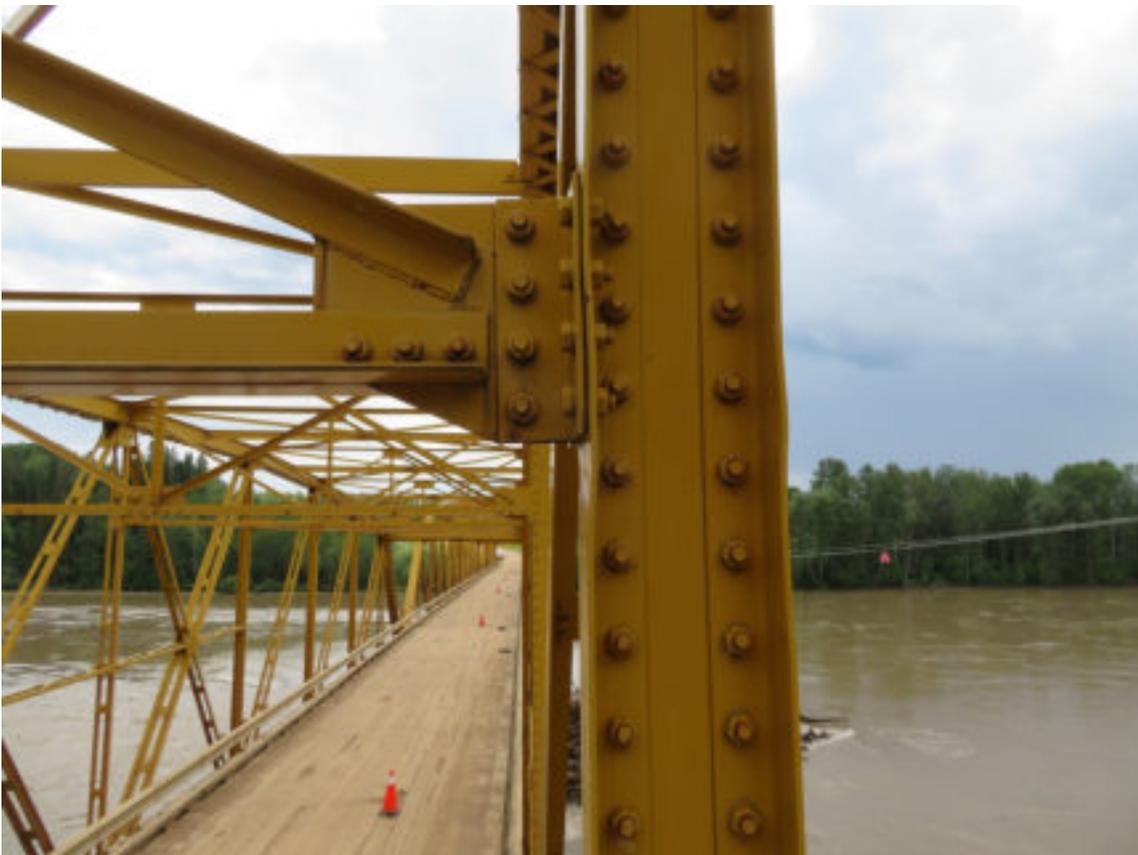
22.  
Span 6 U3L3W  
vertical member with  
bends at sway  
bracing connection.

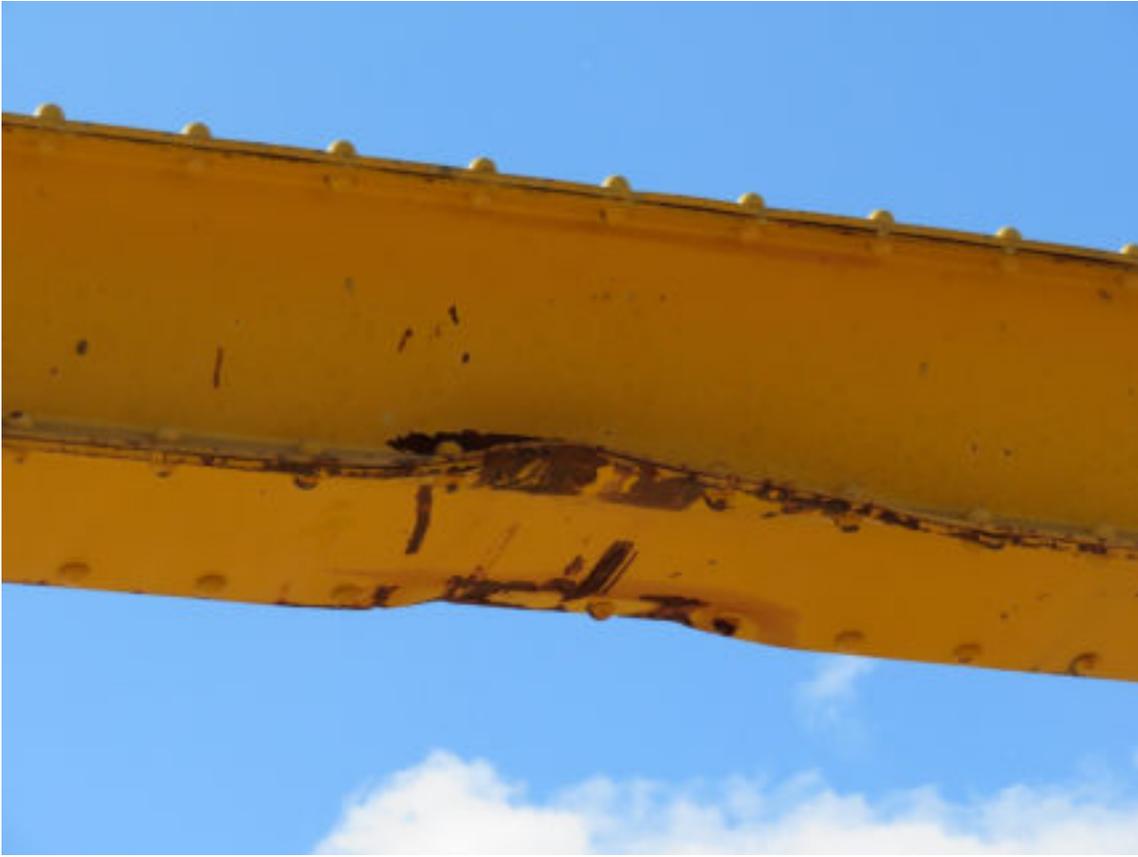
23.  
Span 4 U1U1 north portal with dent and sheared rivets.

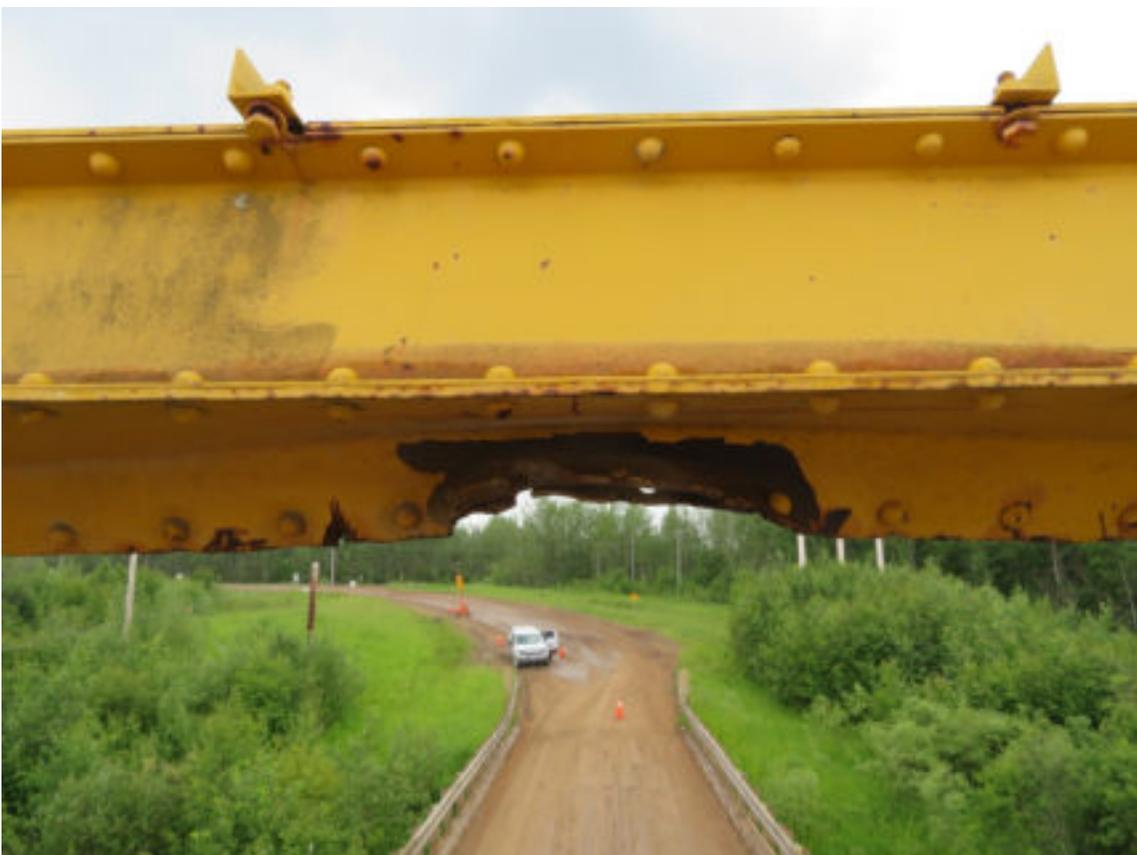
26.

Span 4 U9U9 south portal with highload damage – rivets broken, and holes torn, 60 mm crack in bottom flange – view from north.

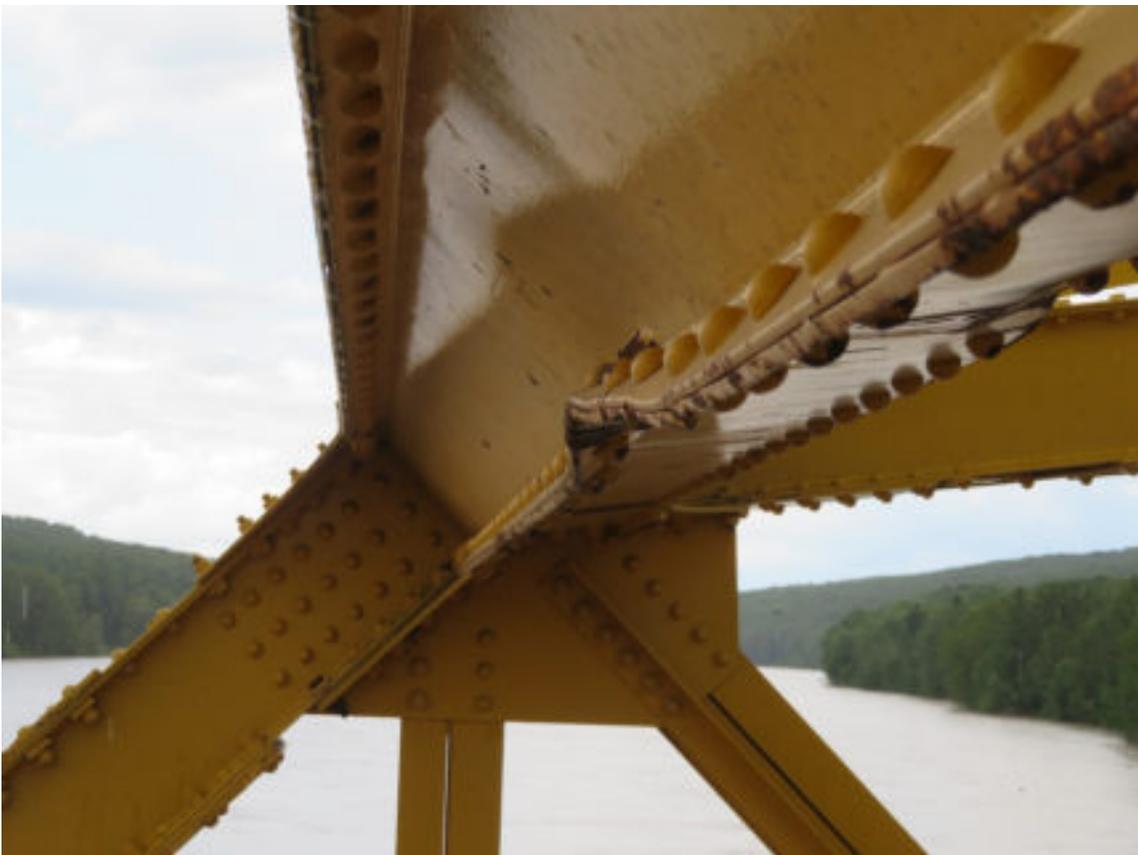
30.  
Span 5 U1U1 north portal bent at bottom side – looking east.

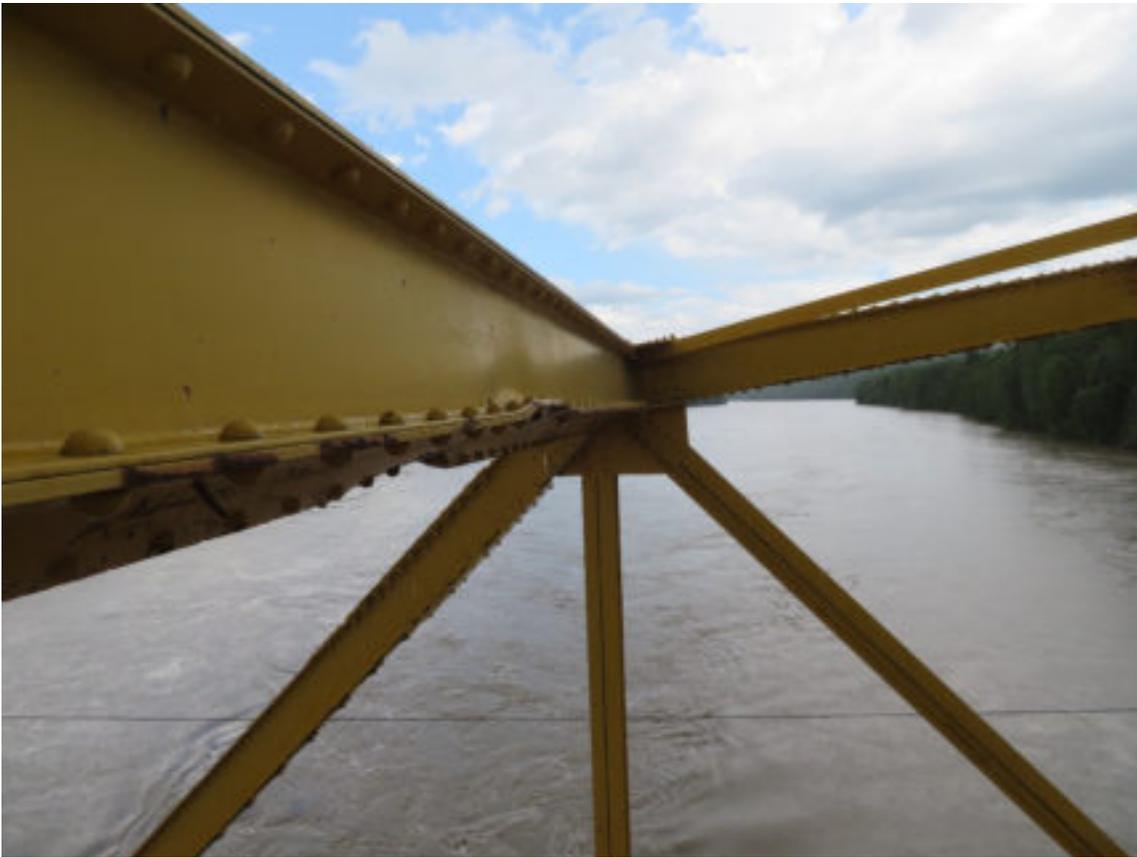
31.  
Span 5 U1U1 north portal bent at bottom side – view from south.

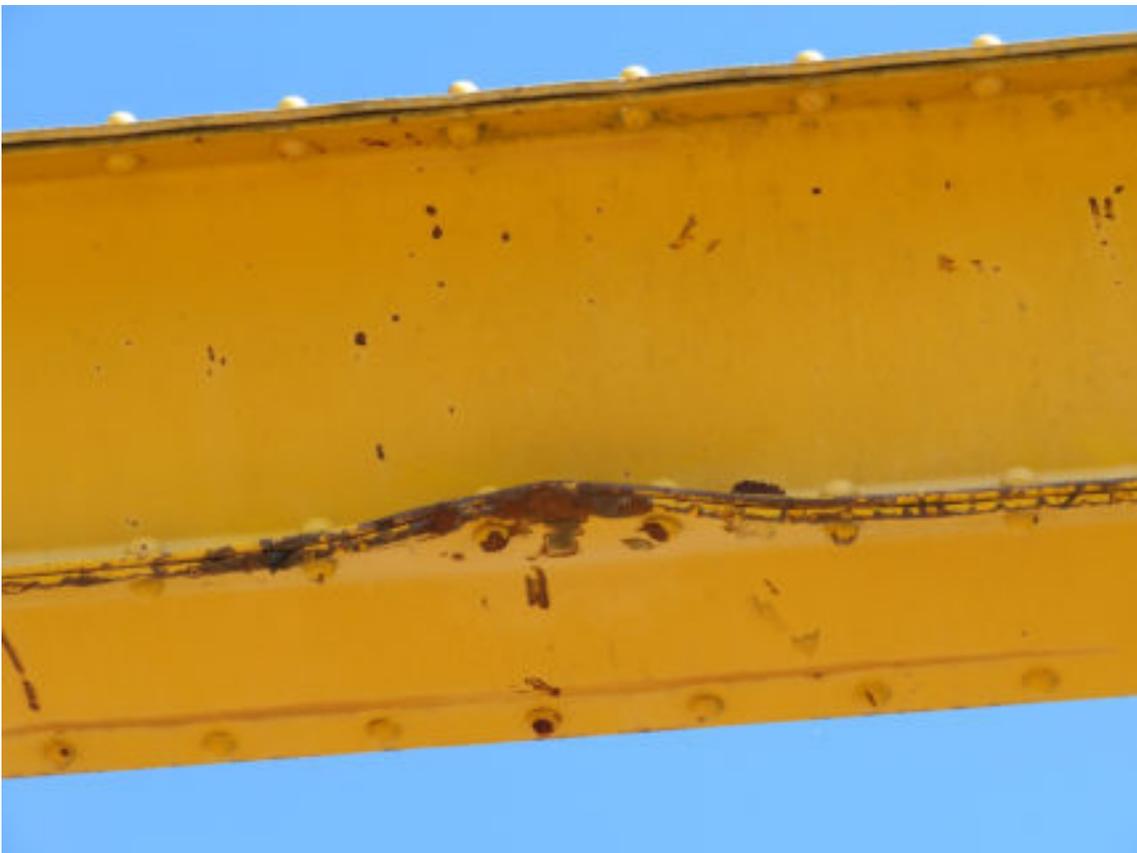
32.  
Span 5 U11U11 south portal bent at bottom two plates.

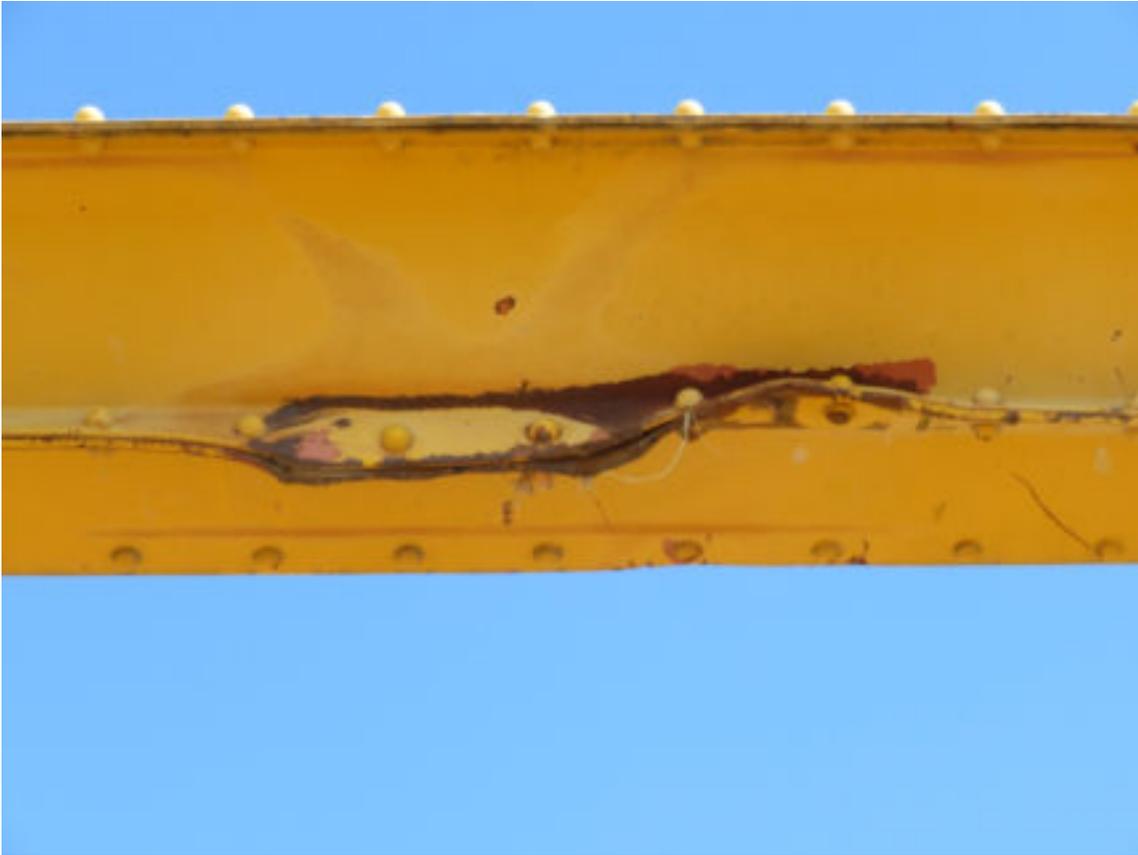
SUPERSTRUCTURE	6	PORTALS	U9W-U9E	U9U9 - High load damage with dent on bottom side.	Heat straighten member.	39-41	3-MED (WITHIN 2 YEARS)	
SUPERSTRUCTURE	4	BOTTOM_CHORD	L2-L3E	L2L3E - Lower outside angle bent 30x200mm.	Heat straighten member.	42	3-MED (WITHIN 3 YEARS)	
SUPERSTRUCTURE	6	BOTTOM_CHORD	L9-L10W	Full of gravel - typical of bottom chords throughout.	Wash deck and bottom chord.	43	2-HIGH (WITHIN 1 YEAR)	
SUBSTRUCTURE		ABUT_SCOUR_EROSION		Erosion gullies at both abutments.	Place approximately 20 m <sup>3</sup> of class 1M riprap on headslopes.	85-87	2-HIGH (WITHIN 1 YEAR)	
SUBSTRUCTURE		PIER_BEARING_SEATS_CAPS		Severe scaling at the top of piers 4 and 5.	Partial depth repairs of piers 4 and 5.	75-83	2-HIGH (WITHIN 1 YEAR)	
SUBSTRUCTURE		DEBRIS		Large amount of drift on the west side of pier 5.	Remove drift buildup.	82-84	2-HIGH (WITHIN 1 YEAR)

41.  
Span 6 U9U9 south portal with dent on bottom side – close view.

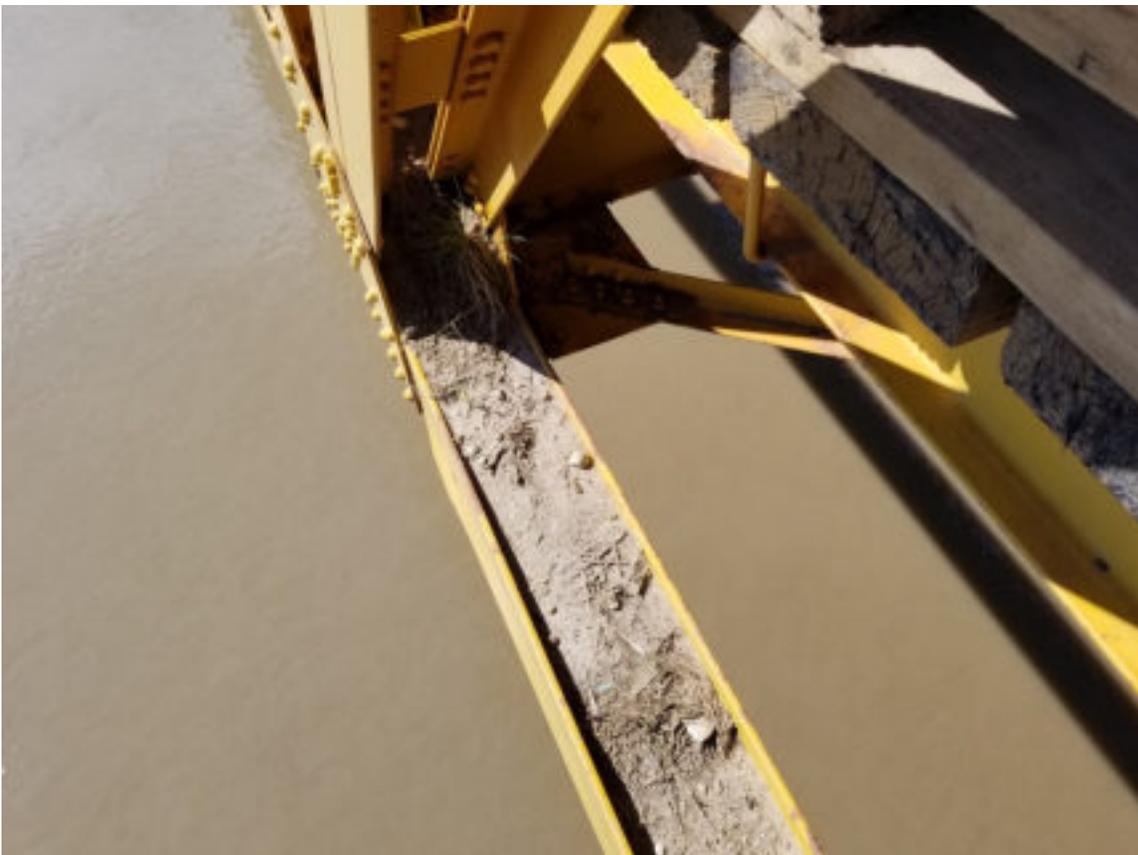
42.  
Span 4 L2L3E bottom chord bent 30x200 mm.

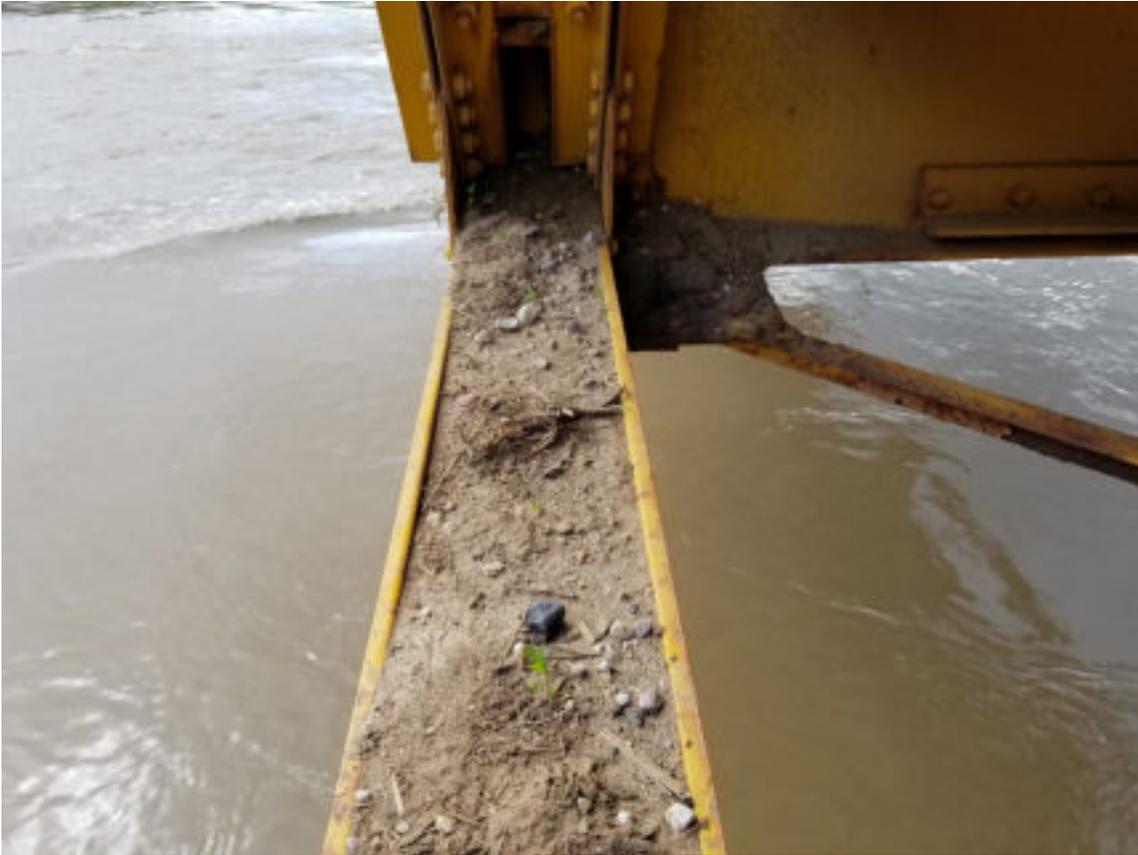
43.  
Span 6 bottom chord filled with gravel, typical.

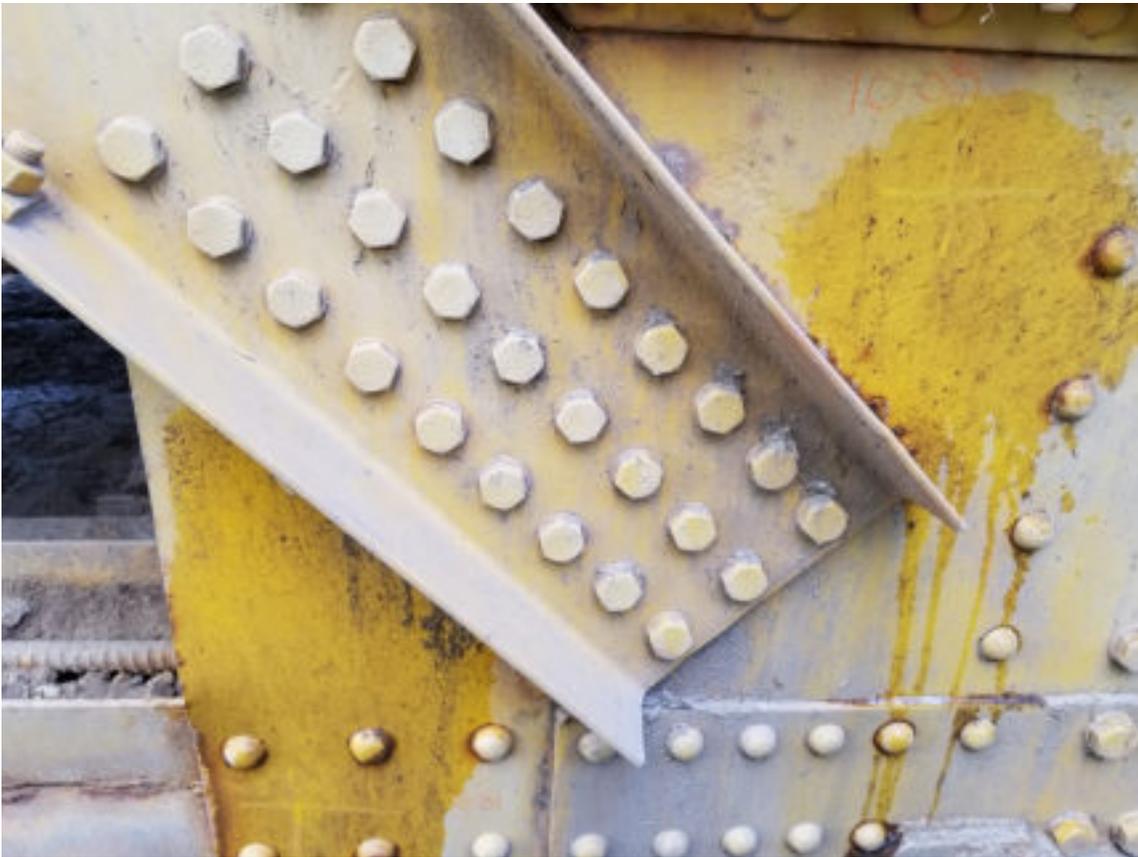
47.  
Span 6 LOE gusset plate.  
Gusset plate thickness measurements: 10.05 mm uncorroded and 6.81 mm as lowest value.

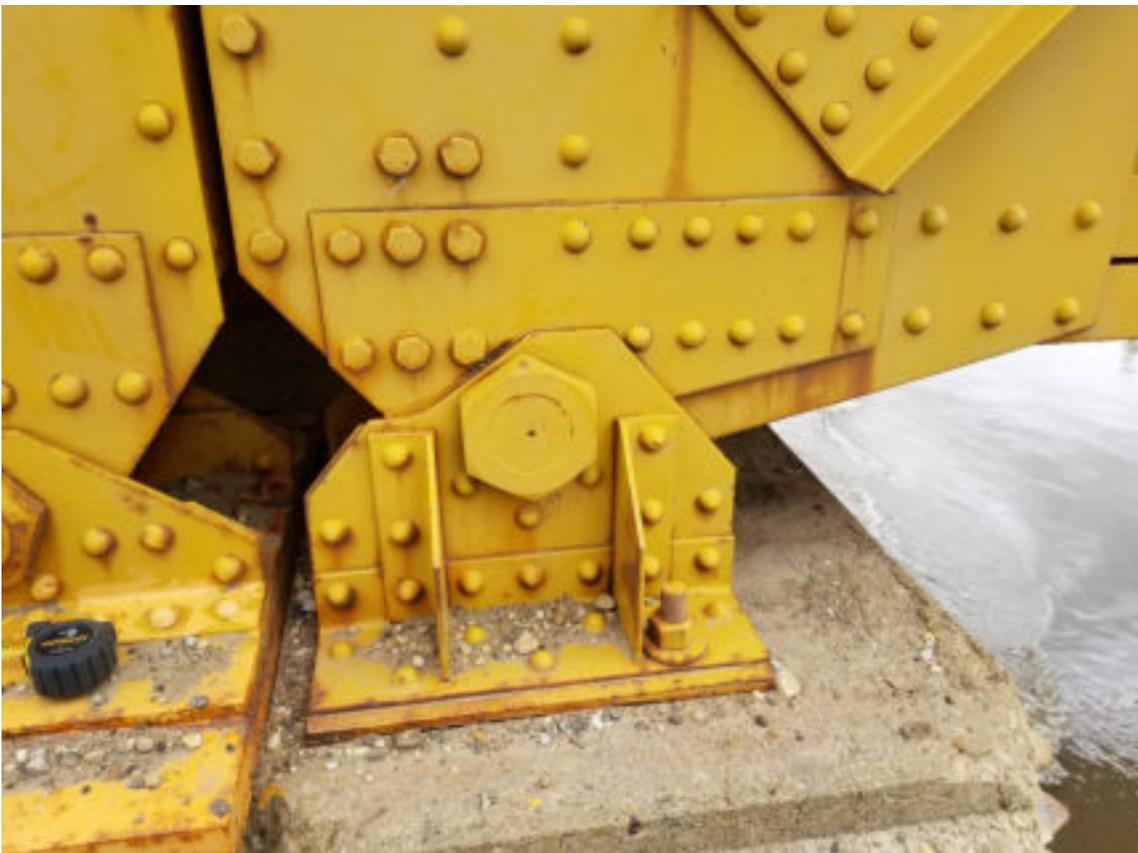
48.  
Span 4 LOW fixed bearing at pier 4.

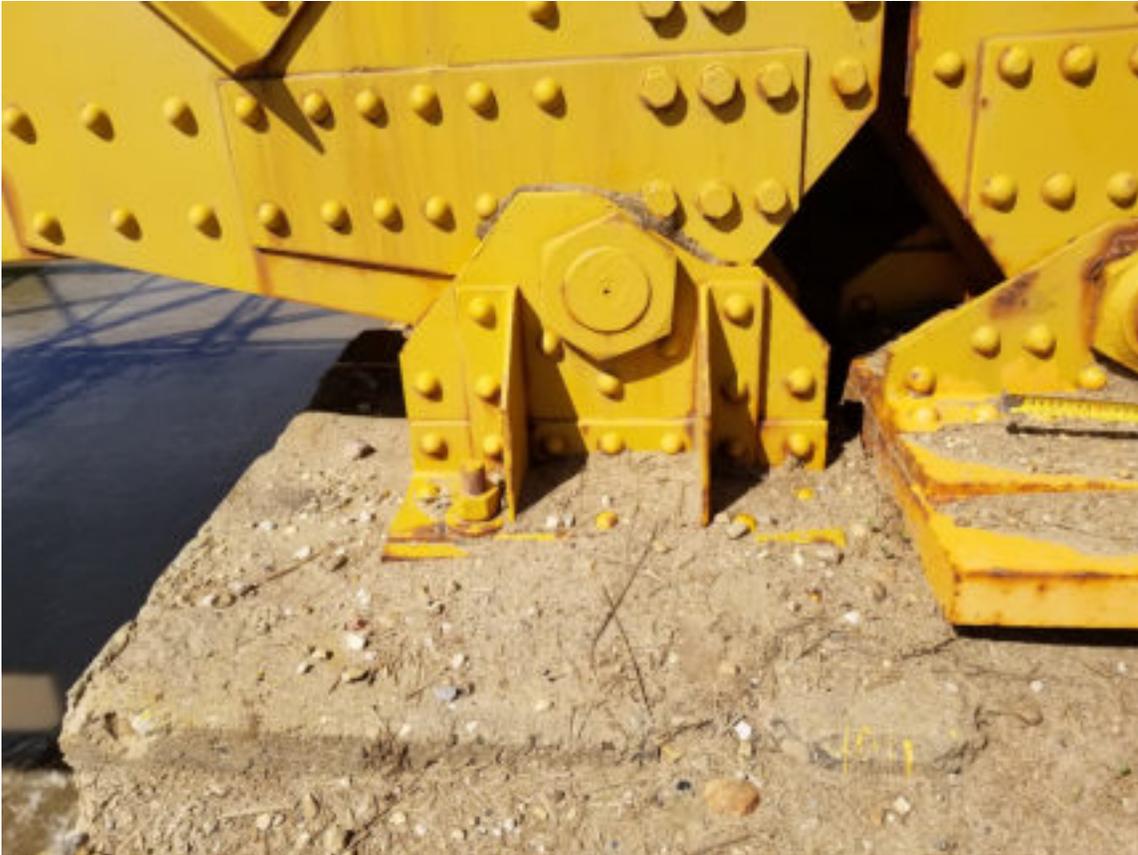
49.  
Span 4 L0E fixed bearing at pier 4

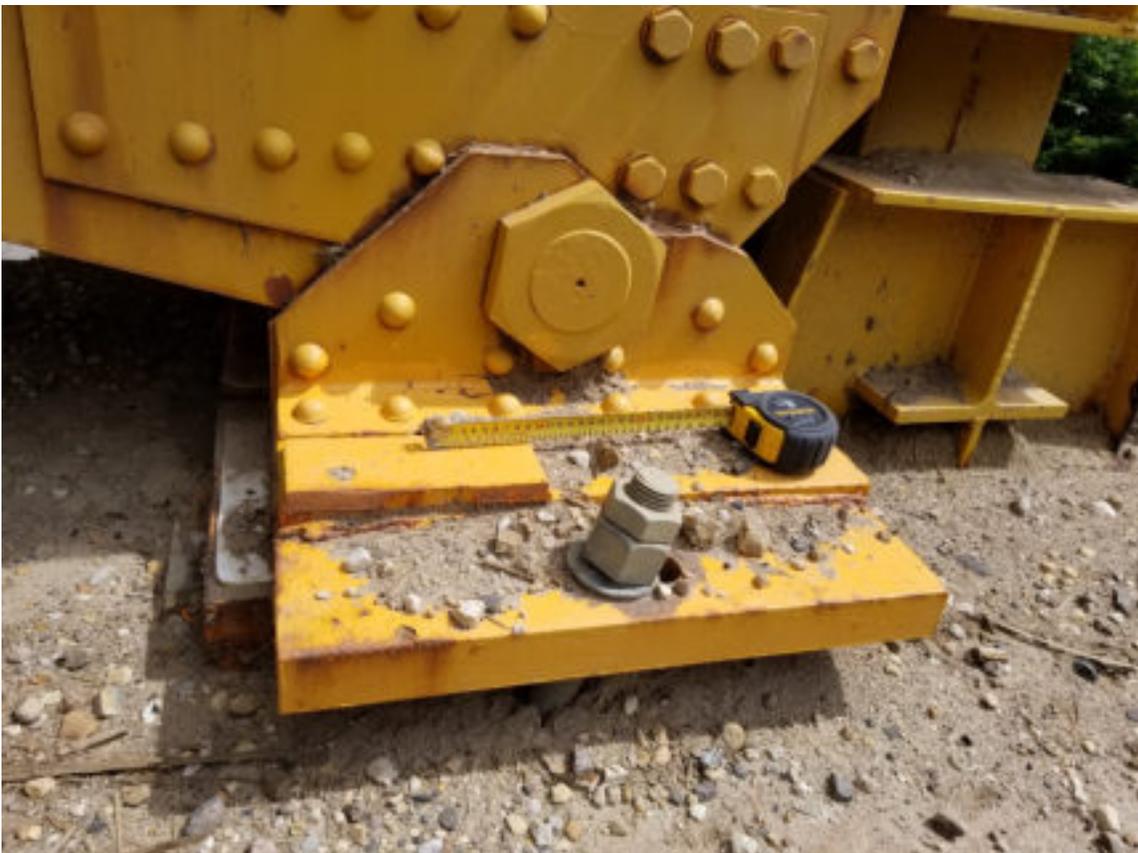
50.  
Span 4 L10W expansion bearing at pier 3.  
Note anchor bolt bent.

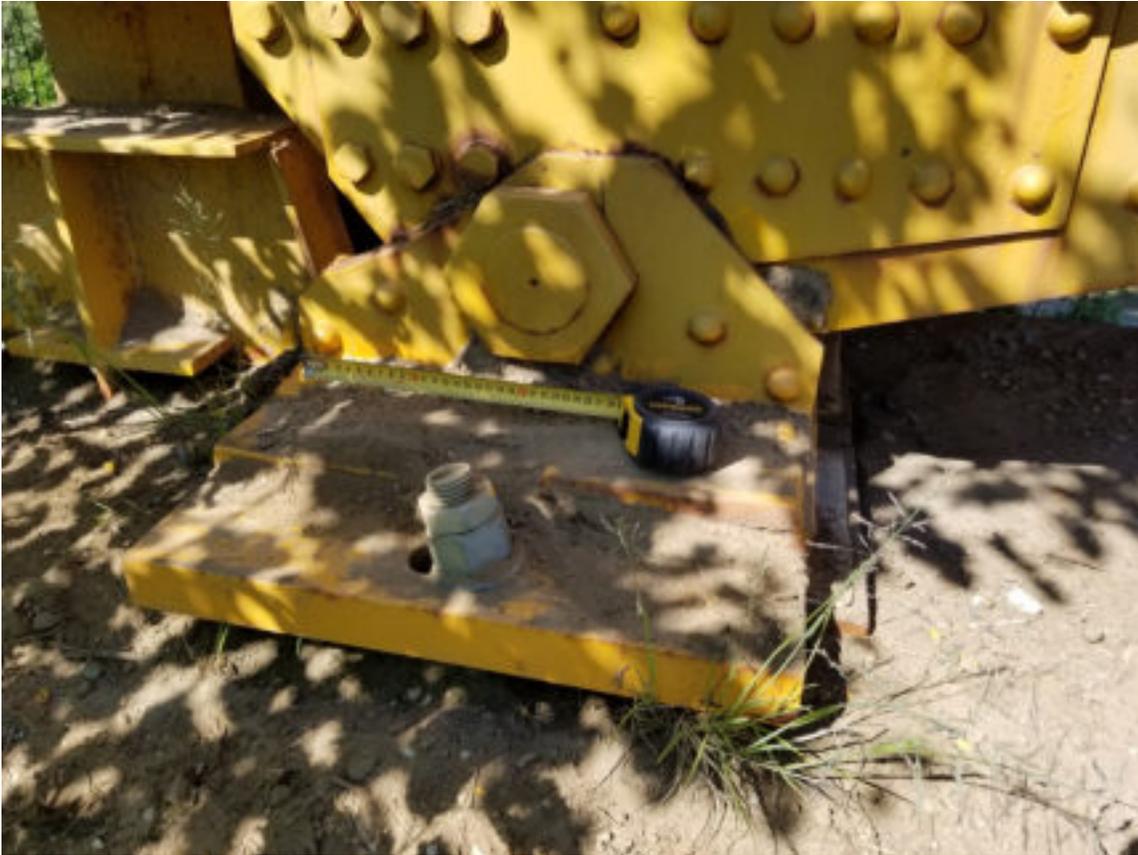
51.  
Span 4 L10E  
expansion bearing  
at pier 3.  
Note anchor bolt  
bent.

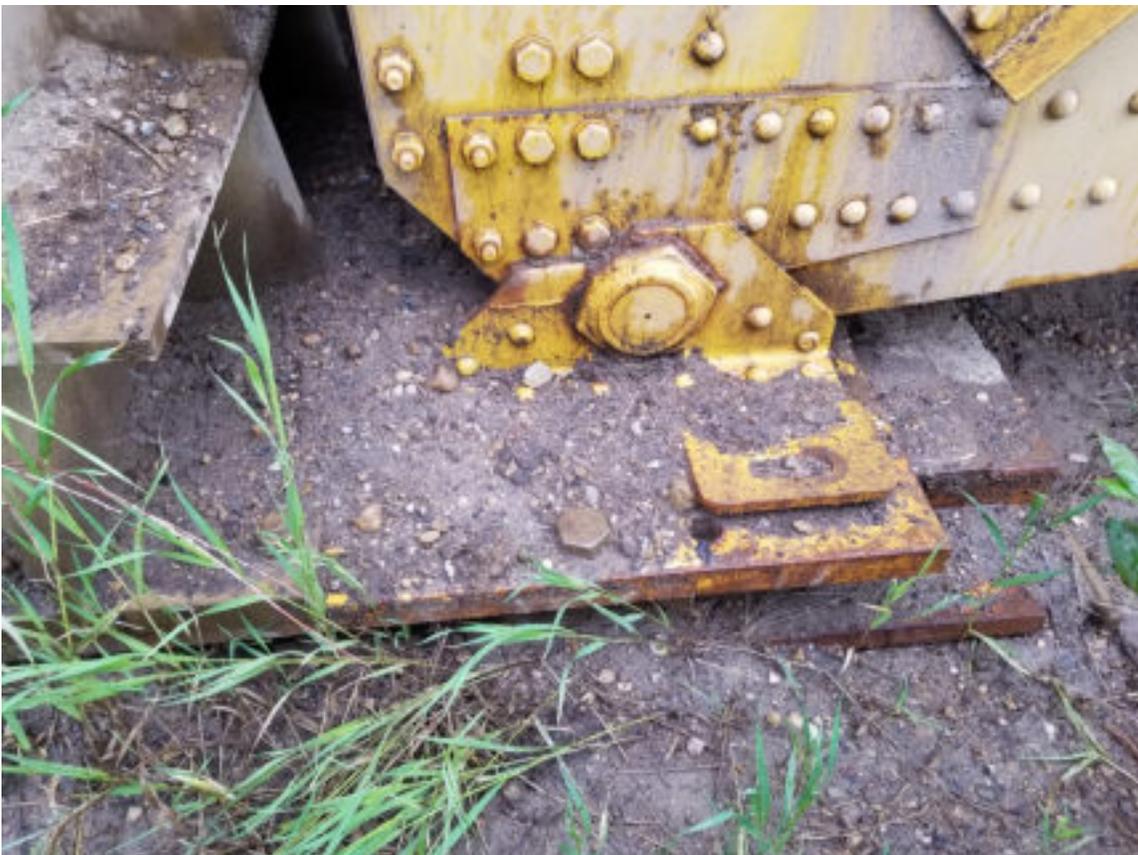
56.  
Span 6 LOW  
expansion bearing  
at pier 6 with no  
anchor bolt at  
exterior.

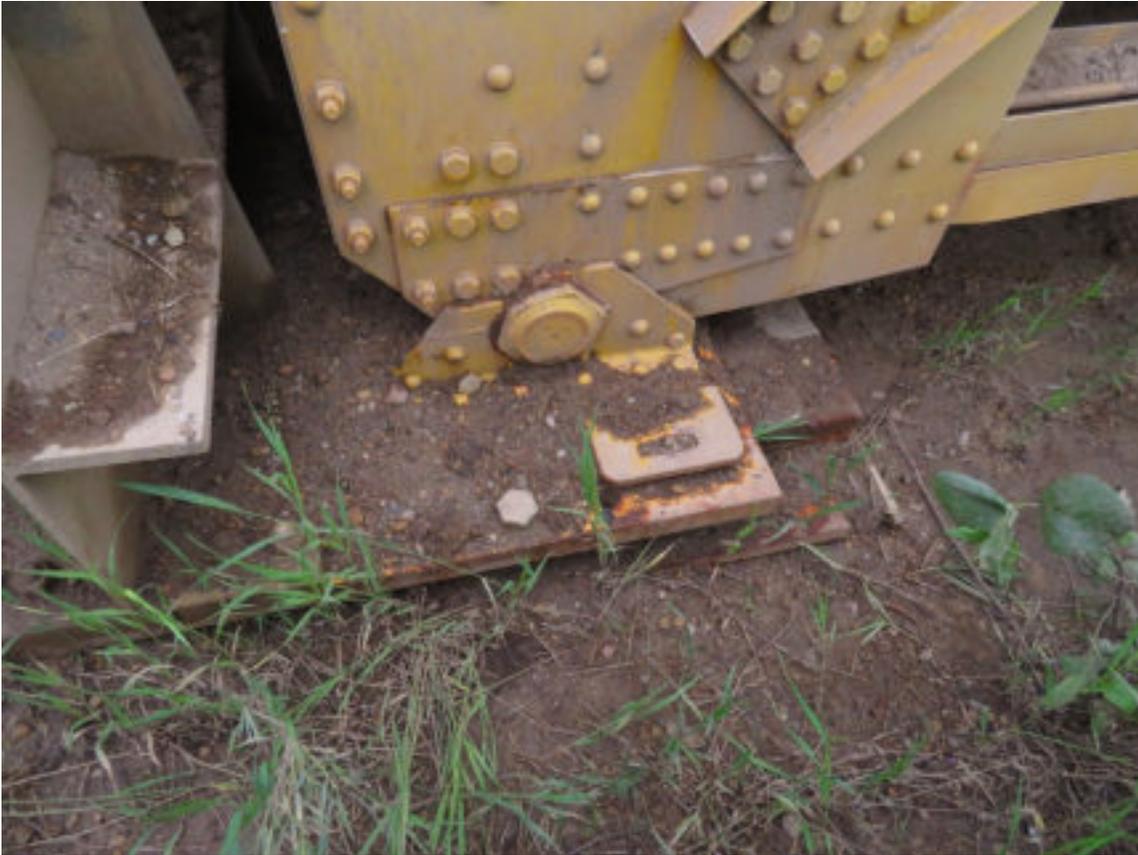
57.  
Span 6 LOW  
expansion bearing  
at pier 6 with no  
anchor bolt at  
exterior.

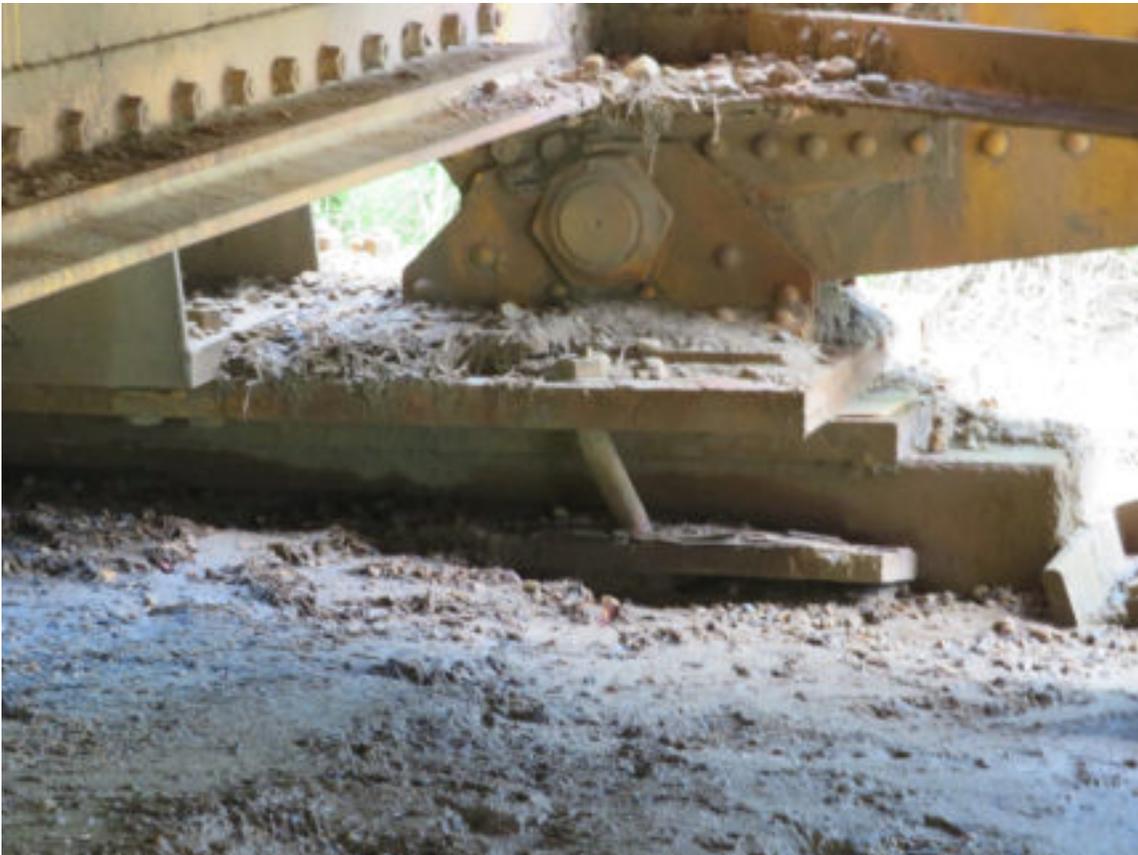
59.  
Span 6 LOE  
expansion bearing  
with anchor bolt  
maxed out and bent.
