# BRIDGE ASSESSMENT REPORT

## Municipal District of Lesser Slave River

Bridge File 71600  
Athabasca River

NOVEMBER 2022

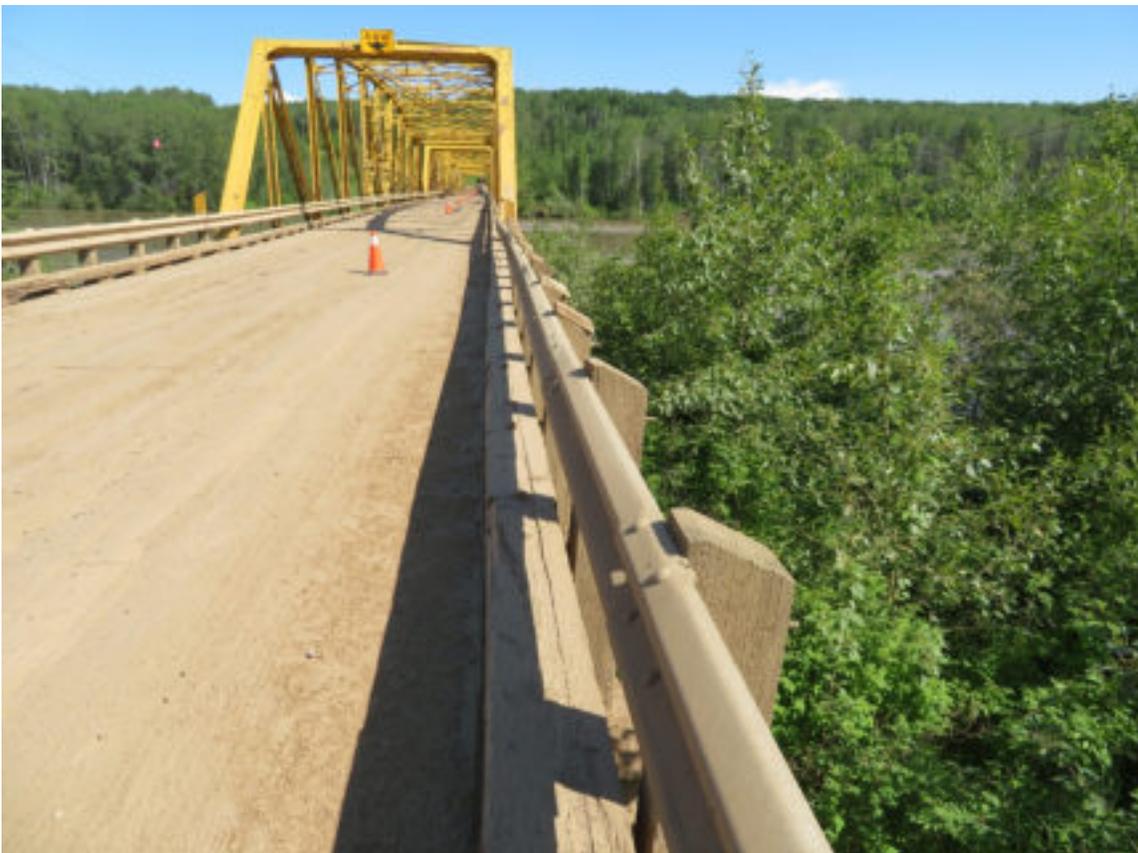
62.  
Southeast bridge rail post leaning.

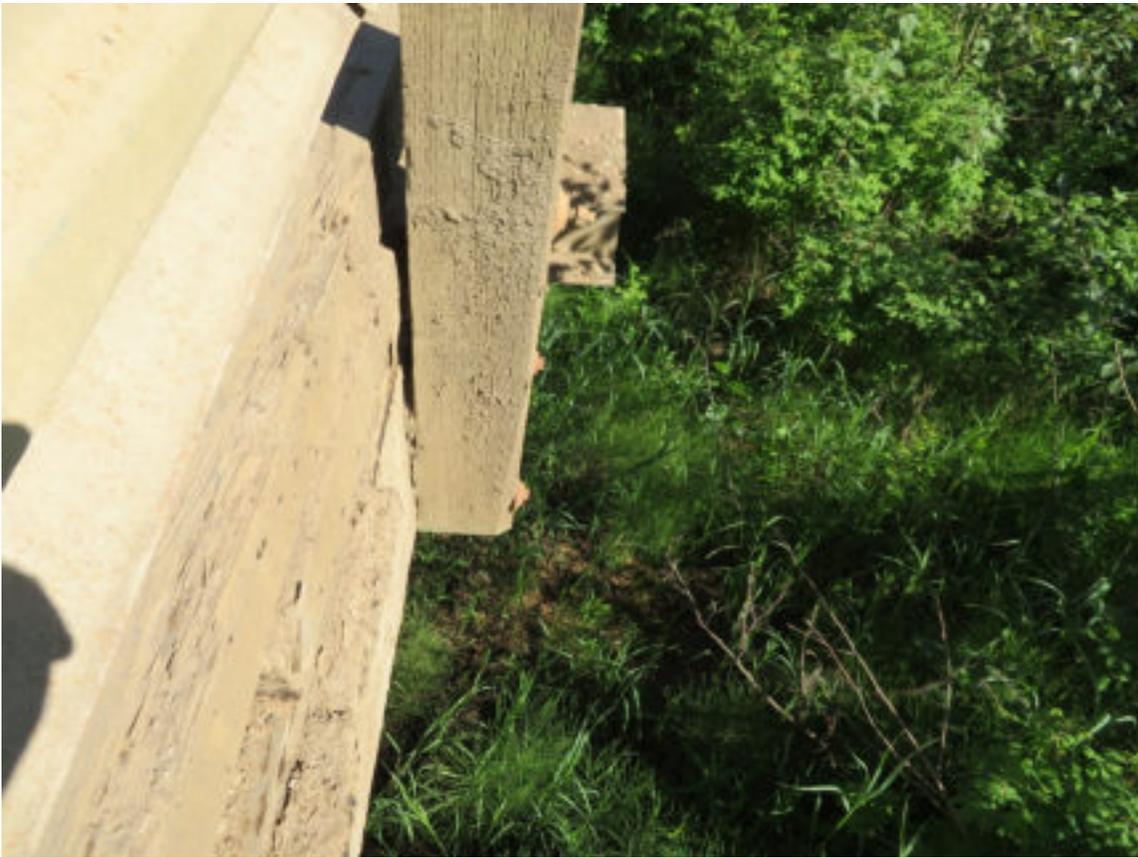
63.  
Southeast bridge rail post leaning with gap at top of post – close view.

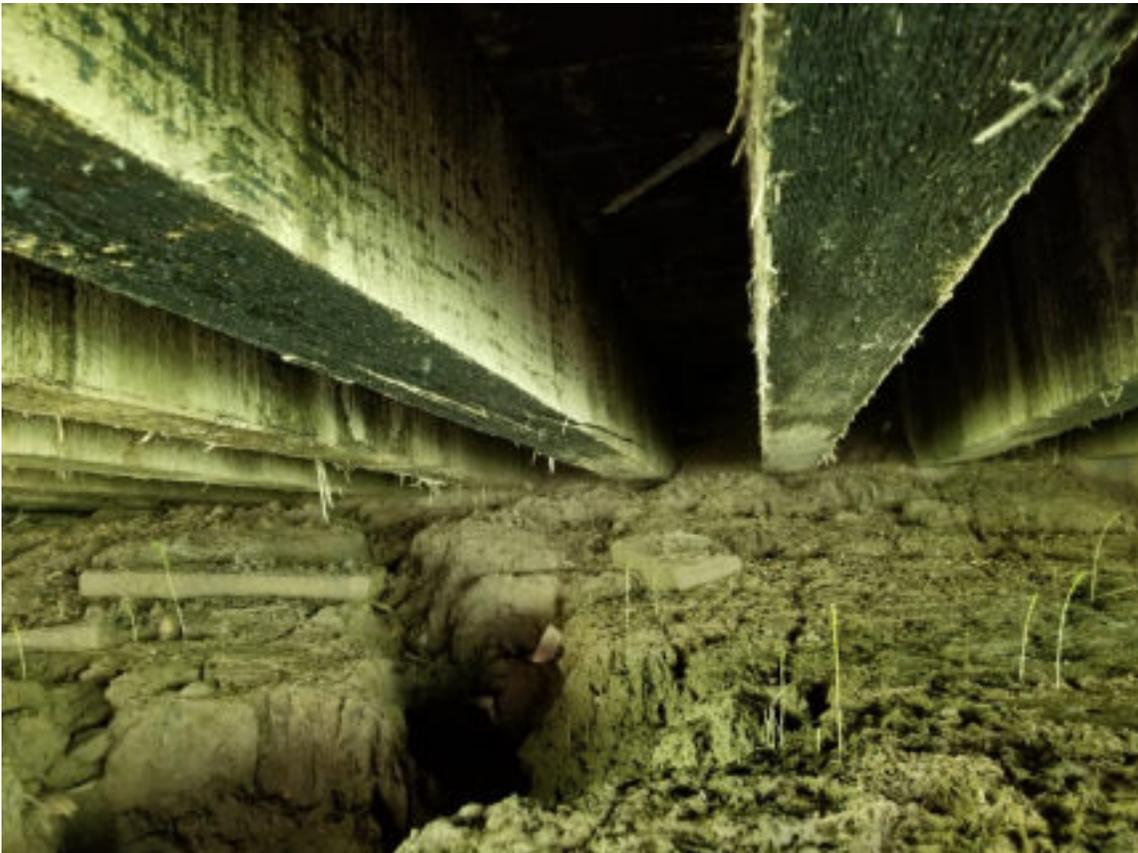
64.  
Span 1 with stringer 6 split along bottom.  
Note erosion at abutment 1 headslope.

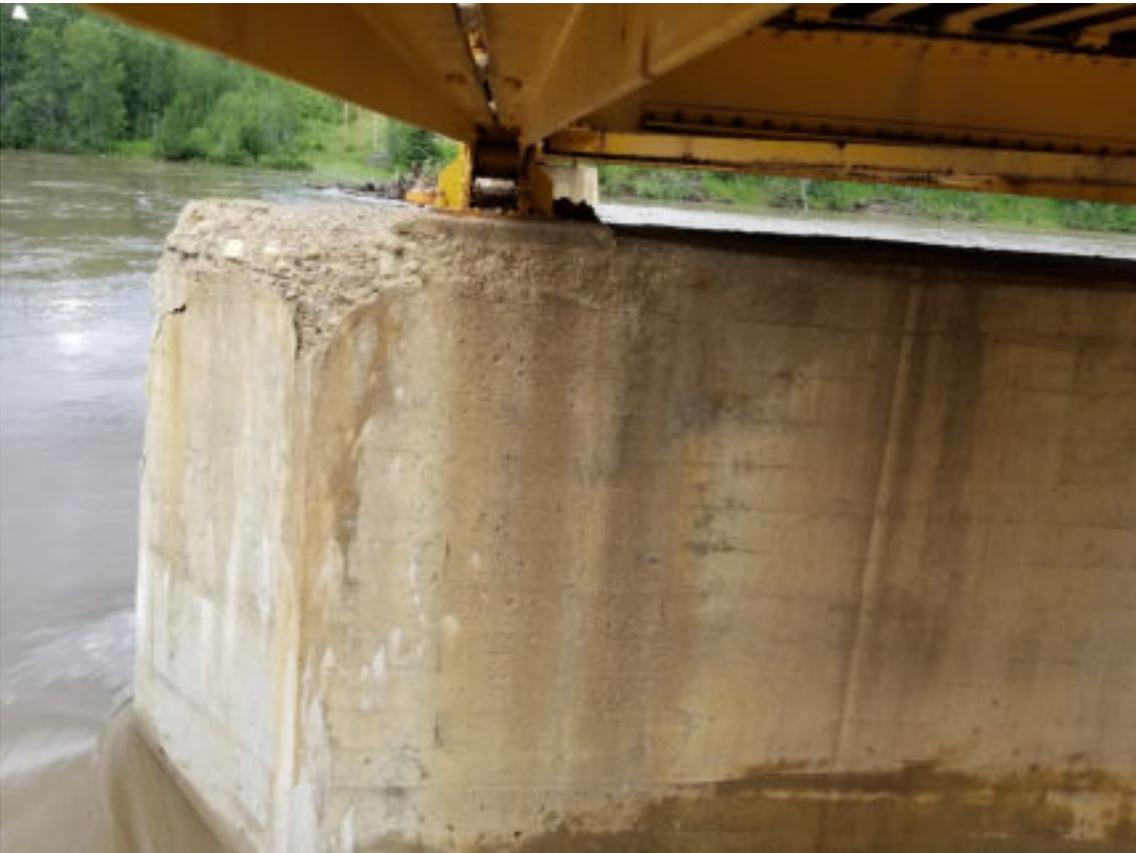
78.  
Pier 4 west with  
severe scaling at top  
– looking north.

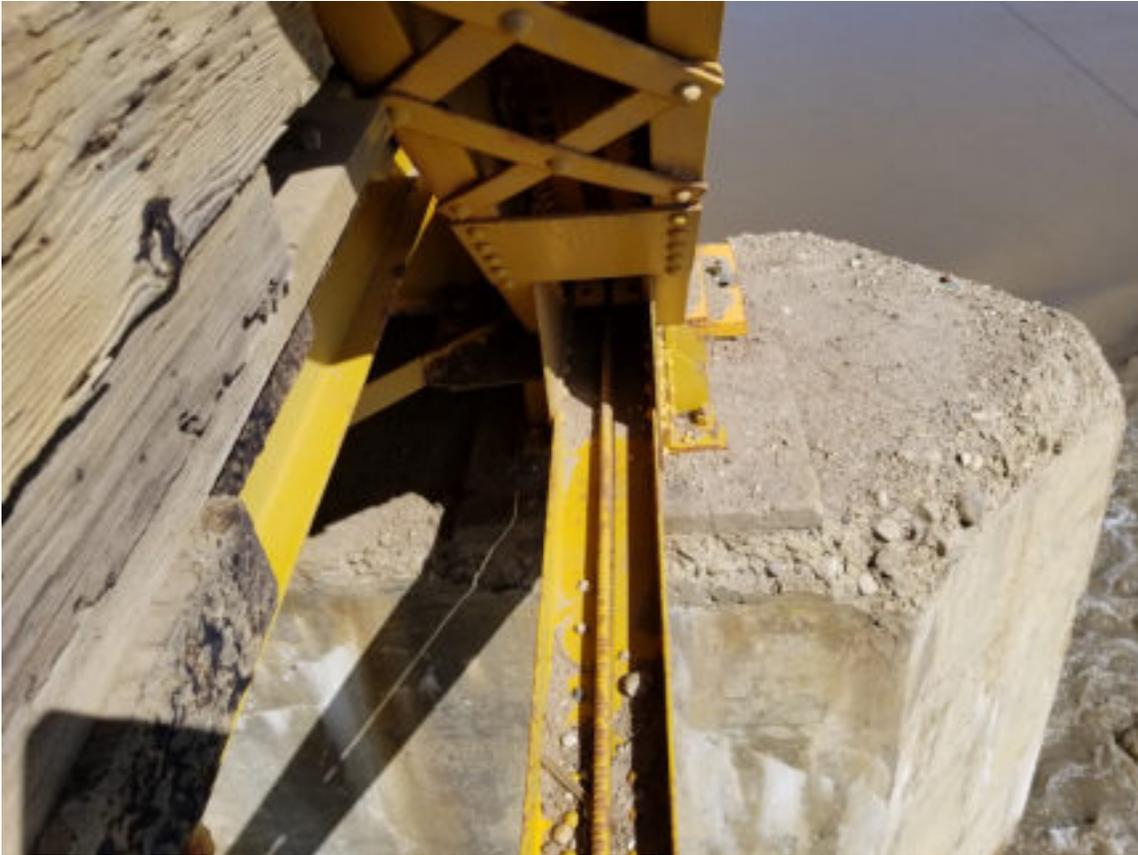
79.  
Pier 4 east with  
severe scaling at top  
– looking north.

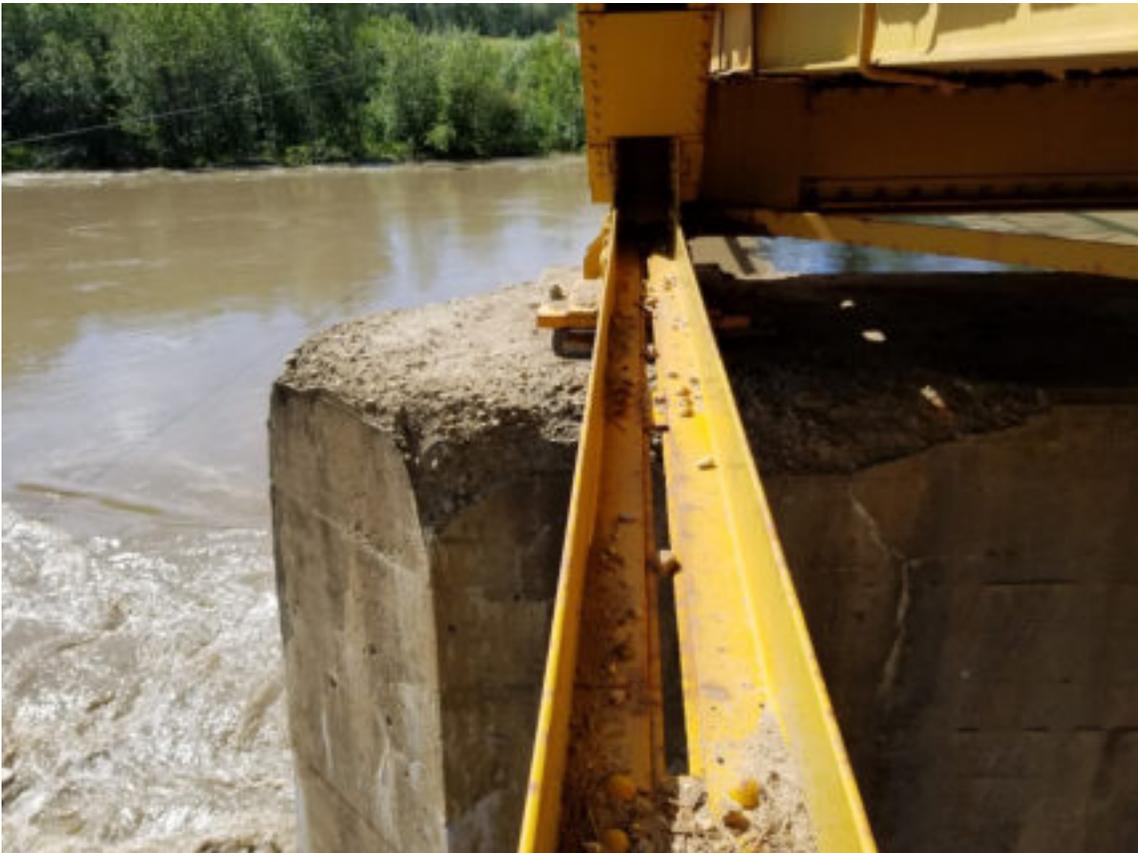
80.  
Pier 4 east with  
severe scaling at top  
– looking south.

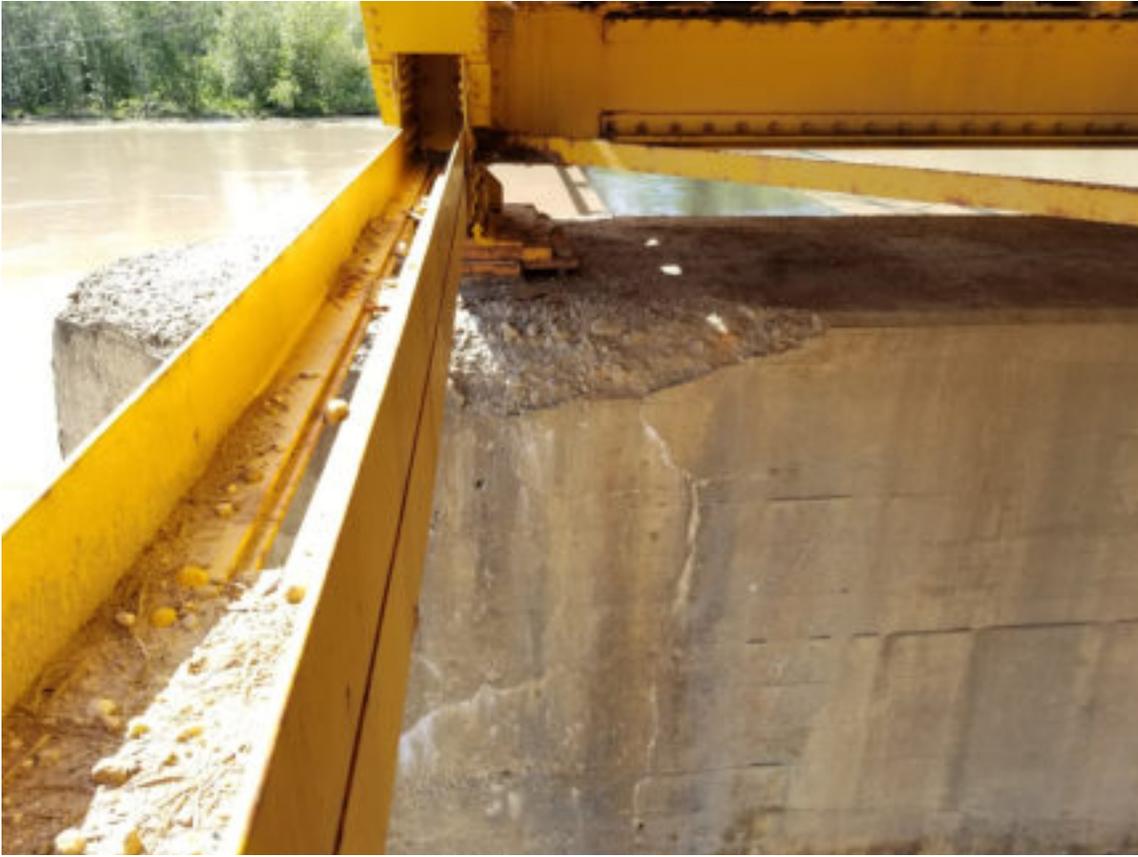
81.  
Pier 4 east with  
severe scaling at top  
– looking south.

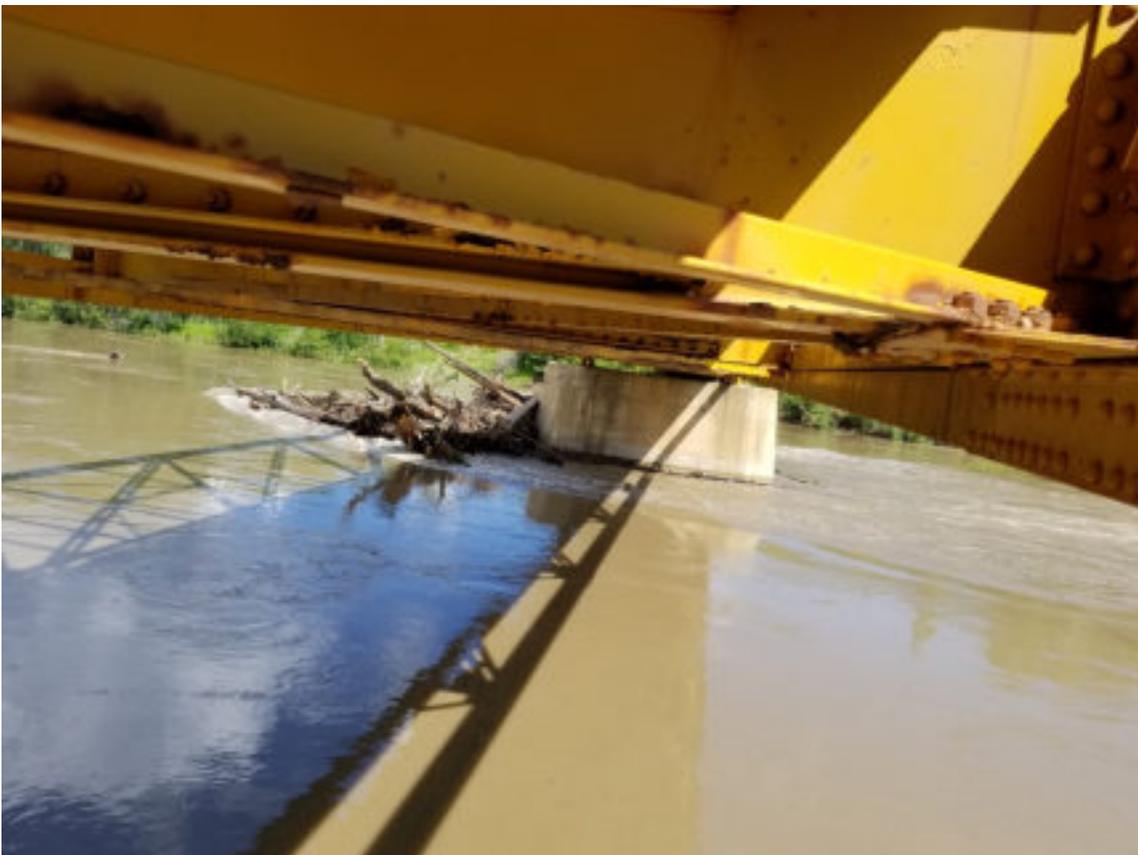
82.  
Pier 5 looking north.  
Note drift on  
westside of pier.

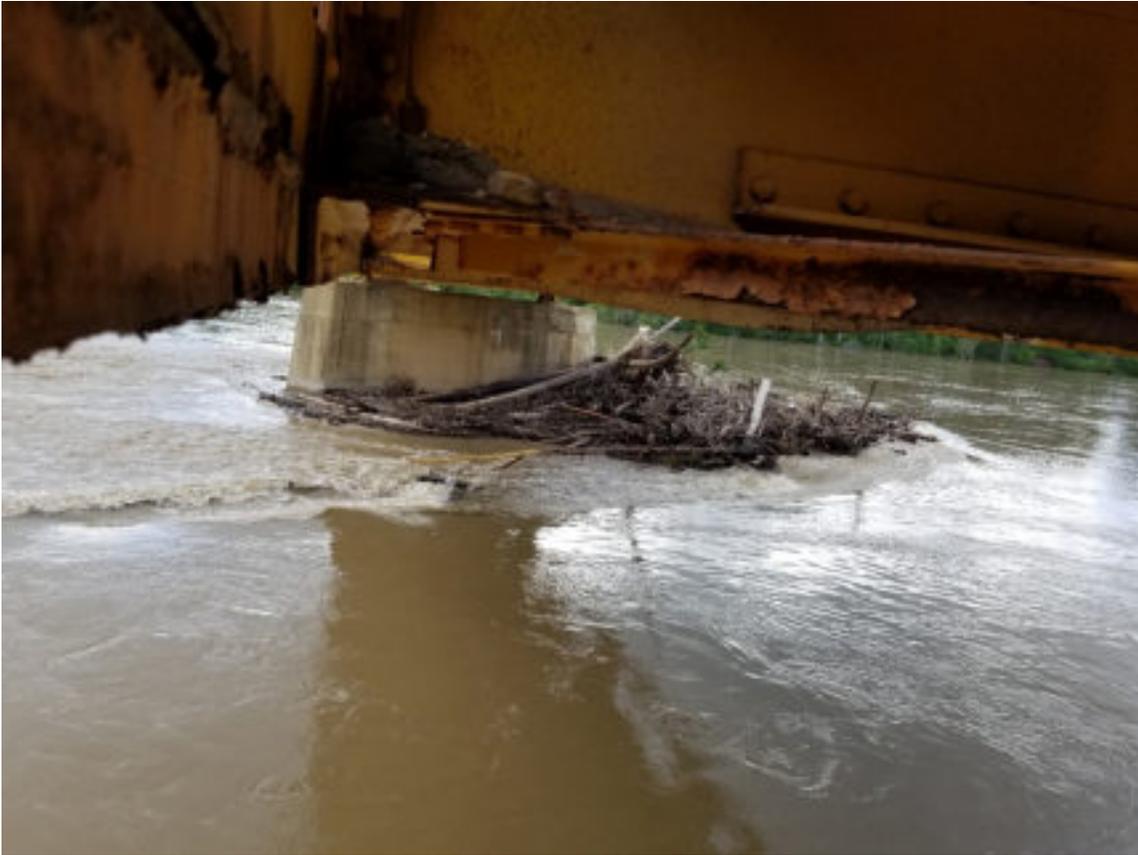
83.  
Pier 5 looking south.  
Note drift on westside of pier.

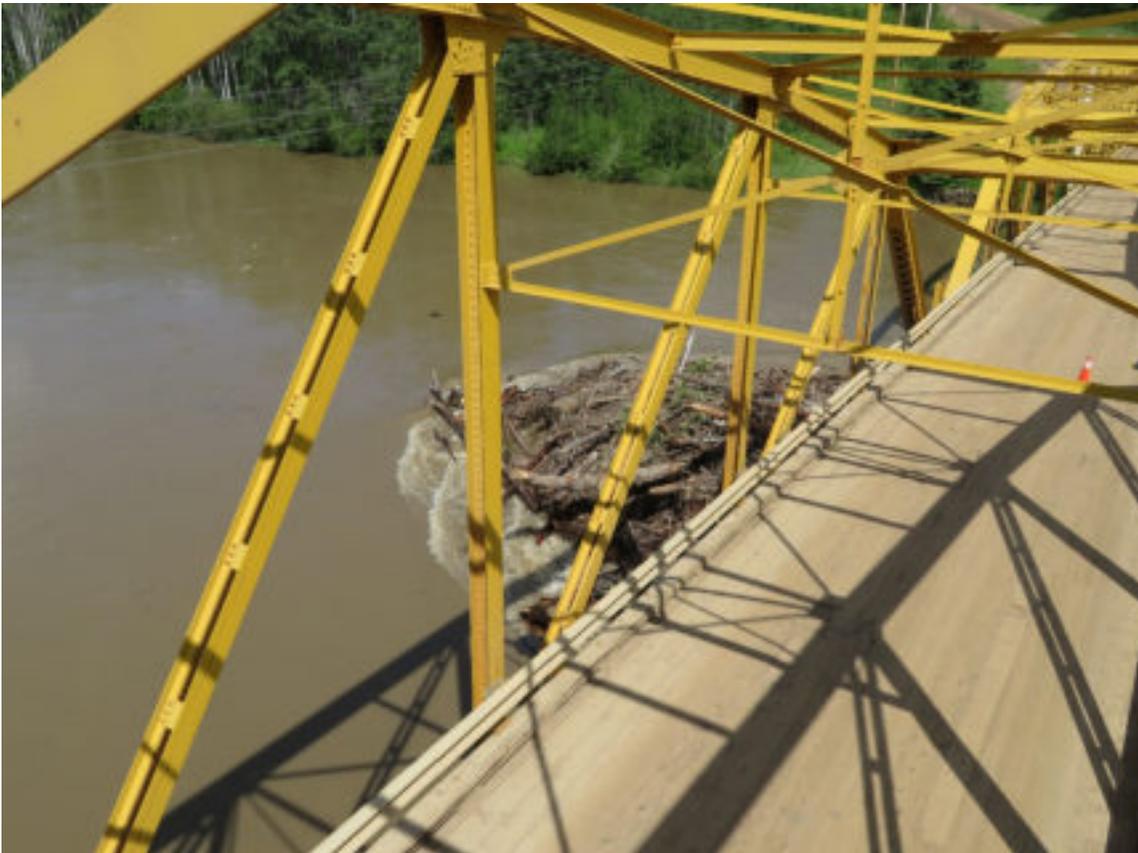
84.  
Drift buildup at westside of pier 5.

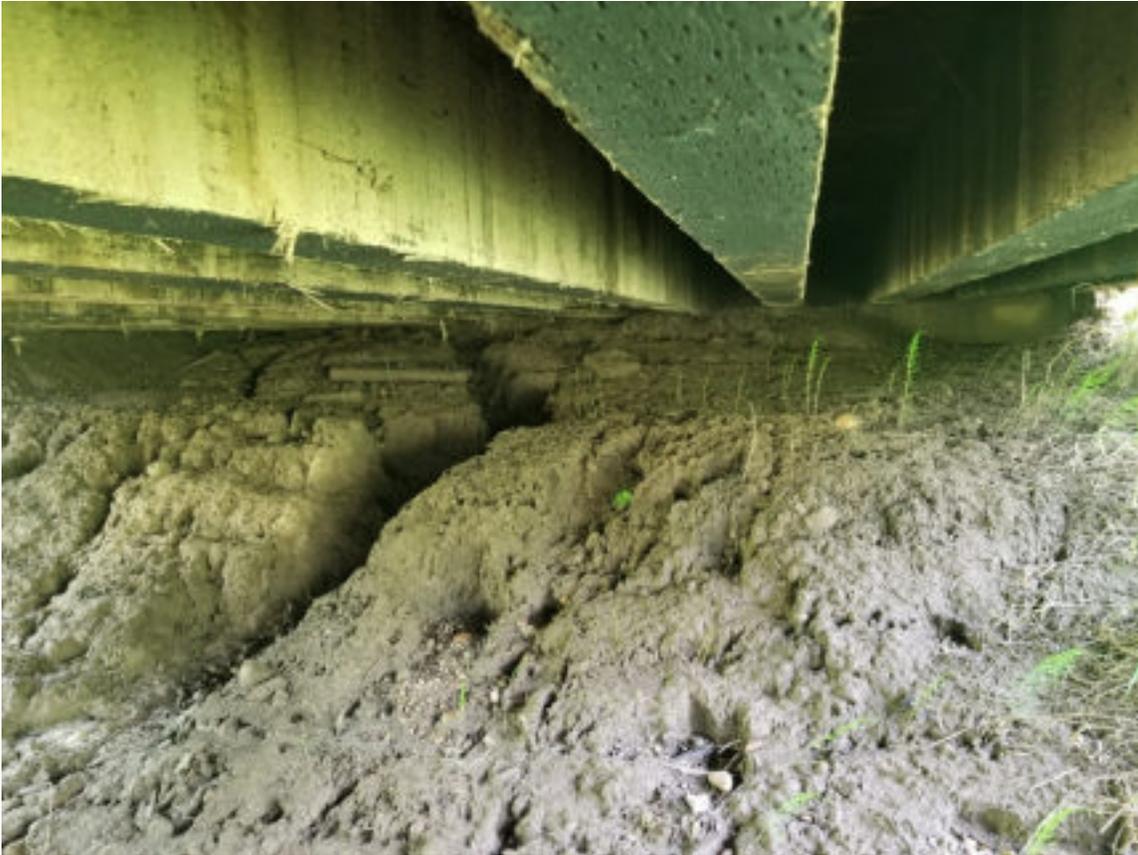
85.  
Abutment 1 with  
erosion of  
headslope.

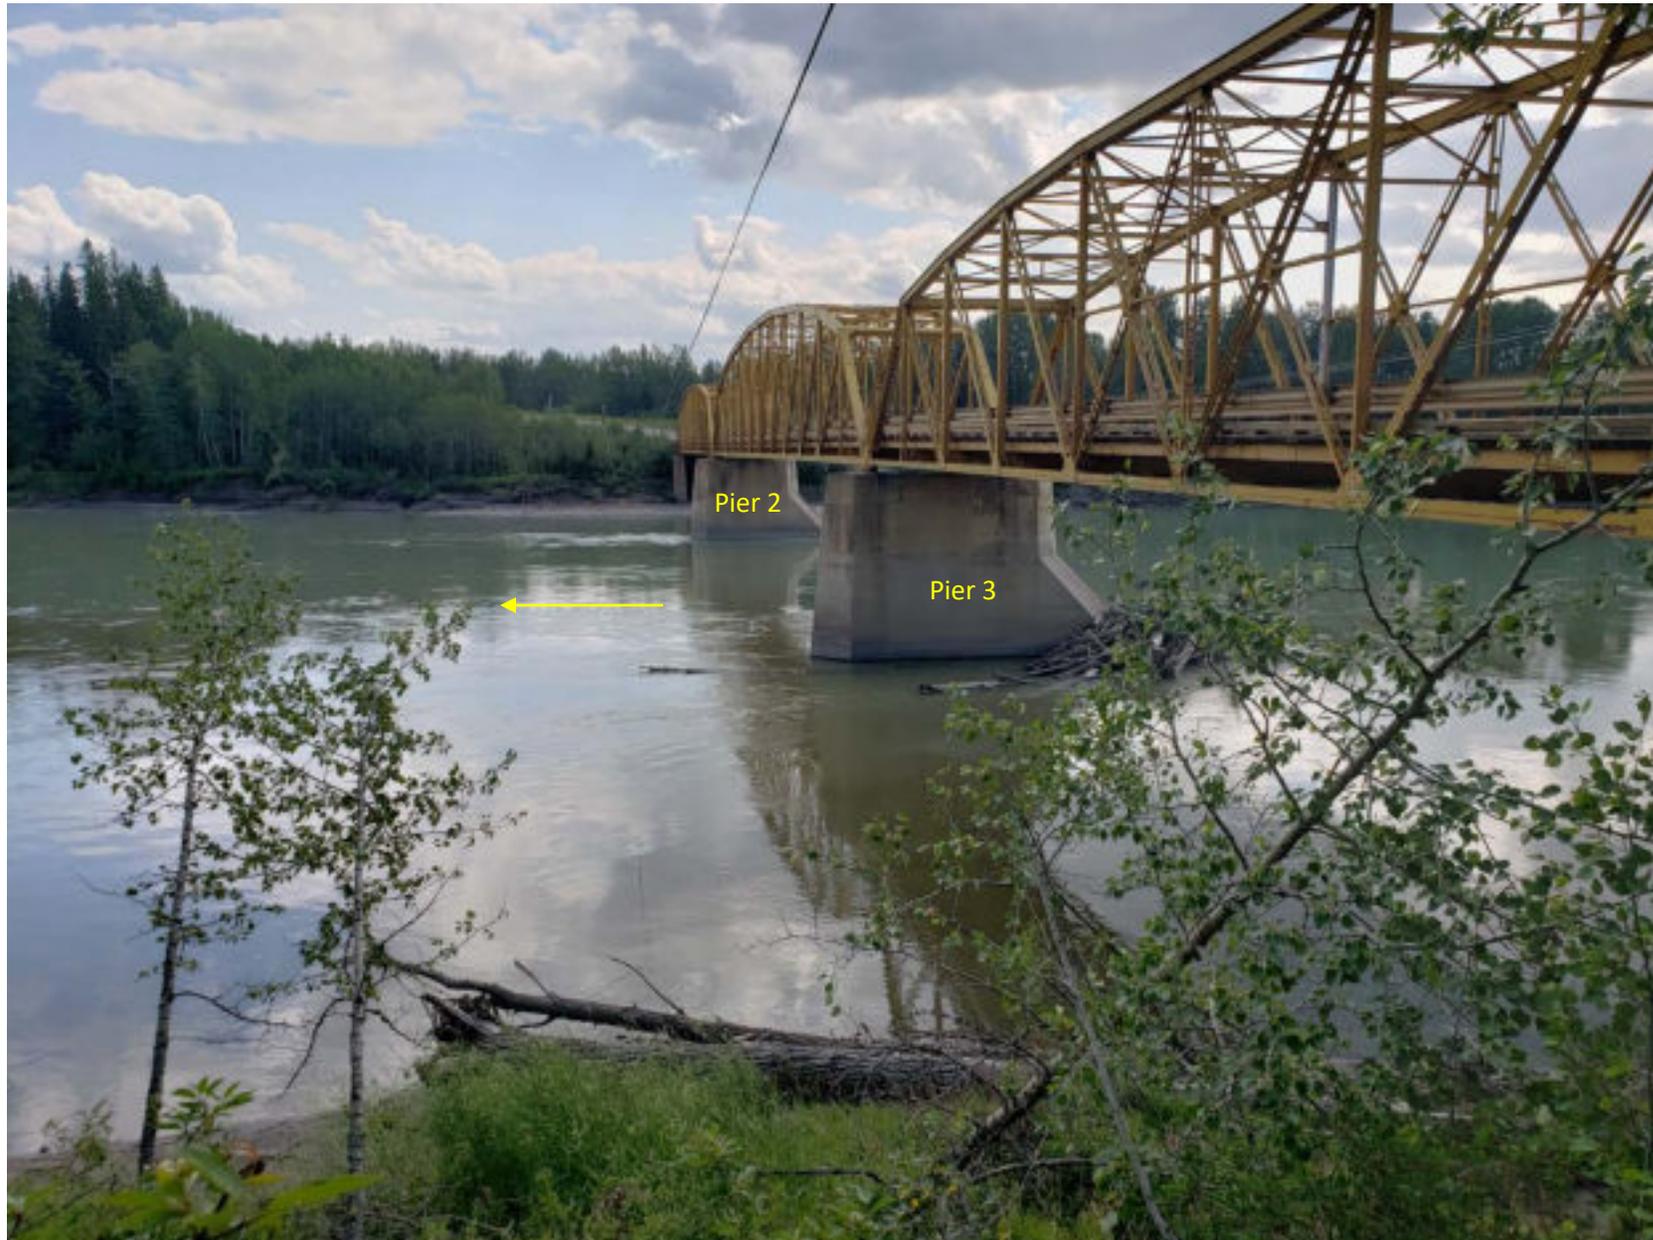
Site Photo 2 – downstream face of the bridge

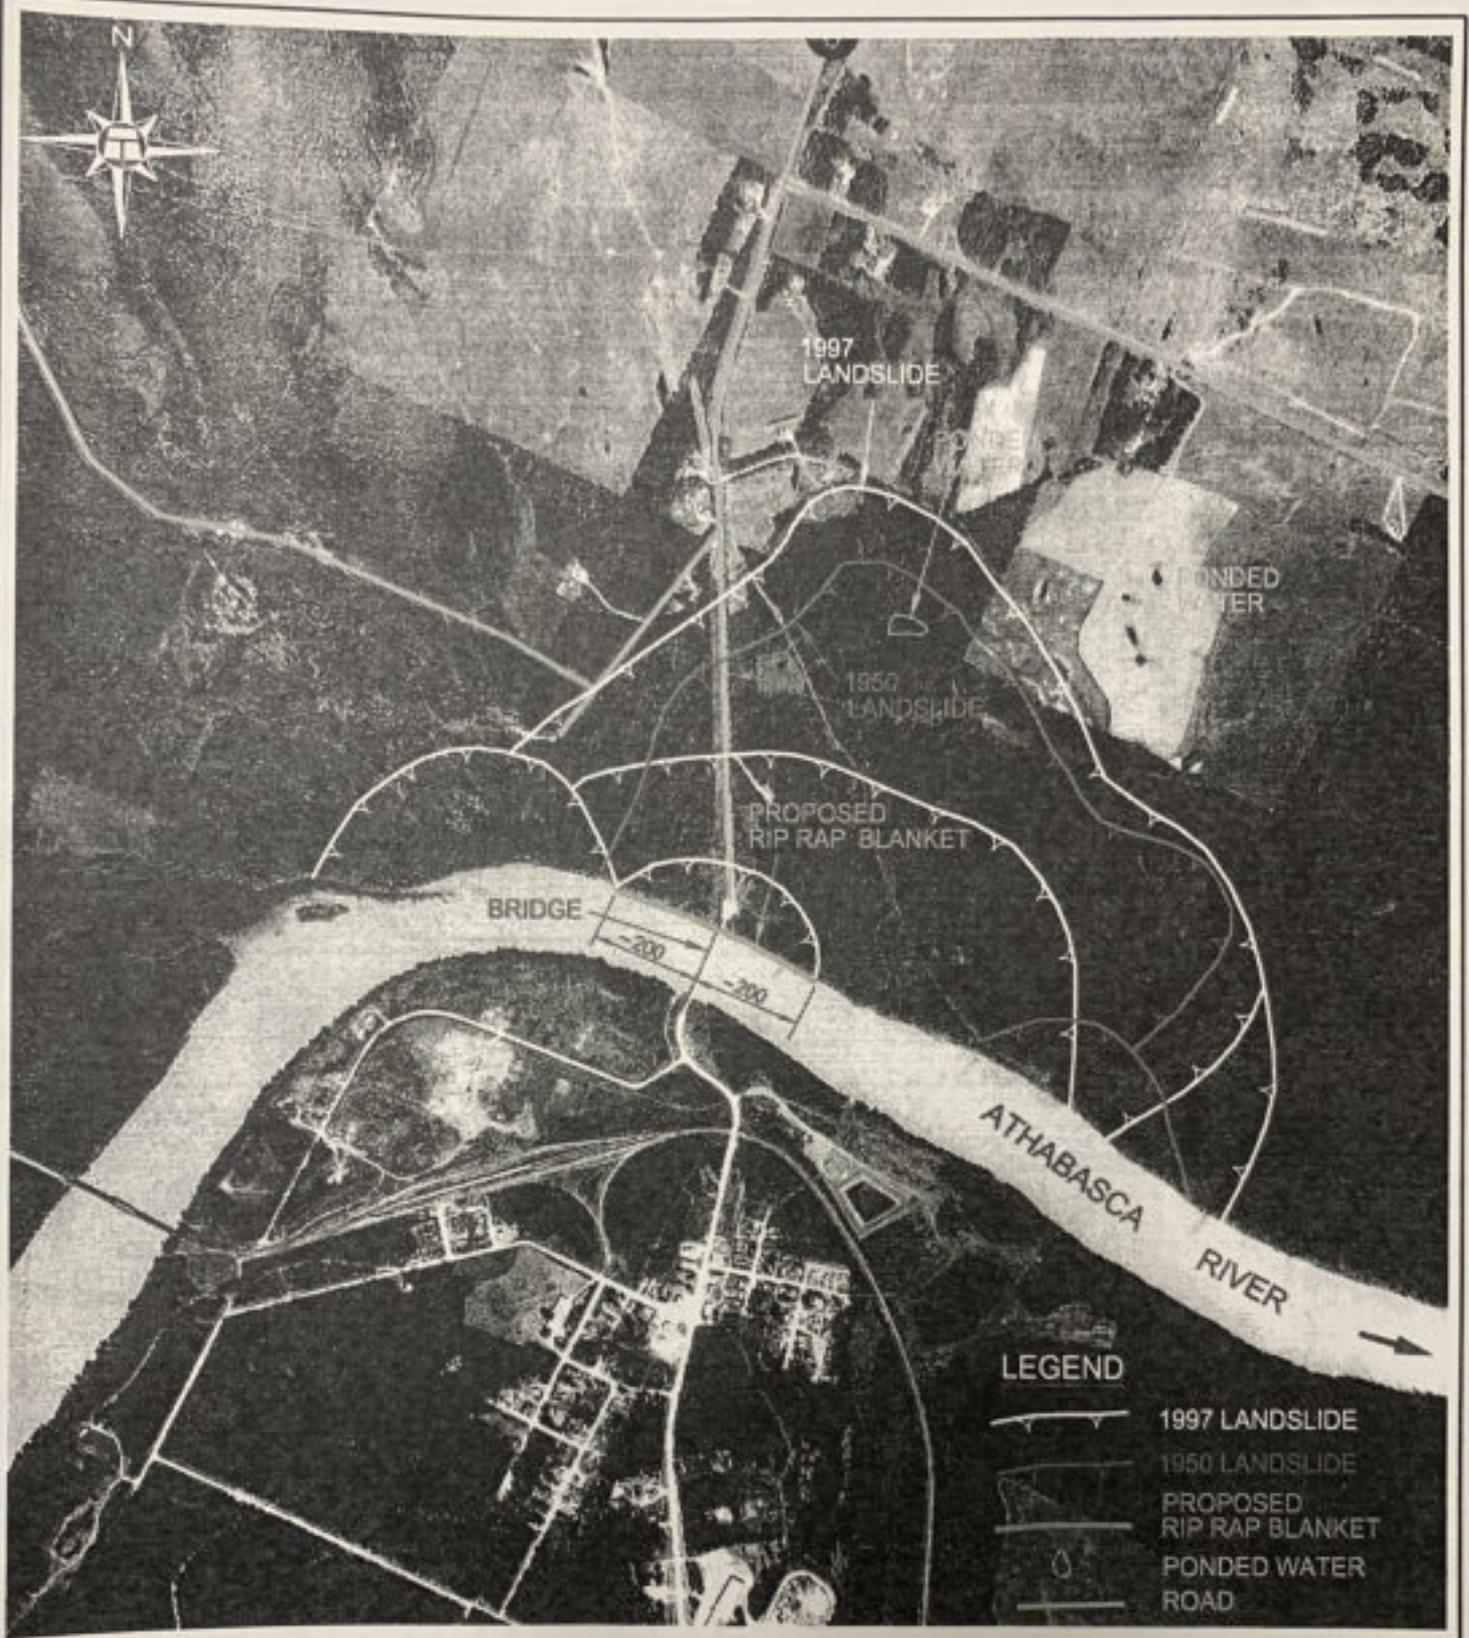
DRAWING No. **FIGURE 1**

The slide appears to consist of a series of blocks moving translationally likely along a common lower shear zone. The upper scarp of the landslide is at prairie level and is about 1000 m north of the river bank. The landslide is about 1500 m wide in the middle of the slope. Based on the air photographs, it is estimated that the landslide extends approximately 500 m upstream and 1200m downstream of the bridge along the slope toe (see Figure 1). The north bridge abutment is situated within the lowest slide block adjacent to the river.

The average slope from prairie level to river surface is in order of 6 to 7°. The slope is heavily wooded and the trees, are largely second growth aspen. Three to four scarps were noted within the overall slide which form the boundaries of the various block movements depicted schematically in Figure 2. Scarps up to a few metre high were present especially at the lower part of the slide (Photo 6 on Figure 5). Several small areas of ponded water were noted within the slide area and these are typically formed in poorly drained features that result from back tilted slide blocks caused by previous sliding (Figure 1 attached).

The rip rap armouring would be laid at the river's edge and extended up slope to design flood level as shown on Figure 1 attached. The rip rap blanket would be underlain by a pit ran gravel filter as a transition zone between the native soil and the rip rap.
